Technical product information

Topic	New GT boot lid motor information required
Market area	Bentley: worldwide (2WBE),Hongkong-Macau (5HK)
Brand	Bentley
Transaction No.	2044673/1
Level	EH
Status	Approval
Release date

New Continental GT

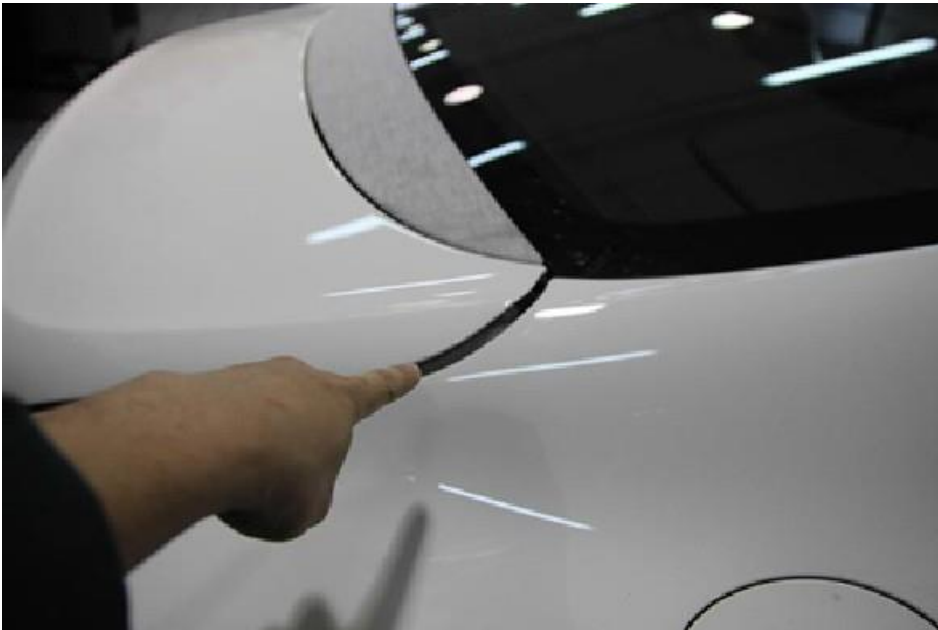
Figure 1

Boot lid hinge failure

As part of boot lid hinge failure investigation Bentley are analysing boot lid drive motor output

Example of hinge failure

14MY cars onwards. In the event of boot lid hinge failure please record the serial number of the motor that was driving the failed hinge. Submit this information via a DISS query quoting this TPI number

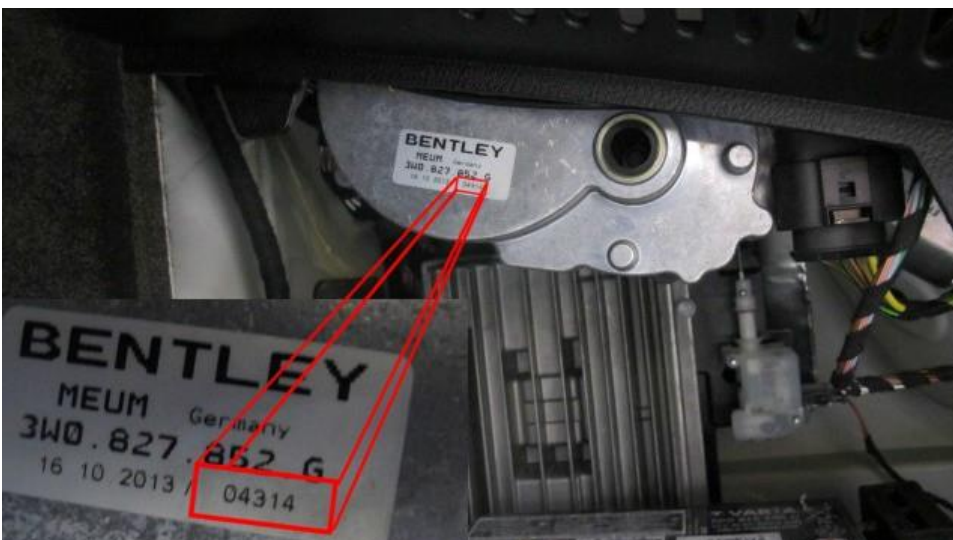
Figure 2

Location of required serial number located on boot lid drive motor
