Technical product information

Topic	Mulsanne rear suspension knock
Market area	Bentley: worldwide (2WBE),Hongkong-Macau (5HK)
Brand	Bentley
Transaction No.	2044308/1
Level	EH
Status	Approval
Release date

Knock from rear suspension

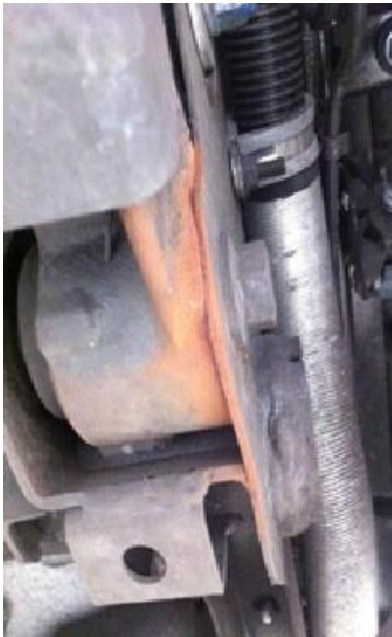
Figure 1

Inner metal sleeve of the rear lower suspension lever inner bush is, by design, not bonded to the elastic element of the bush this in some cases may allow the bush housing on the suspension arm to clash with rear subframe

2. If a clash is evident indicated by red deposits in vicinity of lower lever inner mount (see Figure 1) then remove the lower lever Rep. Gr.42 and inspect each inner bush replace damaged or worn bush as required note inner sleeve of bush is not bonded to elastic element therefore lateral movement in this sleeve within the elastic element is not in isolation grounds for replacing the bush

On receipt of a qualified customer complaint inspect the rear sub frame for evidence of lower lever clash if evident then fit isolation washers as detailed to the inner bushes of both rear suspension lower levers.
