# Service Bulletin

## PRELIMINARY INFORMATION

**Subject:** Foam And Cardboard Insert Found In Trunk During PDI

**Models:** 2016-2017 Chevrolet Volt

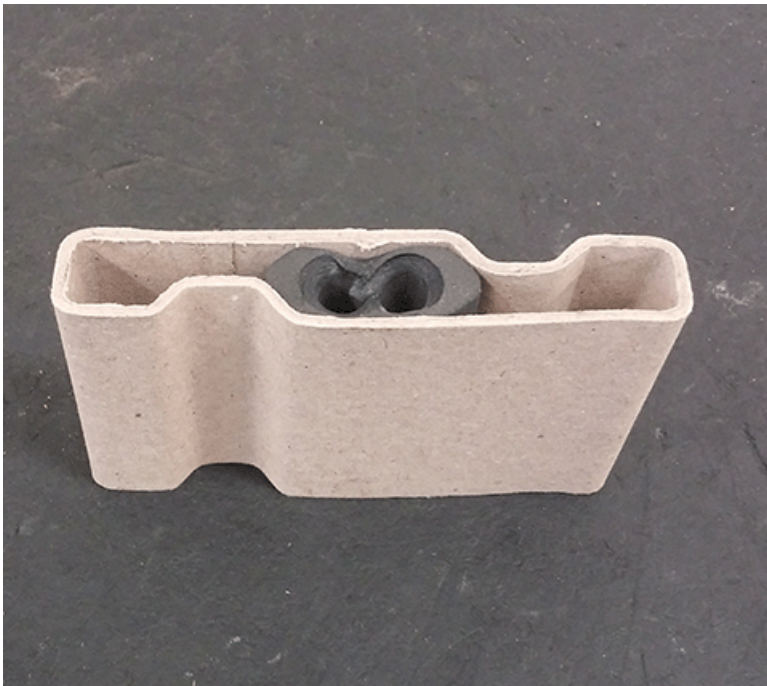
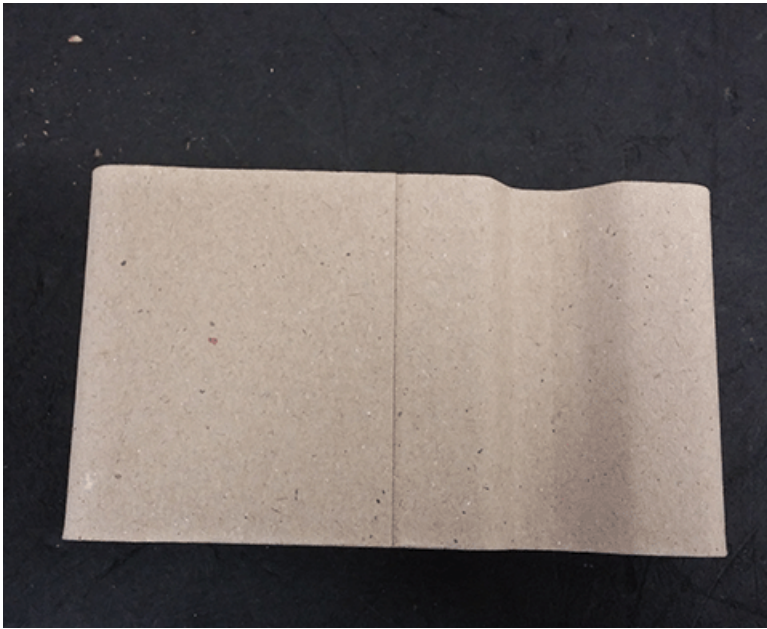
When performing a pre-delivery inspection you may find a piece of foam that is surrounded by a cardboard shell that is found in the vehicle during PDI. ( See Photos below )

This Insert is a spacer that is part of the tire Inflator kit and should be placed between the compressor assembly and the tire sealant canister. This Insert needs to be installed to prevent the damage to the contents of the bag when tightening the hold down for the Inflator kit.
