Service Bulletin

Subject: Diagnostic Aid-Phone Will Not Connect To Android Auto

Models: 2016 All Passenger Cars and Trucks (Excluding Buick Envision, Cadillac SRX)
Equipped with Radio RPO IOA, IOB, I05 or I06

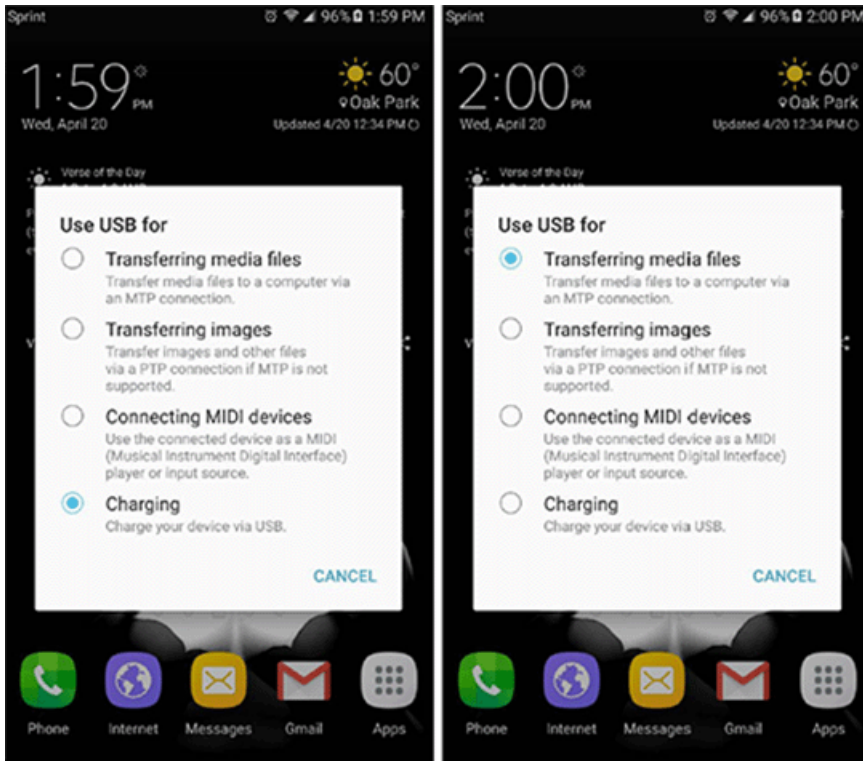
A customer may state that their phone will not connect to Android Auto.

This may be caused by the latest Android update (Marshmallow 6.0) from Verizon.

With the update, the Android phone will now default to "charge only" when plugged into a USB port.

When the phone is plugged in, "Transfer Files (MTP)" will need to be selected.

1. Have the customer connect their device to the vehicle's USB port.
2. On the device, swipe down to from the top of the screen to display the Notification Panel (the list may automatically be displayed on some devices when plugged in via USB)
3. Select the "Connected for Charging" notification.
