Transmission Fluid Pan Leaks

AFFECTED VEHICLES

2016 Accord with CVT

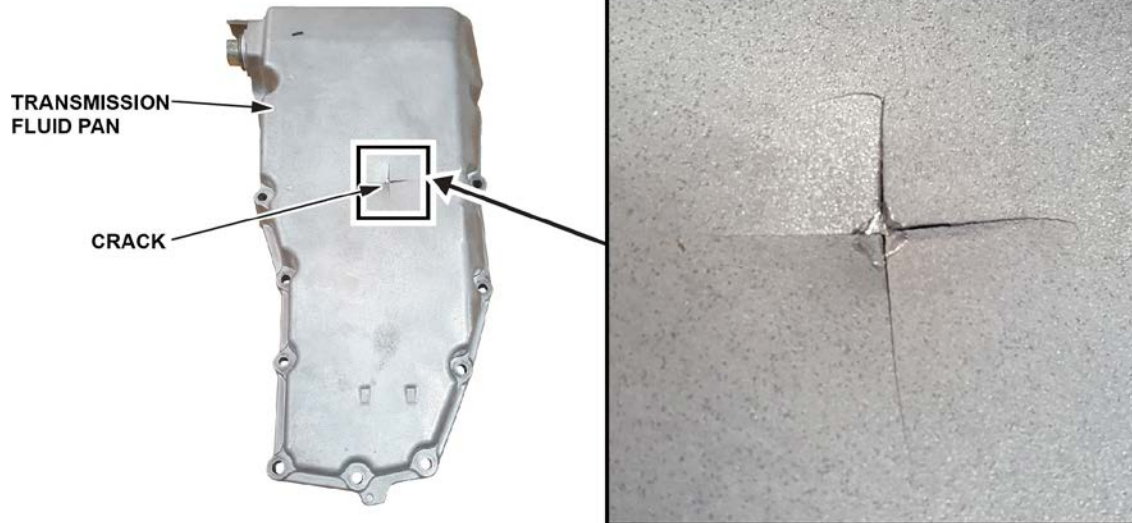
Is the transmission fluid pan leaking from a crack like you see here?

Chances are your customer accidentally ran over something that drove the lower engine cover up into the transmission fluid pan. The cover's front clip, which is made of metal, cracked the pan from the impact.

When replacing the transmission fluid pan, be sure to replace the lower engine cover (P/N 74110-T2F-A01) as well. The replacement lower engine cover eliminates the front hole and clip and replaces the metal clip for the second hole with one made of resin.

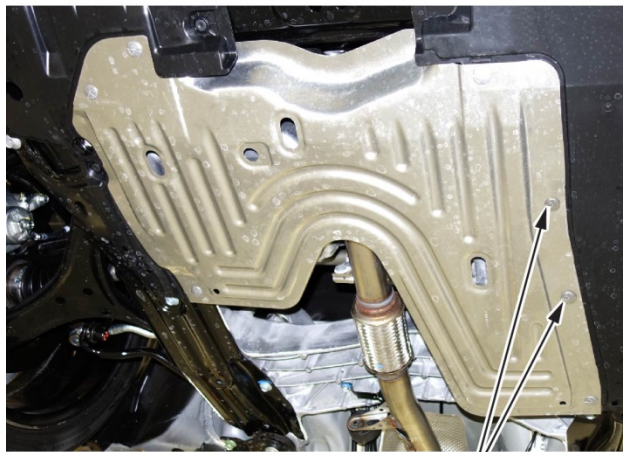
Lower Engine Cover - Old

METAL CLIPS (2)

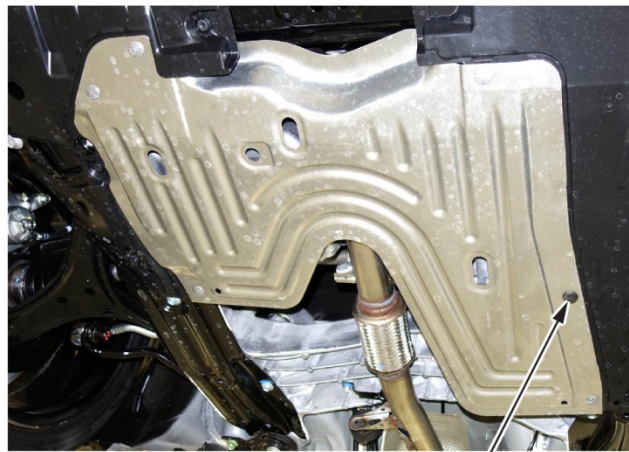
Lower Engine Cover - New

RESIN CLIP
