Technical Service Bulletin TS 04 92916

Driveshaft Flange and Oil Seal for Spare Parts Supply

Affected Models: All 4WD SX4 (RW420) Models

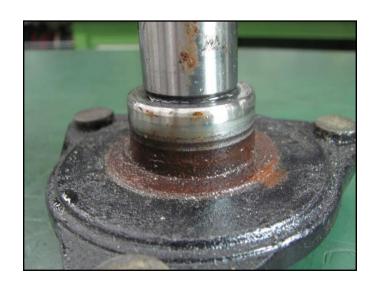
These new parts have been designed to improve prevention of corrosion to the driveshaft flange seal and driveshaft flange. Corrosion has been identified on vehicles driven in severe winter conditions, such as driving on roads with de-icing agents.

If visual inspection reveals corrosion on the driveshaft flange as shown here, the oil seal lip might be damaged.

Replace both the driveshaft flange and oil seal with the new parts listed in this Technical Service Bulletin.
