iNformation

MSN 15742 (1602)

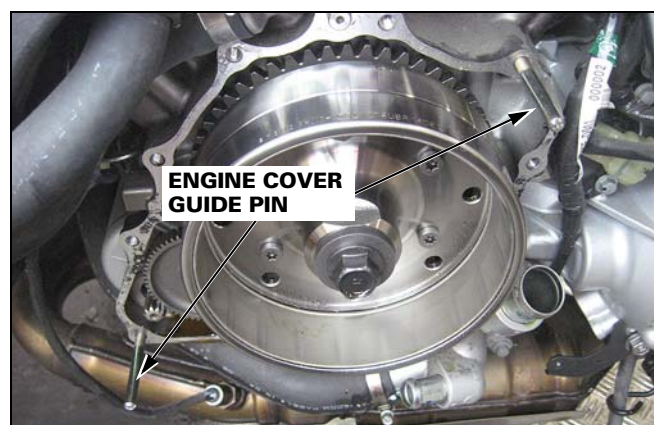
Installing Engine Covers

Proper alignment is critical for engine covers on torque converter equipped engines, DCT type transmissions where the oil feed tubes could be damaged if the cover is not installed correctly; or an engine cover with a gear position switch which has to be indexed correctly and could be knocked out of alignment during the installation. Potential problems can be avoided by using a pair of guide pins installed on the engine-side of the assembly to ensure the cover goes on correctly. Guide pins can be easily fashioned from long case cover bolts by cutting off the head of the bolt and slotting the tip for a flat-blade screwdriver. Install the guide pins on opposite sides of the cover so that it is supported evenly. Use caution when installing alternator covers this way as the cover is magnetically attracted to the flywheel and may pinch your fingers.

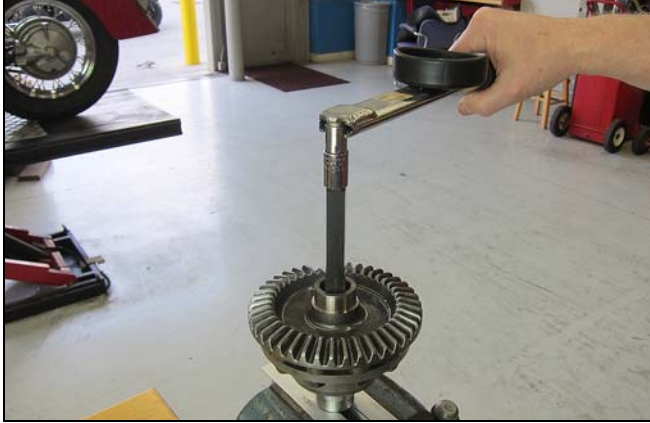
5. Apply the torque wrench to the hex fitting on the end of the tool and check that the

differential slips somewhere between the lowest and highest value of the specified torque range.

14 – 17 N·m (1.45 – 1.75 kgf·m, 10 – 13 lbf·ft)

12 N·m (1.2 kgf·m, 9 lbf·ft)

If the slip torque is out of specification, disassemble the differential and perform the components inspection as the differential may be faulty.

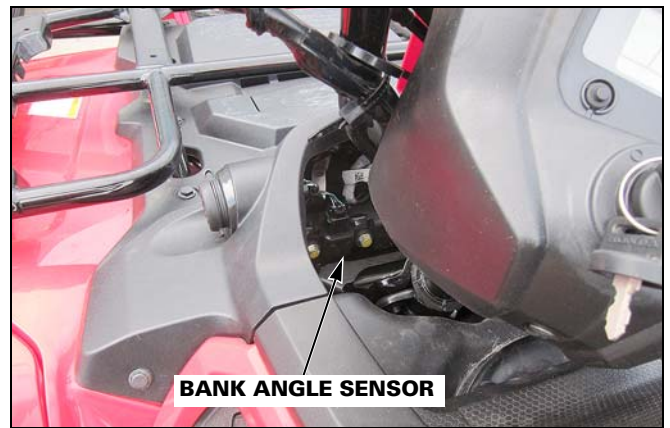
Bank Angle Sensor Location

Reports from the field indicate that a faulty bank angle sensor (BAS) is often to blame when the engine fails to start, or starts and then quits. There are also BAS failures that don't cause the engine to stop, but cause the MIL (check engine light) to flash. But, before troubleshooting the BAS specifically, check all the simple stuff like fuel level, engine stop switch, and battery voltage.

The BAS is located on the frame just ahead and to the left of the steering shaft as shown. The Service Manual advises removing the front fender/carrier to access BAS, but it can be accessed by turning the handlebar fully to the right as shown.

- If the engine does not shut off, the BAS is faulty - replace it.
- If the engine shuts off within 10 seconds, the BAS is OK. Connect the MCS tester and proceed to troubleshoot for DTC 54-1 or 54-2 (Bank Angle Sensor Circuit) by following the procedure in the Service Manual.

1. Disconnect the BAS connector from the BAS body and then start the engine.
 - If the engine starts and continues to run, the BAS is faulty - replace it.
 - If the engine does not start, proceed to troubleshoot the cause by following the SYMPTOM TROUBLESHOOTING table within the PGM-FI section of the appropriate Service Manual.

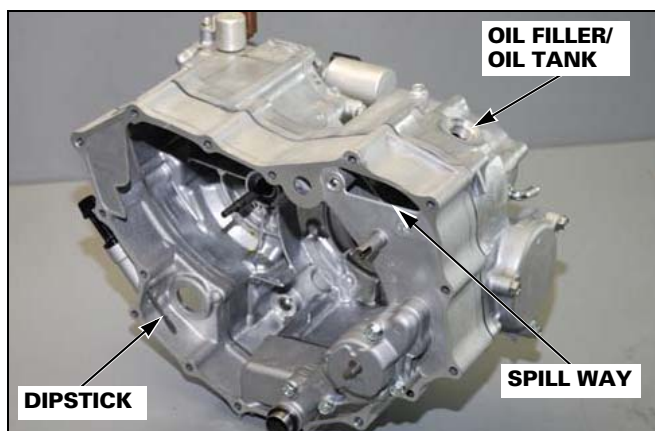
Oil Changing Tip

These models utilize a semi-dry sump oiling system where the oil tank is integrated into the crankcase. Because of this feature, when refilling the oil tank it appears that oil will come out of the filler hole before anything shows up on the dipstick. This is a normal condition as the oil needs to fill up to the top portion of the oil tank before it flows over the spill way and then down into the front crankcase cover where the dipstick is located.

The best way to refill the oil on this machine is to pre-measure the amount of oil and slowly pour it into the engine. Once filled, run the engine for three to five minutes, turn it off and then check the oil level after waiting two or three minutes for the level to settle. Use the following volume specs, and the oil level should be spot-on.

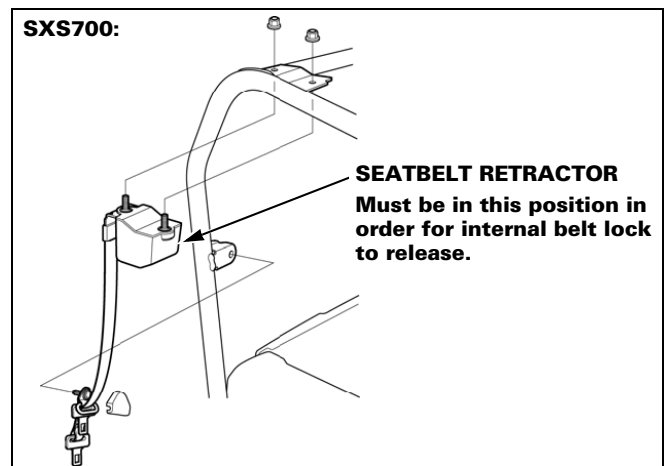
Rear Seatbelt Retractor... Won't

If you're testing the rear seat belt retractor before it is mounted to the vehicle and you find the belt is stuck in its housing and won't pull out or retract, that's because it's designed to lock the belt when the vehicle tilts.

The rear seat belt retractor has an internal locking mechanism within the housing that will lock the belt if the housing is at an angle other than how it is normally mounted in the vehicle. If the belt gets stuck, hold the housing in the orientation that it would normally be mounted in the vehicle as shown. Then, feed a small amount of the belt back into its housing, then *gently* pull it back out. This should de-activate the locking mechanism and it should operate normally again. This method can also be used to free a customer's stuck seat belt.
