| SUBJECT: | Lower door spherical bearing and pivot bracket replacement |
| JUSTIFICATION: | This campaign is being issued to highlight the lower door bearing and pivot bracket replacement done by Vapor. |

FMI-14-043A

FMI-14-048A

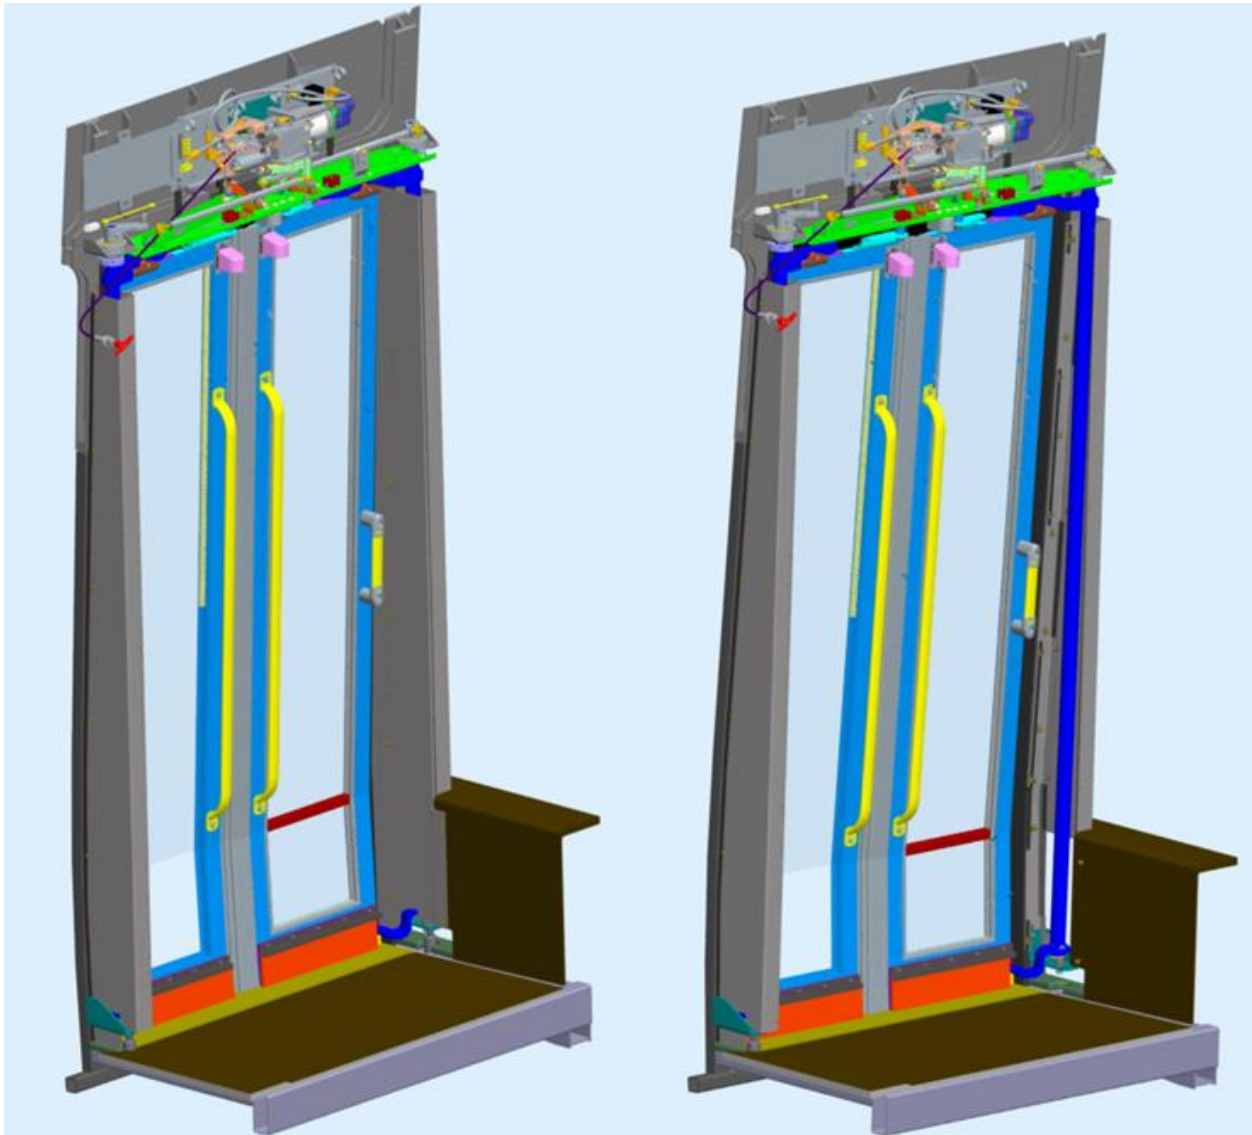
**H.1.** Remove the Post Capping to expose the Shaft Assembly and the Lower Pivot Bracket. Determine if there is contact between the lower arm and the Lower Pivot Bracket and/or noise when the door opens. If either situation occurs proceed to step H.2. If neither exists replace the Post Capping and move the next Door opening.
