Service Bulletin

Bulletin No.: 15-08-51-001C

Subject: Availability of Insulator Service Part for Prevention of Liftgate Rust/Corrosion at Center Applique

Models: 2010-2015 Chevrolet Equinox
2010-2015 GMC Terrain

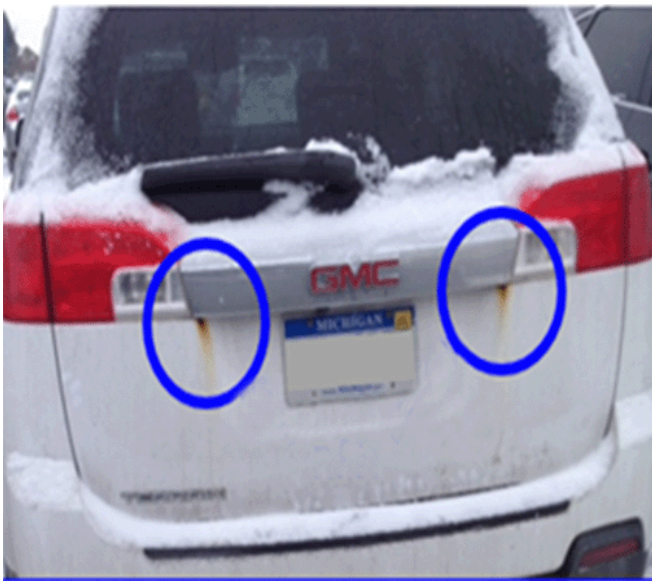
4252404

On some vehicles, due to the applique contacting and rubbing on the liftgate painted surface, rust spots (shown circled above) may be evident at the lower corners of the center chrome applique on the rear liftgate. Insulator service parts, that install between the applique and the liftgate, are now available as a preventative measure to avoid this rust condition.

When repairing this rust spot condition, it will be necessary to remove the original applique, and repair any rust spot condition following common industry standards. Then, depending on model being repaired, follow the appropriate service part replacement advised below:
