GROUP ELE	MODEL 17MY Sportage (QL)
	NUMBER PS453	DATE June 2016

SUBJECT: INTERMITTENT AM/FM RADIO STATIC

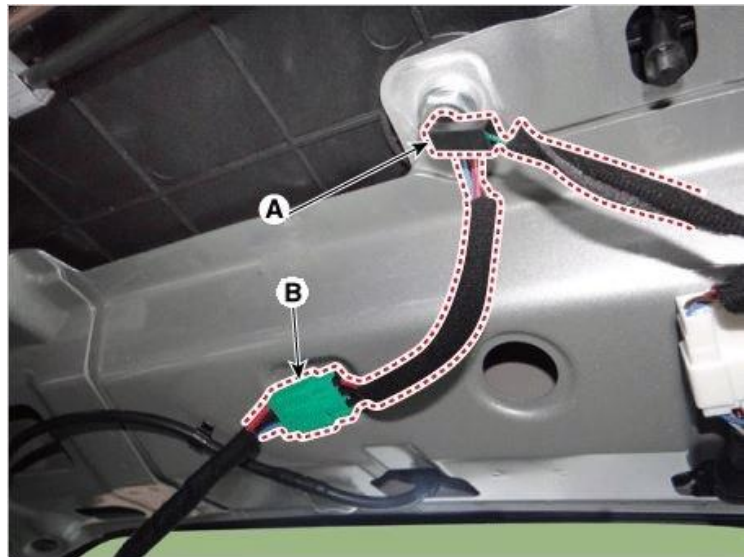
Some 2017MY Sportage (QL) vehicles may experience AM/FM radio static, especially when the vehicle drives over bumps. This condition can be caused by loose connections at the base of the antenna. Follow the procedure outlined below to resolve the concern.

1. Expose the base of the roof antenna by removing or lowering the rear roof trim by referring to the applicable service procedure on KGIS.
2. Check the indicated connectors A and B.
