Service Update

38240 Manual Front Seat Track Lockset Pin Broken or Not Crimped

Reference Number: N162038240
GWM Number: 2038240

Release Date: June 2016
Revision: 00

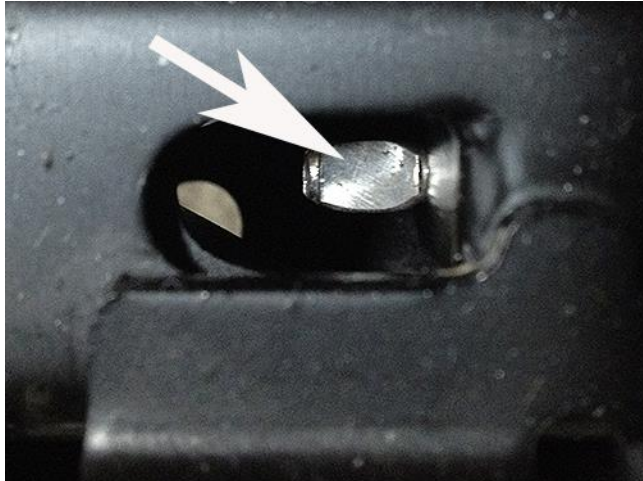
4489433

Proper Crimp - acceptable condition

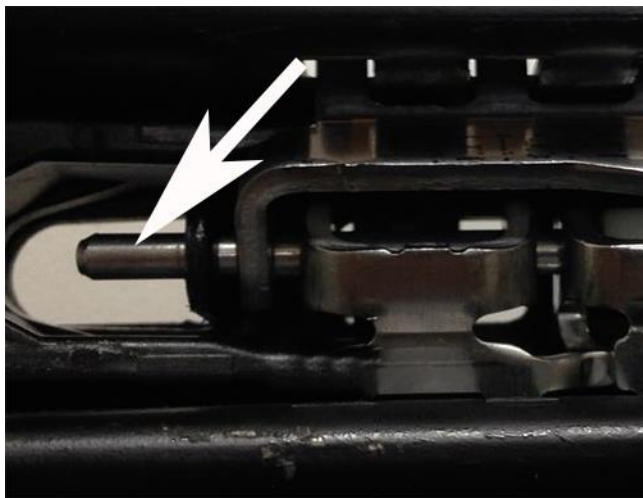
4489441

No Crimp - unacceptable condition

If any of the pins display an unacceptable condition, replace the lower seat frame assembly. Refer to *Driver or Passenger Seat Cushion Frame Replacement* in SI

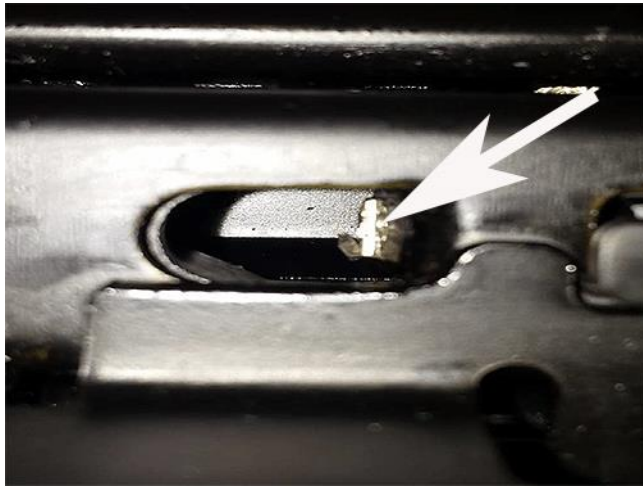
4489445

Pin Broken Off At Crimp - unacceptable condition

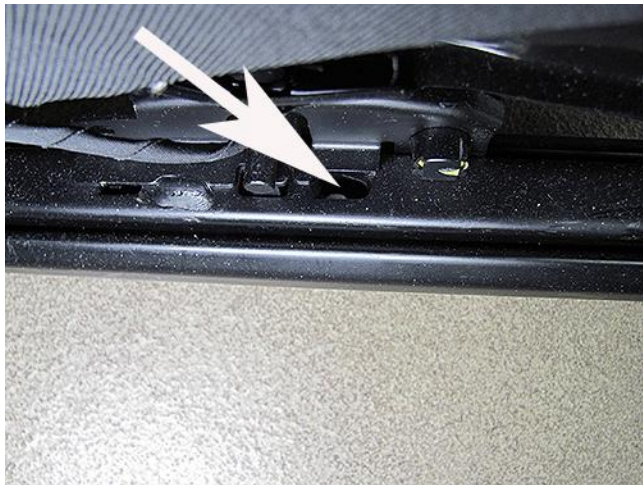
4489453

2. Looking through the front clearance hole in the outer seat track assembly, determine if the steel pin is properly crimped.

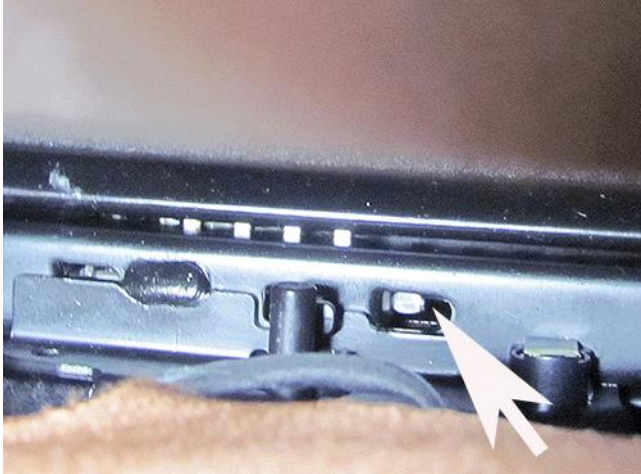
4489449

3. Looking between the seat and console, locate the front clearance hole in the inner seat track assembly, determine if the steel pin is properly crimped.
 - If the steel pins are properly crimped, no further action is required. Reinstall the outer seat track garnish molding. Refer to *Front Seat Adjuster Track Finish Cover Replacement* in SI for Cruze vehicles. Refer to *Front Seat Belt Anchor Plate Tensioner Cover Replacement* in SI for Volt vehicles.
