Service Update

43940 Brake Transmission Shift Interlock (BTSI) - Transmission Won't Shift Out of Park

- Subject: 43940 Service Update Brake Transmission Shift Interlock (BTSI) Transmission Won't Shift Out of Park
- Models: 2016 Chevrolet Malibu 2016-2017 Chevrolet Volt

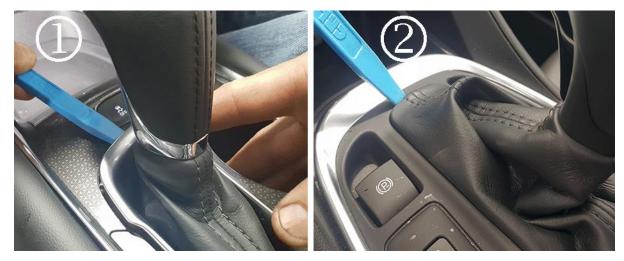
2. Using a plastic trim tool, remove the front floor console transmission shift opening bezel ((1) Malibu (2) Volt) and pull up the shift boot to gain access to the BTSI.

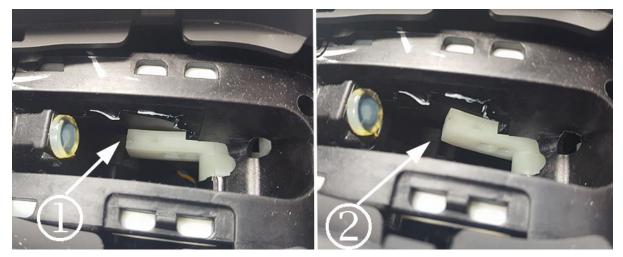
- 3. With the ignition on, check the function of the BTSI by pressing down and releasing the brake pedal multiple times. The BTSI should travel from resting (1) to fully open (2).
 - If the BTSI functions properly, no further action is required.
 - If the BTSI binds or does not travel fully, continue to step 4.
- 4. Remove the transmission control. Refer to Transmission Control Replacement (Without Base) in SI.
- 5. Install the transmission control. Refer to Transmission Control Replacement (Without Base) in SI.
