This Pitstop provides information relating to 2014-2015MY Optima (QF) vehicles with Blind Spot Detection (BSD), which may exhibit a "Check BSD System" message and no communication with the BSD system after collision repairs. This concern is commonly caused by the rear bumper harness installed backwards.

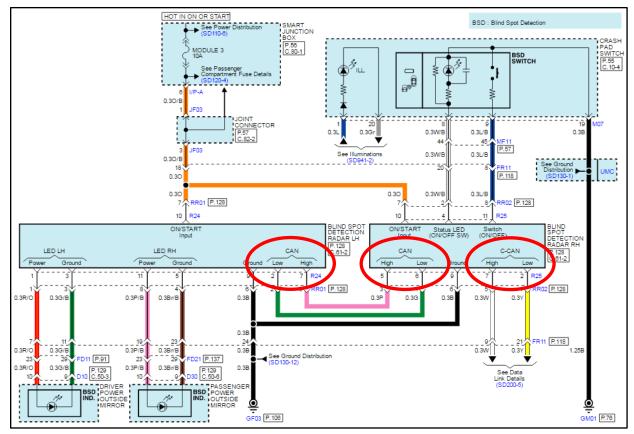
The master BSD module, located at the right side of the rear bumper, is the only BSD module that communicates on the C-CAN. The slave module (left side of bumper) communicates to the master module via local network CAN. The master (R25) and slave (R24) module connectors are physically identical and may be mistakenly swapped.

To confirm correct installation of the harness, verify that the yellow and white wires of the master (R25) module connector are at pins 2 and 7. See diagram below.

It is important to note that the BSD system calibration must be performed after any rear collision repairs. Failure to do so can result in improper BSD system operation.
