NISSAN BULLETIN

FRONT PROP SHAFT BOLT TORQUE Dealer Inventory Inspection

Reference: PC474
Date: July 30, 2016

DEALER SERVICE ACTION PC474 - 2016 TITAN (A61) – FRONT PROP SHAFT BOLT TORQUE

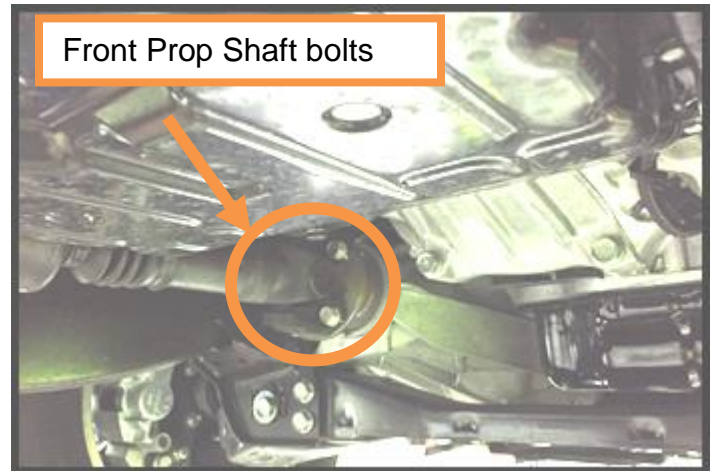
Figure 1

2. Locate the (4) front prop shaft bolts (Figure 1).

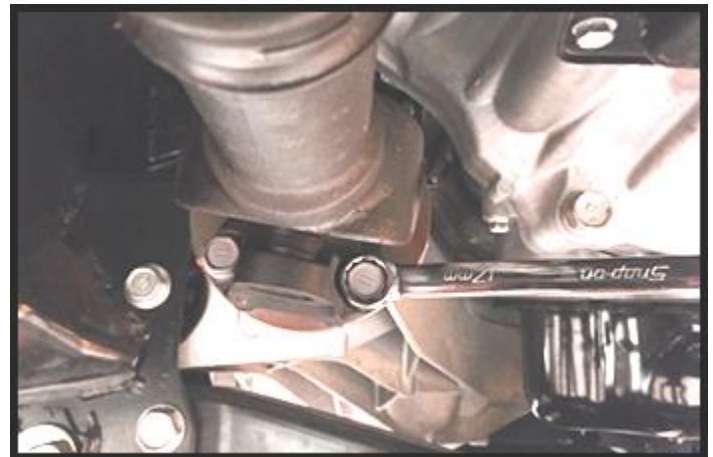
Figure 2

3. Place a 17MM box end wrench on one of the bolts, while holding the Prop Shaft in place and apply LIGHT to MODERATE force, repeat on the other bolts. (Figure 2):

- If **any** of the bolts move (NOT the prop shaft) **replace** all 4 of the front prop shaft bolts and nuts, (see Parts Information below).
- Torque NEW Front Prop Shaft bolts and nuts:

80N·m (59 ft-lb)
