2017 Mirage G4 Sedan

TECH TALK

Volume 220 - May, 2016

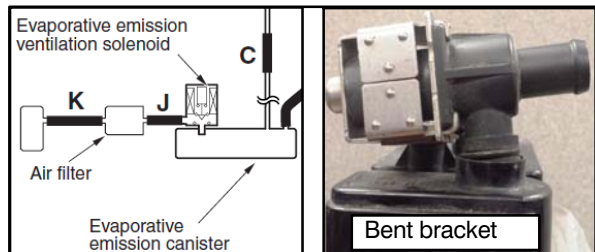
The vent solenoid bracket attached to the evaporative canister may be susceptible to bending and cause DTC P0442 to be stored in the ECM. During DTC P0442 troubleshooting, a visual inspection of the vent solenoid bracket

may assist in proper diagnosis.

Also, inspect the hose clamps around the evaporative canister and ensure they are positioned correctly. If either of these conditions are present, repositioning the part(s) may correct the issue. You can force the monitor to run with MUT-III to determine if the repair was effective.

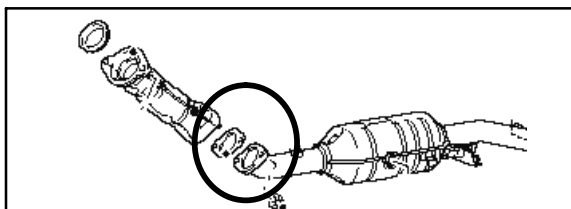
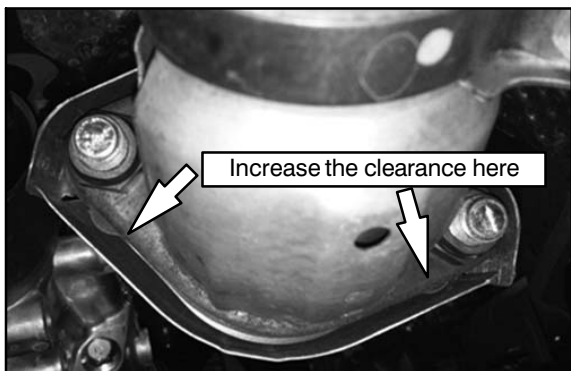
When diagnosing a buzzing noise from under the vehicle, the source could be either of the following locations:

If the noise occurs around 2500 rpm, while driving or in Park, inspect the exhaust gasket between the front pipe and catalytic converter. It's possible that a front pipe heat shield is contacting the exhaust gasket tabs. The noise can typically be recreated with the vehicle in Park for easy confirmation. To resolve this condition, increase the clearance between the heat shield and the tabs using a long screwdriver or appropriate pry bar. Retest to confirm the repair.

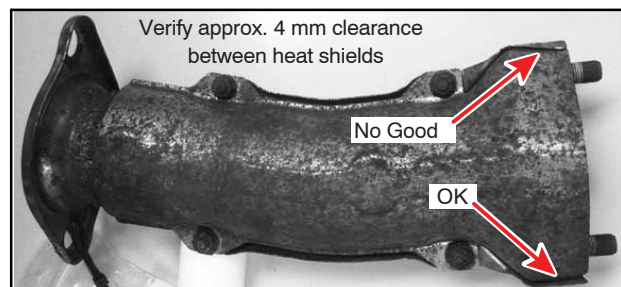
Also verify that the heat shields shown in the photo below are not touching. If the heat shields are touching, use a screwdriver or appropriate device to pry them apart so there is approximately 4 mm clearance. Do NOT replace the center exhaust pipe with catalytic converter until all other potential causes of BSR have been eliminated.

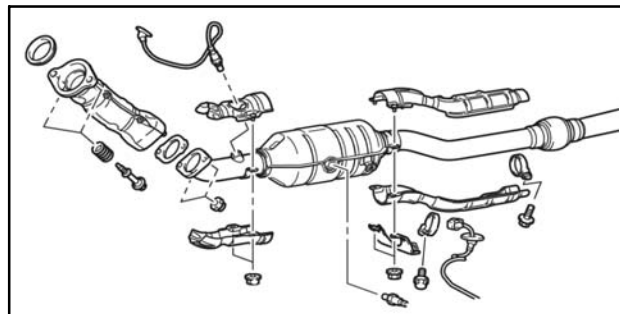
Several of the exhaust pipe heat shield components are now available as service parts. When repairing a vehicle for a noise due to a loose heat shield, do NOT replace the center exhaust pipe with catalytic converter if the heat shield can be serviced separately. Consult CAPS for further details.

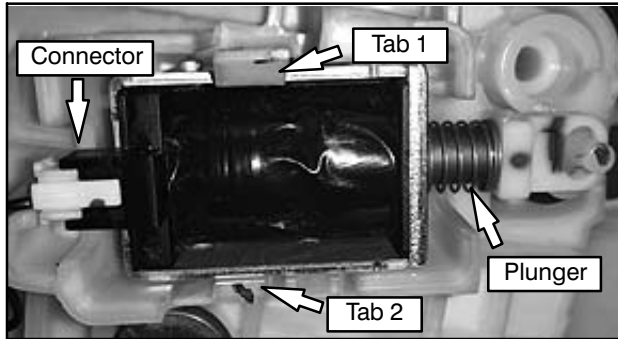
Remove the RH console side panel. While watching the movement of the shift lock solenoid, have someone apply the brake pedal with the ignition ON to determine if the solenoid retracts. If the solenoid does not retract, it may be due to foreign material, identified as a sugary drink (e.g., Cola) residue built up in the solenoid

plunger bore and on the solenoid plunger. This prevents the solenoid from retracting and the shifter cannot be moved from Park.

Remove the solenoid for cleaning as follows:

- Remove the solenoid from the shifter assembly by GENTLY releasing TAB 1.
- Carefully wedge a small screwdriver into the channel of TAB 2 to release the lower locking tab.
- Remove the solenoid by pulling it straight out.
- Unplug the electrical connector.
- Remove the spring and plunger and clean them with soap and water.
- Dampen a wet paper towel or lint-free rag with water and insert it into the bore of the solenoid to clean it.
- Reattach the electrical connector and re-install the solenoid to the shifter in reverse order of removal.
- Confirm solenoid and shifter operation and reinstall the console side panel.

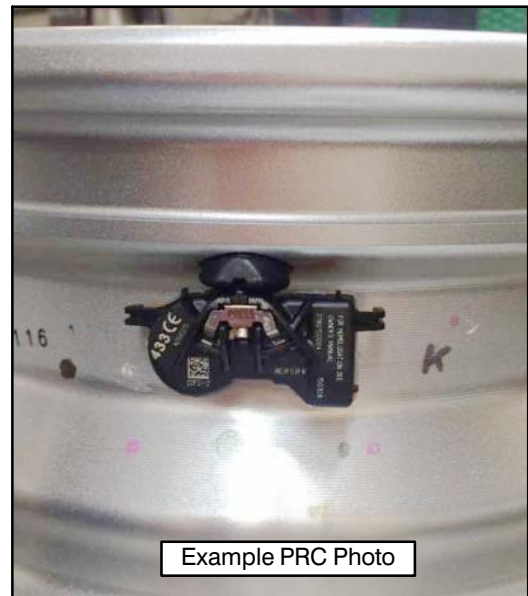
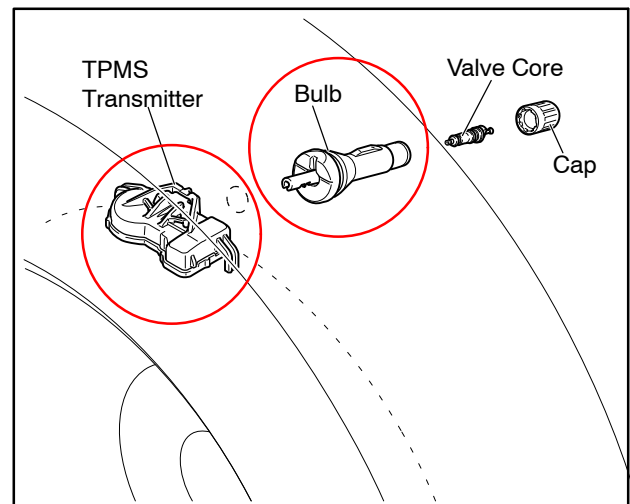
If you replace a TPMS sensor on any 2014 – 2015 Mirage you are required to submit a photo to the PRC. The photo needs to show whether or not the TPMS sensor (body) was attached to the wheel (valve stem) when the tire was dismantled. In addition to posting the photo, please report the failure DTC(s) on the PRC report, and add a comment describing whether

or not the tire had ever been dismantled prior to this service (e.g., YES – The tire was dismantled prior to this service, or NO – the tire was never dismantled prior to this service). If it is not apparent that the tire was previously dismantled, the customer should be able to provide that information. MMNA will issue a Warranty Parts Return Request for all replaced (Mirage) TPMS sensors (which includes the valve stem and bulb in addition to the sensor body). Once returned, the TPMS sensors will be combined with their respective PRC photos and forwarded to the supplier for analysis. Please continue posting the TPMS sensor photos to the PRC until a cancellation notice is published by MMNA headquarters. Upload PRC photos into the category titled “TPMS Sensors in Wheel Photos.”

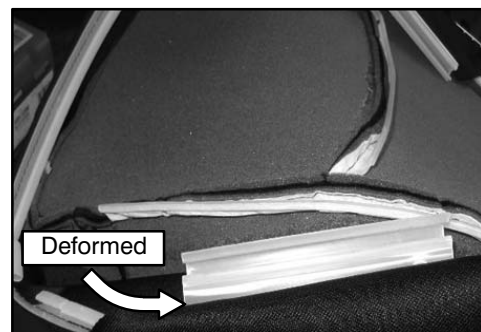
If a customer reports the seat cushion cover (seat bottom) is loose, check under the seat to see if the cover retaining strips are detached. Over time, the white plastic “J hooks” can lose their shape and become detached, causing the cover to loosen. If you find that a loose seat cushion cover is caused by detached cover retaining clips, discuss the possibility of repair with a local upholstery shop to determine if the cover can be securely reattached using “hog rings” or some other suitable retention method.

Do NOT replace the cover unless it cannot be successfully reattached by an upholstery shop.

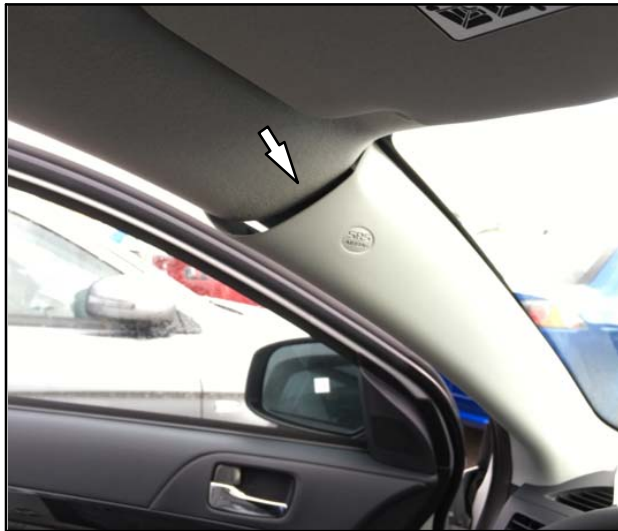
If a vehicle exhibits loose trim at the top of the right or left A-pillar, dealers are asked to take clear photos of the condition, then submit a Product Quality Report (PQR) in MDL, attaching the photos to the report. This should be done prior to any A-pillar trim removal.

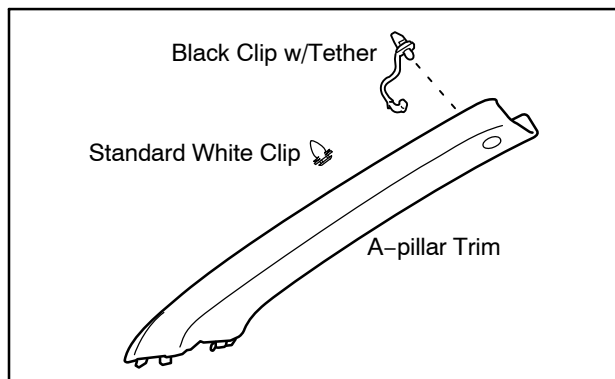
When replacing the A-pillar, be aware that there are 2 different clip types used, specific to location. The black clip with the tether is positioned at the top of the trim, as shown below.

Inspect for any damage to the clip ends. Note in the PQR which portions of the clips have come loose. Replace the clips as necessary using Service Manual procedures.

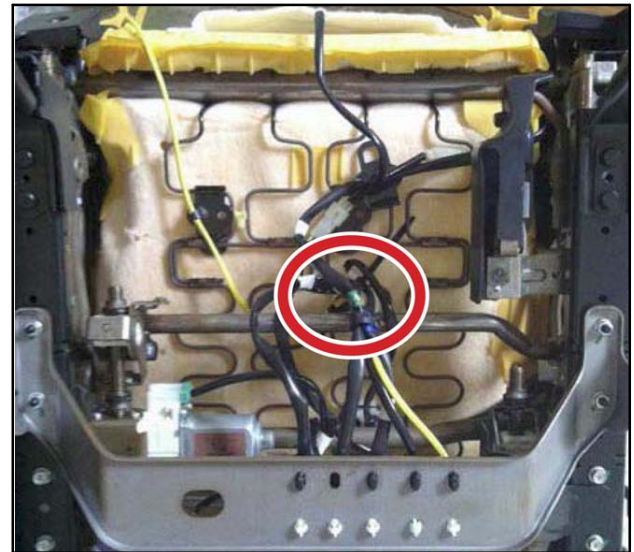
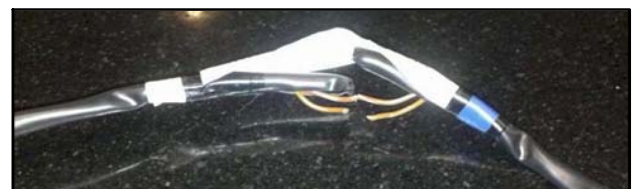
As published in TIN-15-52B-001, MMNA has identified warranty claims for SRS DTCs B1558 (Occupant Classification-ECU DTC Present) and B1556 (Driver’s Seat Slide Sensor Malfunction [Occupant Classification-ECU]) with OCM DTC B1B8D (Driver’s Seat Slide Sensor Open Circuit). Additional OCM DTCs that may also be present are: B1B8C (Driver’s Seat Slide Sensor Circuit Performance) and B1B8E (Driver’s Seat Slide Sensor Short Circuit).

During diagnosis, technicians should check for damage to the driver’s seat slide position sensor harness in the location shown below.

If a damaged harness is found, DO NOT replace the front seat adjuster or SRS ECU for this condition. The harness is now shown in CAPS and is available as P/N 6979A429.

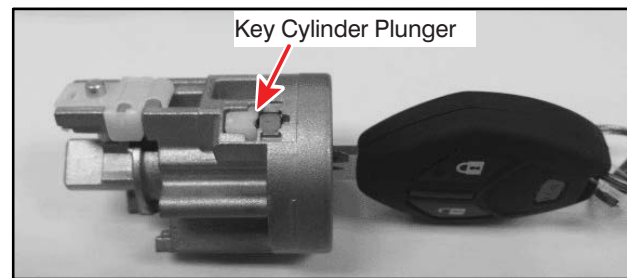
Step 2. Remove the key cylinder lock from the housing and inspect the key cylinder plunger. Remove and insert the key into the cylinder several times to determine if the key indicator plunger properly retracts into the cylinder housing when the key is removed. Lightly lubricate the plunger and retest. If foreign material is present on the plunger, also apply lubricant into the key opening to loosen any foreign material inside the cylinder.

- If the plunger does not operate freely, replace the key cylinder. The repair is complete.
- If the plunger functions properly, reinstall the Lock Cylinder & Key Set into the housing. Go to step 3.

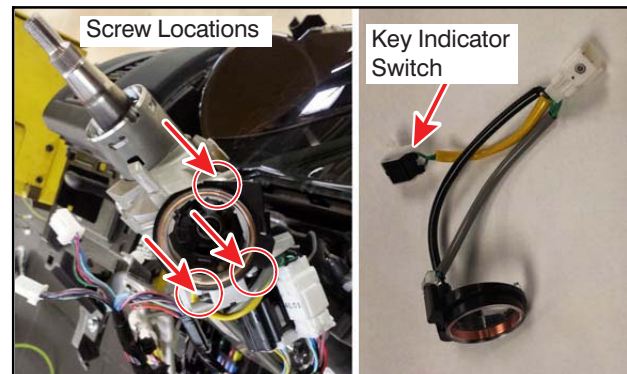
If the malfunction continues, replace the Engine Starting Switch-Attaching Switch (P/N 4408A155). Remove 3 screws (marked with circles below; 1 for the antenna and 2 on the micro-switch), detach the switch, replace, and reassemble. Check for proper function.

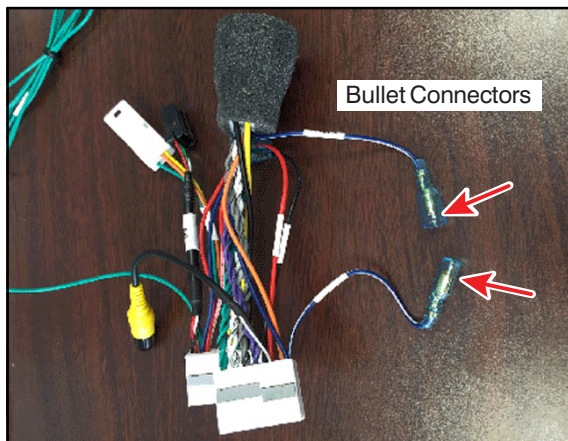
Customers may complain that the rear view camera image is not displayed on DAS when vehicle shift selector is placed into reverse. One possible cause may be the bullet connector (blue wire with white stripe – reverse signal) on the DAS wire harness is disengaged. Reconnect bullet, and check that the bullet connectors are properly secured prior to reassembly.

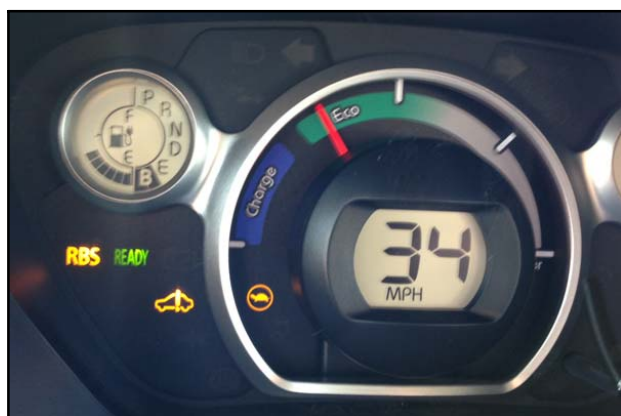
On certain brands of FAST / DC / QUICK (level 3) chargers, DTCs may occur if the electric motor key (aka ignition key) is turned to the ON position while the vehicle is being charged. When either of the following DTCs set, the RBS warning light, the Yellow car warning light, and the Turtle light will illuminate.

- DTC P101B: Quick CHG Contactor P Weld
- DTC P101C: Quick CHG Contactor N Weld

The vehicle will also go into a reduced power mode which limits vehicle speed to 34 miles per hour. Erasure of the DTC will return the vehicle to normal operating conditions.

Dealers should advise i-MiEV drivers to avoid cycling the electric motor key while the vehicle is being Fast Charged. Refer to section 3 of the Owner's Manual for additional Quick Charging information.

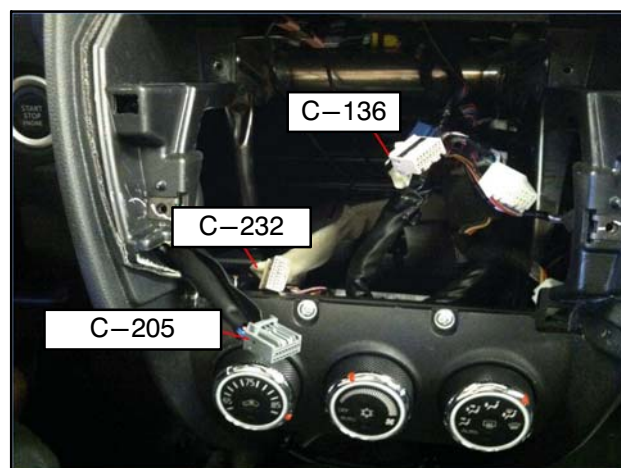
There are three 16-pin connectors behind the center instrument panel that are interchangeable. Improper connection may disrupt operation of the HVAC system, hands-free module / microphone and hazard switch. Warnings such as passenger air bag 'OFF' light (SRS DTC B1489), security light

circuit, and seat belt warning light may also appear.

C-136 16-pin: Tan connector, part of navigation harness. Plugs into the back of the navigation unit for hands-free module / microphone operation.

C-232 16-pin: Tan connector, harness has foam shield and runs to the right side of instrument panel. Plugs into HVAC controller.

C-205 16-pin: Grey connector, harness has black shield and runs to the left side of instrument panel. Plugs into audio surround panel for hazard switch, air bag warning light and security light operation.
