Technical Service Bulletin

SUBJECT:			No: TSB-16-00-008
2015 LANCER EVOLUTION “FINAL EDITION” SERVICE MANUAL INFORMATION – SERVICE MANUAL REVISION			DATE: June, 2016
			MODEL: 2015 Lancer Evolution Final Edition
CIRCULATE TO:	<input type="checkbox"/> GENERAL MANAGER	<input checked="" type="checkbox"/> PARTS MANAGER	<input checked="" type="checkbox"/> TECHNICIAN
<input checked="" type="checkbox"/> SERVICE ADVISOR	<input checked="" type="checkbox"/> SERVICE MANAGER	<input checked="" type="checkbox"/> WARRANTY PROCESSOR	<input type="checkbox"/> SALES MANAGER

A 2015 Lancer Evolution “Final Edition” Service Manual will not be issued. Use the 2014 Lancer Evolution Service Manual along with this TSB and TSB-14-00-019 for complete maintenance and repair information for the 2015 Lancer Evolution “Final Edition.”

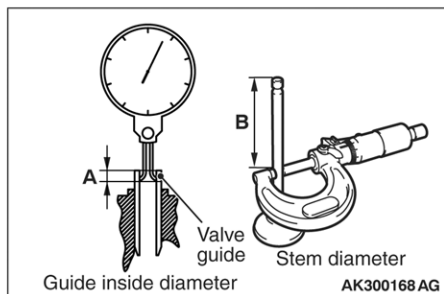
VALVE GUIDE <EXHAUST VALVE SIDE>

Measure the inside diameter at the upper side of the valve guide, and the outside diameter of the valve stem. Then calculate the clearance between the two. If it exceeds the limit, replace the valve guide or/and the exhaust valve. Follow the table below to select an appropriate exhaust valve, which matches the measured inside diameter of the guide.

Inside diameter of the guide	5.500 – 5.503 mm (0.21654 - 0.21665 inch)	5.504 – 5.512 mm (0.21669 - 0.21701 inch)
Outside diameter of the stem	5.451 – 5.455 mm (0.21461 - 0.21476 inch)	5.455 – 5.459 mm (0.21476 - 0.21492 inch)

- A: Approximately 5 mm (Approximately 0.2 inch)**
- B: Approximately 60 mm (Approximately 2.4 inch)**

0.045 – 0.057 mm (0.0018 – 0.0022 inch)

0.067 mm (0.0026 inch)
