2016 Mazda6 MIL ON WITH DTC P0137

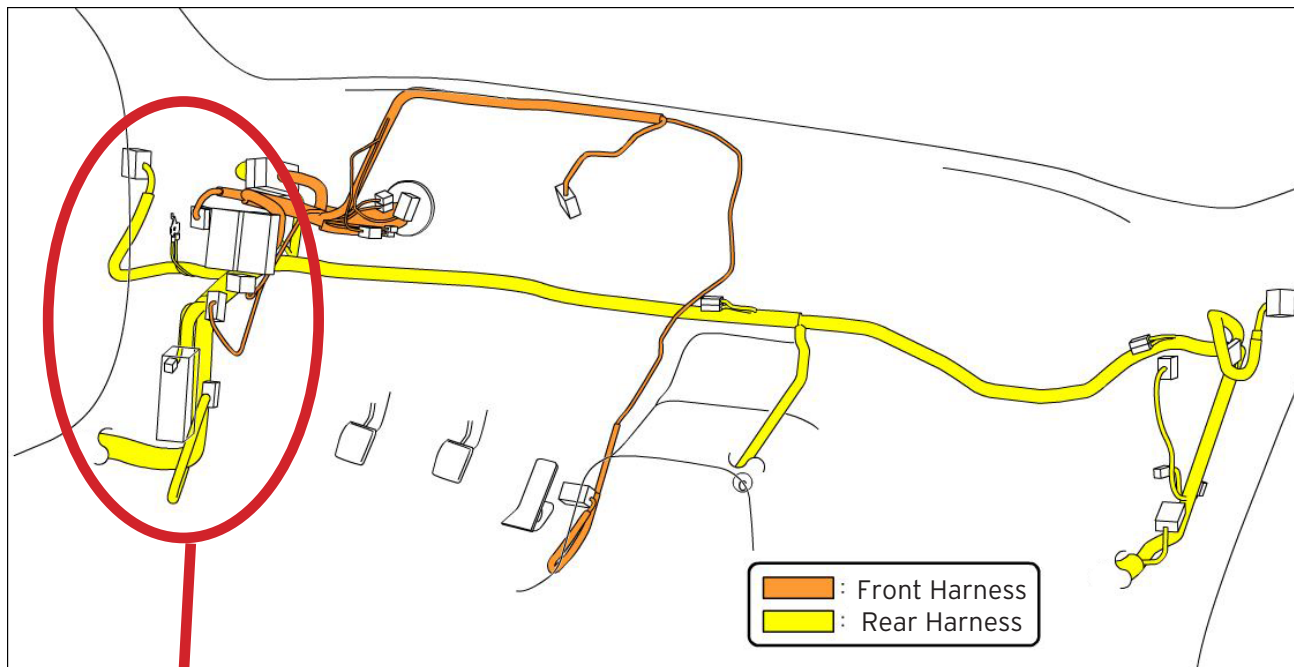
Lower Dashboard

Some customers may complain about a Check Engine Light on with DTC P0137 (HO2S circuit low input) stored in PCM memory. This may be caused by rear harness damage from an aftermarket alarm system installation.

Inspect the rear harness HO2S protector tube near the left kick panel. The HO2S protector tube may be damaged by aftermarket alarm electro-tap connectors. Repair or replace the rear harness as needed.

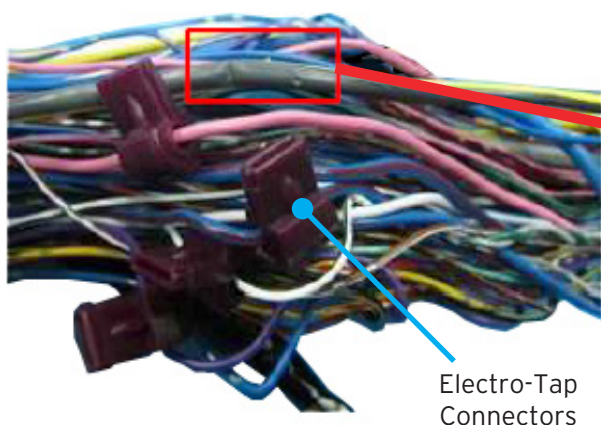
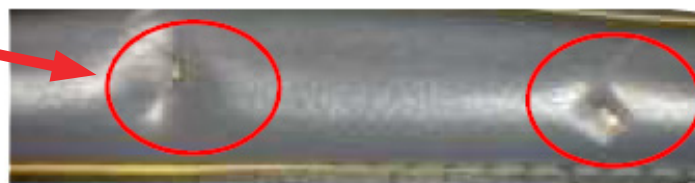
HO2S Protector Tube Damage
