2016 CX-9 (EQUIPPED WITH POWER LIFTGATE) *POWER LIFTGATE INOPERATIVE WITH DTC U3003:16*

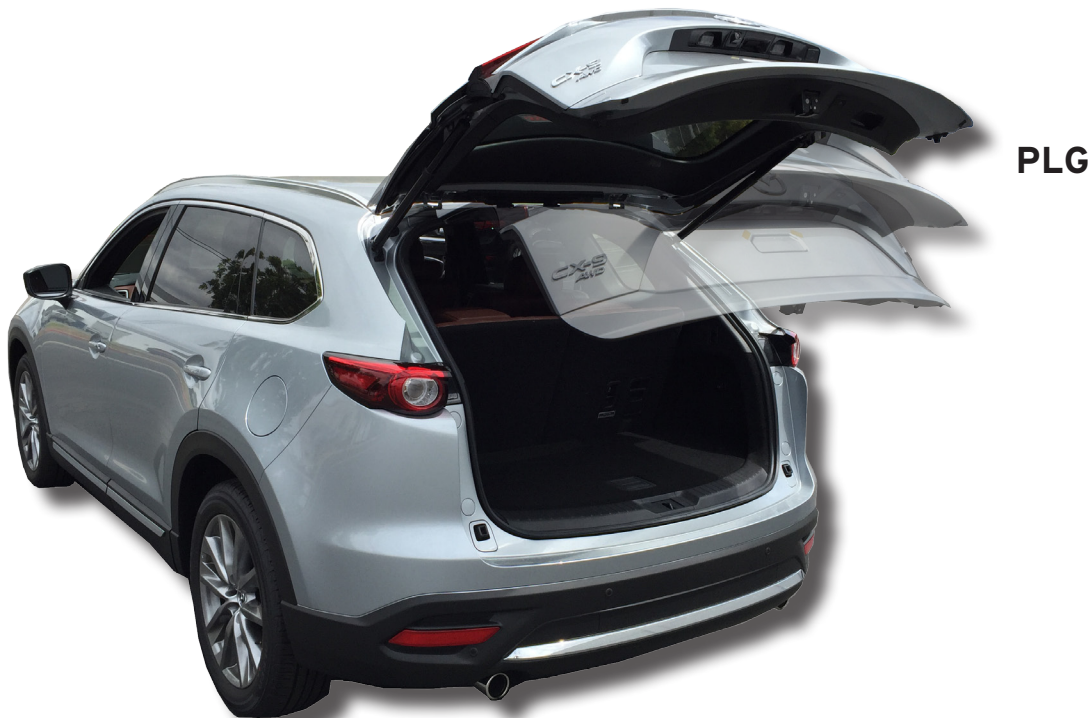
Some customers may complain about an inoperative power liftgate (PLG). DTC U3003:16 (Power liftgate (PLG) control module power supply voltage low input) is stored in memory. This may be caused by low battery voltage.

1. Recharge the vehicle battery.
2. Confirm the lift gate is closed, disconnect the negative battery terminal.
3. Clear the KAM by stepping on the brake pedal and holding high beam on for 1 minute.
4. Reconnect the negative terminal and confirm PLG operation.
5. Clear DTC's.
