2010-2013 Mazda3

CONNECTOR 0918-501 AND 0920-403 SERVICE CAUTION

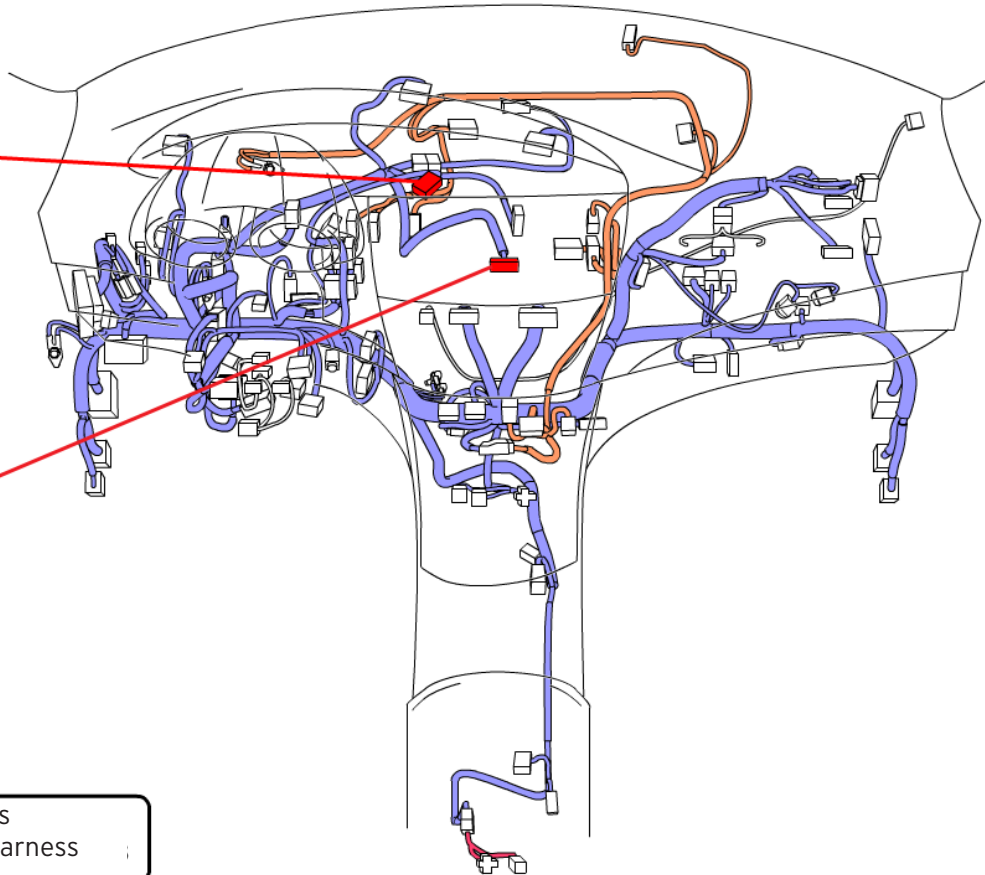
When performing electrical repairs on the instrument panel harness (e.g. 2010 MAZDA3 DASHBOARD UPPER PANEL STICKY SURFACE SSP99), take caution when re-connecting connectors 0918-501 and 0920-403. Both connectors are identical and near the same location. If connected incorrectly, multiple electrical malfunctions will occur (e.g. hazard lights stay on).

0920-403
Microphone

0918-501
Hazard Warning Switch
