DENSO Driving Assist & Safety Eng. Div.3
Driving Assist & Safety Quality Assurance Div.

Title Filed claim investigation result for Airbag sensor (DRAS II)

Part Name : SENSOR, AIR BAG, FR

Part Number : 89173-06120

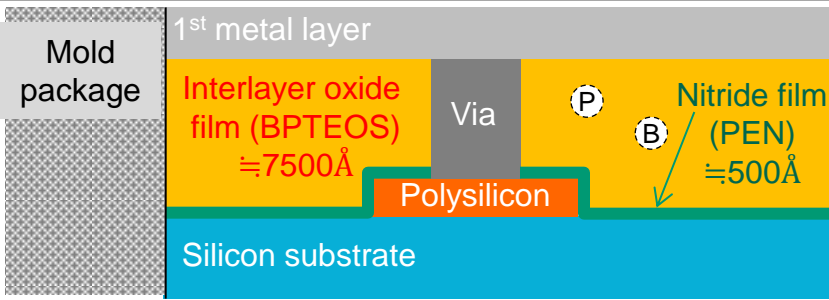
| Process | Interlayer film condition | Description |
|--|--|--|
| Initial | | <p>Interlayer oxide film contains P(Phosphorus) and B(Boron).</p> <ul style="list-style-type: none"> ... P and B protect the impurity ion in order to acquire the transistor characteristics. |

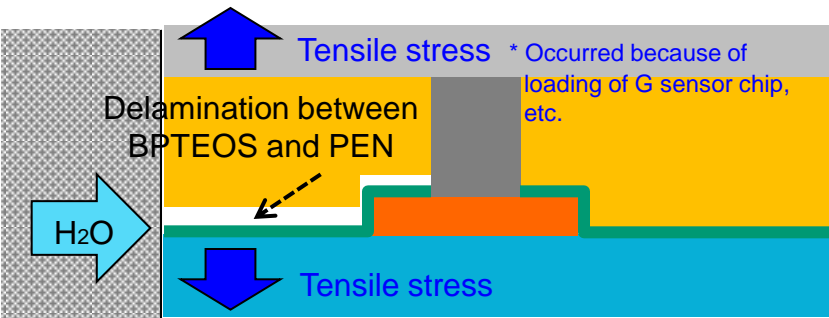
| Process | Interlayer film condition | Description |
|--|--|--|
| <p>Absorb moisture ↓ Delamination occurs</p> | | <p>When P concentration between BPTEOS and PEN increased, the interfacial bond strength decreased, and interlayer film was delaminated.</p> <p>➔ Mechanism of bond strength decrease on the next page.</p> |

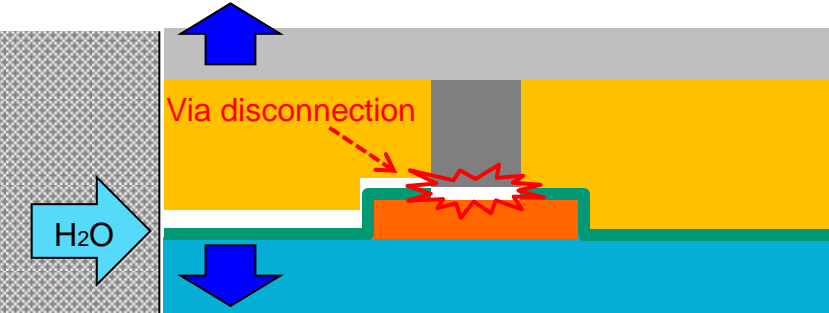
| Process | Interlayer film condition | Description |
|--|--|--|
| <p>Via disconnection occurs</p> | | <p>Via was disconnected because of tensile stress.</p> <p>(Delamination/disconnection occurred at chip edge with large internal stress.)</p> |

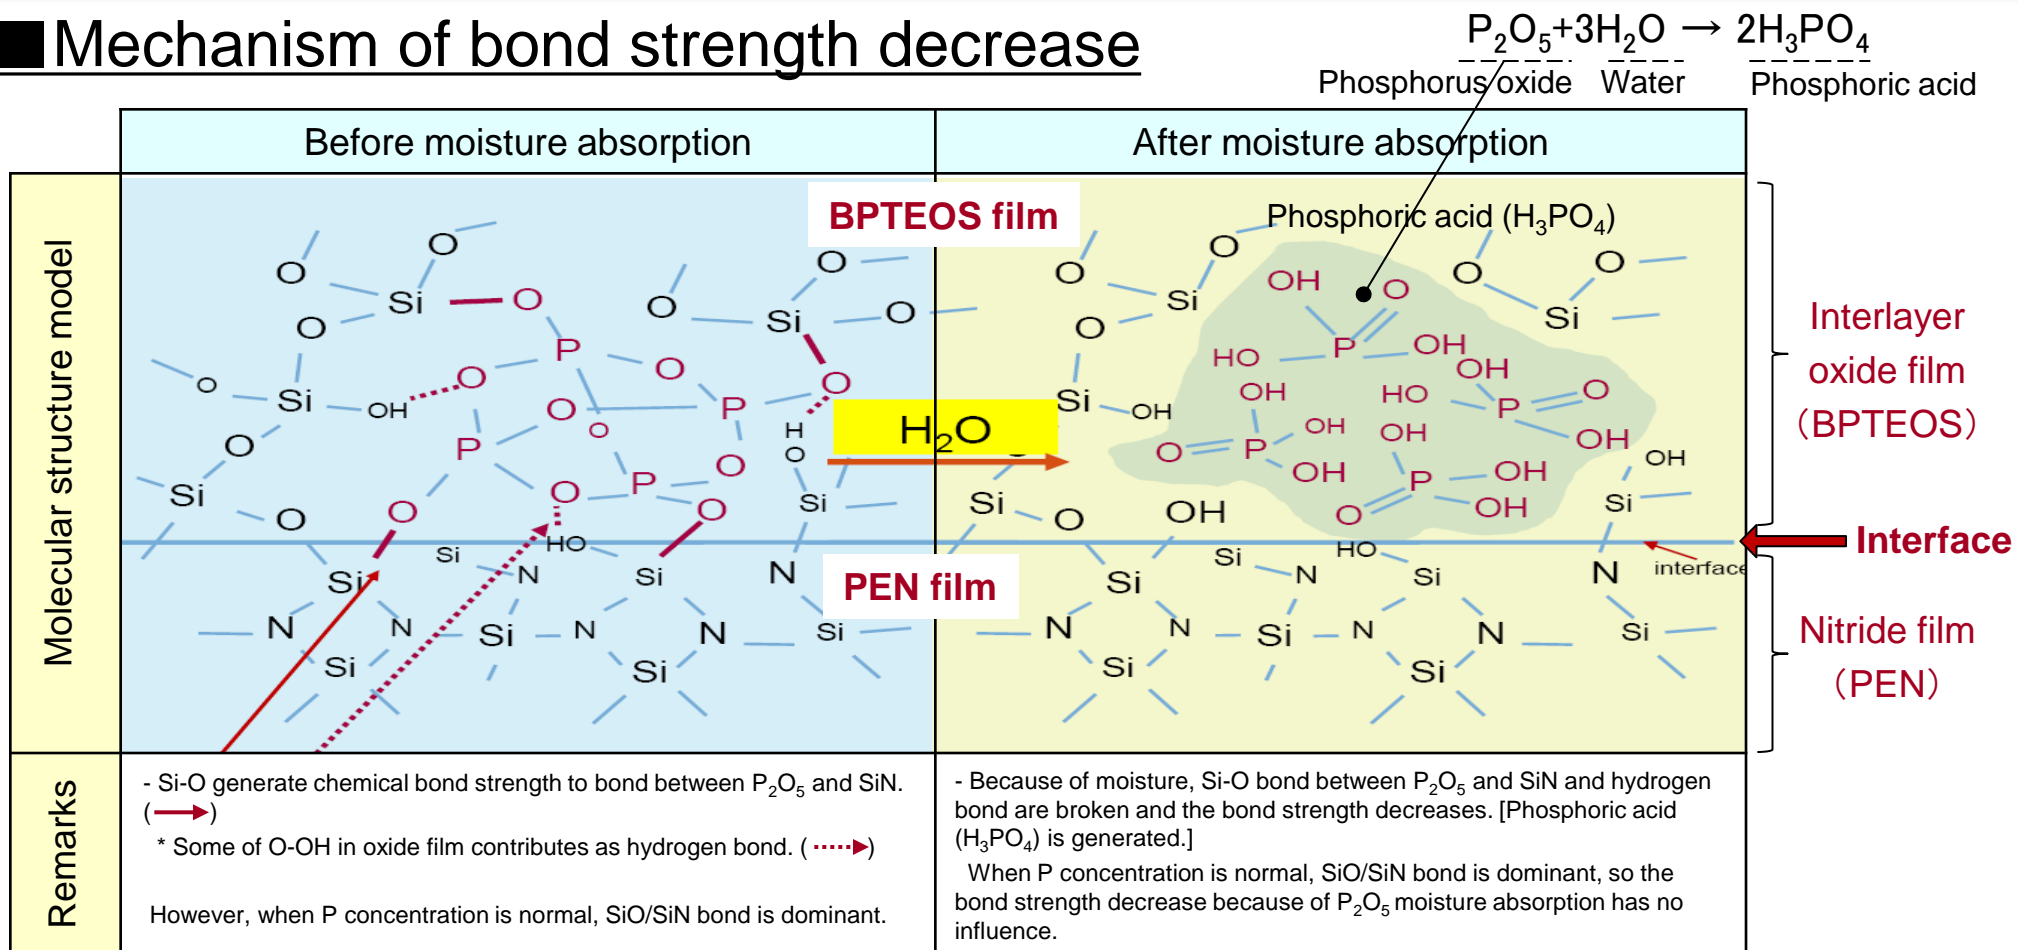
Mechanism of bond strength decrease

- in case of **normal P concentration** ⇒ P area is **small** ⇒ bond strength > Tensile stress ⇒ No delamination
- in case of **rich P concentration** ⇒ P area is **wide** ⇒ bond strength < Tensile stress ⇒ **Delamination**

P concentration affects the interfacial bond strength.

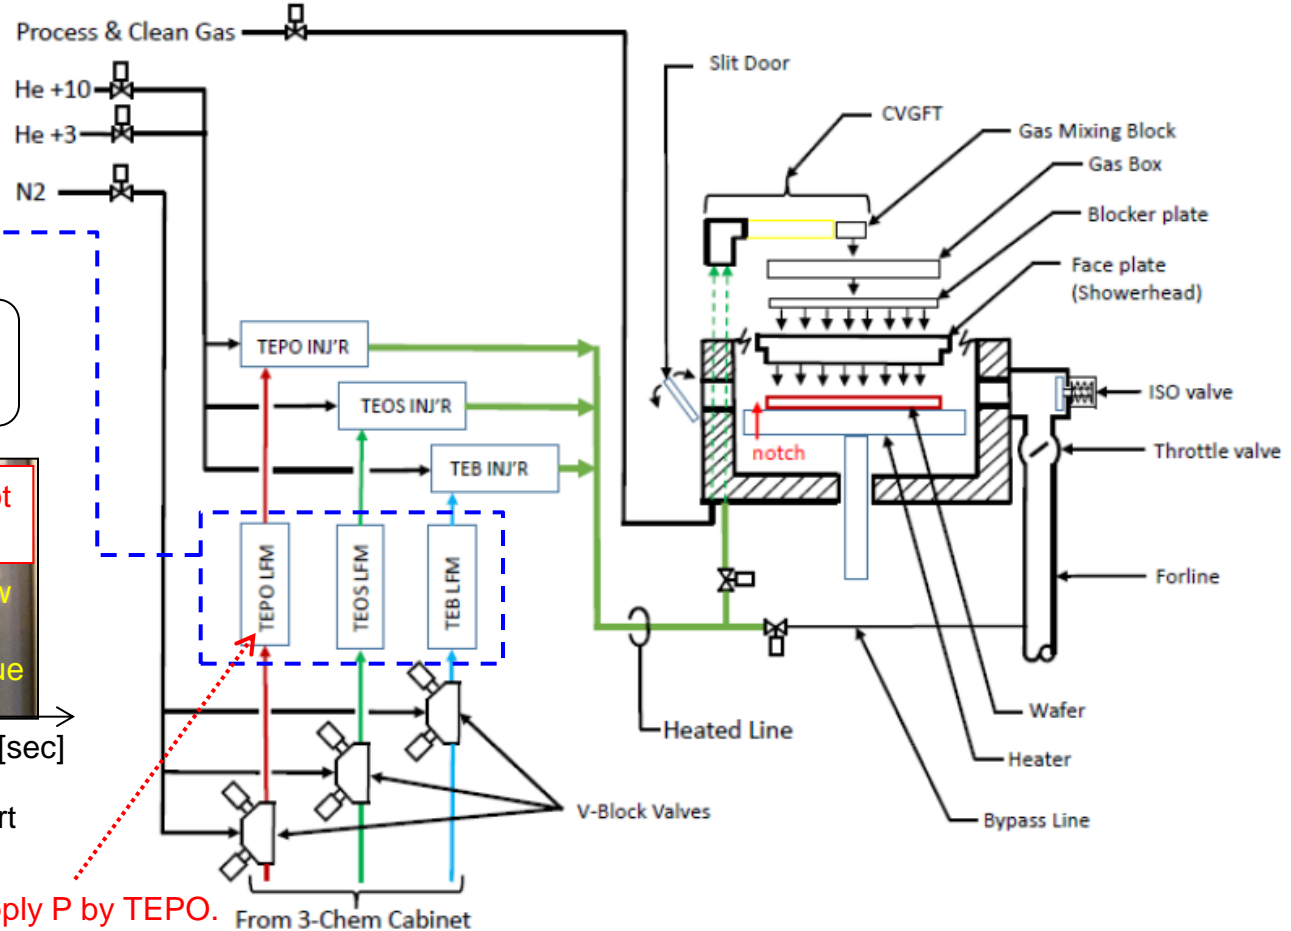
Gas injection setting profile

Supply P by TEPO.

Confirmed that the process change of TEPO flow setting was happened. → Next page

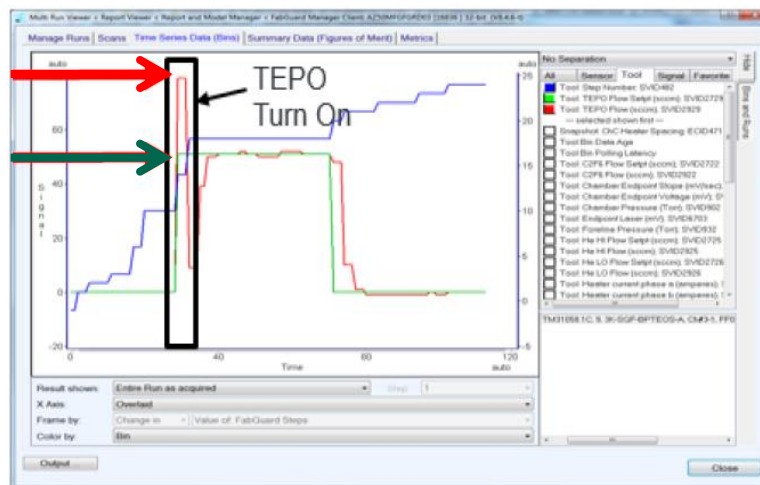
<TEPO flow volume setting value x Peak ratio >

* The above is the waveform of ratio ≈ 1.5 . (Created intentionally.)

Perform 100% monitoring of peak ratio for TEPO flow volume setting value in flow volume profile. (Sept. 1, 2015 ~)

Control item: TEPO flow volume setting value x Peak ratio

Control interval: 100% monitoring

Control value: 1.2 or less

* In the case of over 1.2 --- Machine stops. (Scrap the product.)

After adjusting the machine, check with SIMS result, and then flow.

Perform 100% monitoring to see that flow volume profile is not overshoot.

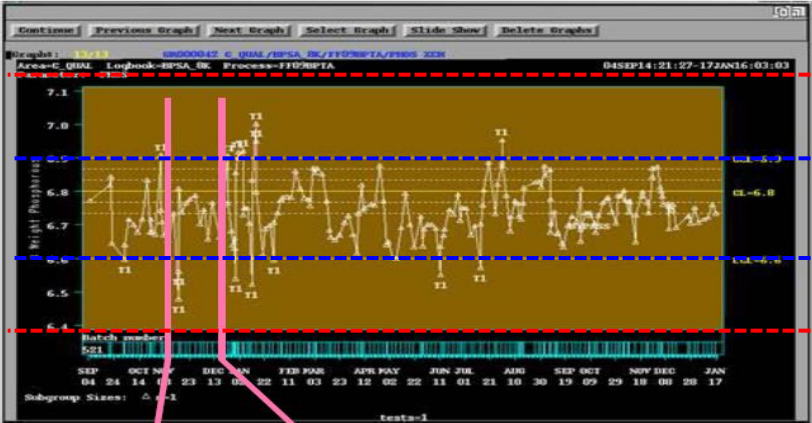
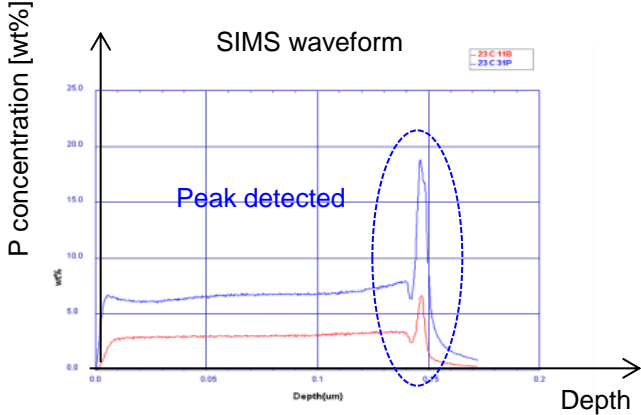
| Cause | Countermeasure |
|--|---|
| <p>- P concentration has been controlled by X-ray fluorescence. In this method, only average value of P concentration in deposition direction can be obtained, and local P concentration increase cannot be detected.</p> <p>* No knowledge that increase of local P concentration causes delamination.</p> <p>Process control width: 6.6 ~ 6.9wt% (Product spec: 6.4 ~ 7.2wt%)</p> <p><X-ray fluorescence P concentration near target lot></p> <p>Target lot period: '14/11/15 ~ '14/12/13</p> <p>→ During the target lot period, P concentration (average value) increase was not detected.</p> <p>* Correlation between P concentration (average) by X-ray fluorescence and P concentration (local) by SIMS is weak.</p> | <p>- Introduce SIMS to control local P concentration. ('14/12/17~) (Continue concentration control by X-ray fluorescence.)</p> <p>Control item: P concentration peak Control value: MAX 9.2% Control interval: 2/week or after every maintenance * Chamber A: 1/D (under special control)</p> <p>Measuring position: Center of wafer (Set as a result of investigation of distribution in wafer surface)</p> |

Introduced SIMS control for workmanship control of P concentration peak value.
