# Technical Service Bulletin

## 01 MIL on; small EVAP leak (DTC P045600)

01 16 72 2044156/2 August 10, 2016. Supersedes Technical Service Bulletin Group 01 number 16-63 dated May 10, 2016 for reasons listed below.

Model(s)	Year	VIN Range	Vehicle-Specific Equipment
A6	2016	000001 - 111348	3.0 TFSI

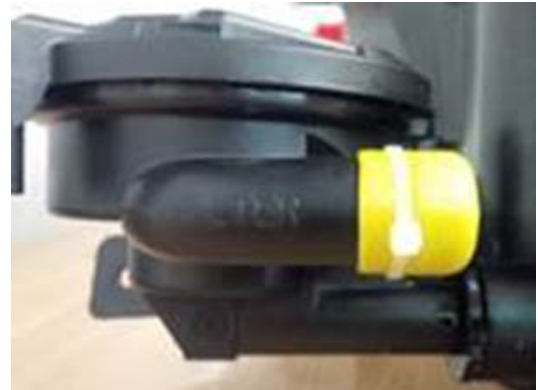
**Figure 1.** Block the filter port on the NVLD sensor.

3. Block off the filter port on the NVLD sensor (Figure 1).

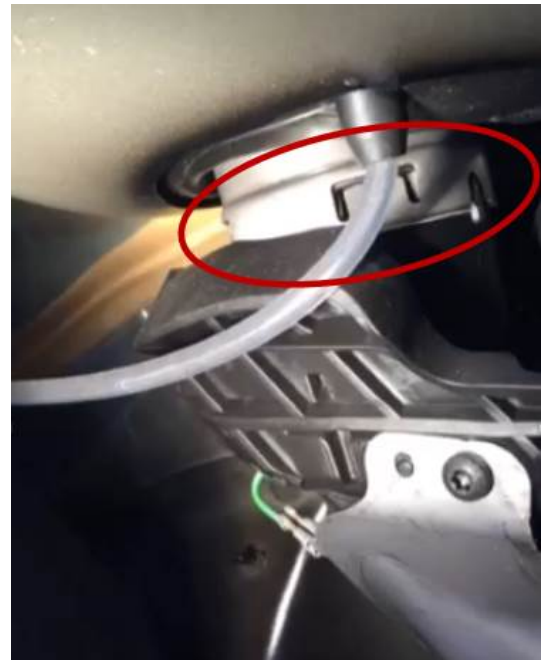
Rubber O-ring at tank filler neck is out of position.

**Figure 2.** Check for smoke escaping around the filler neck.

4. Connect the tester to the vehicle and pressurize the system (3–5 minutes).
5. Take a picture of the flow meter.
6. Remove the purge line from the N80 valve.
7. Generate smoke with the smoke function of the KLI9210 tester until smoke comes out of the purge line on the N80 side.
8. Smoke EVAP system under pressure.
9.
  - If smoke is escaping around the filler neck of the fuel tank (wheel liner removed) replace fuel tank (Figure 2).
  - If no leak can be found, contact TAC.
