TECHNICAL INSTRUCTIONS
FOR
LIMITED SERVICE CAMPAIGN CLC
AIR CONDITIONER ECU REFLASH
EARLY 2013 MODEL YEAR GS350

UPDATED MAY 24, 2012

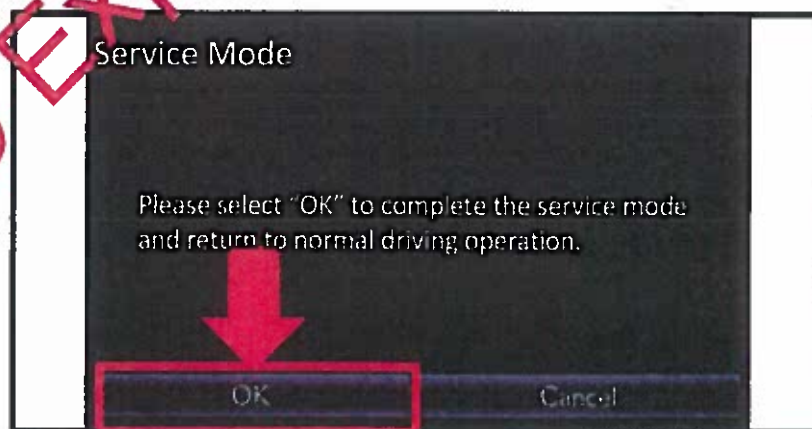
After completing the reflash the navigation system will be in 'Service Mode'. To remove the system from 'Service Mode', follow these steps.

- Disconnect Techstream.
- Turn vehicle off.
- Turn vehicle on.
- After initializing, the navigation screen will indicate service mode. Select OK.

NOTE: If these steps are not followed, or cancel is selected, the vehicle will return to 'Service Mode' every time the vehicle is restarted.
