# Service Bulletin

**Subject:** Wet Carpet/Floor at Driver and/or Passenger Footwell Areas

**Models:** 2010-2017 Chevrolet Equinox  
2010-2017 GMC Terrain

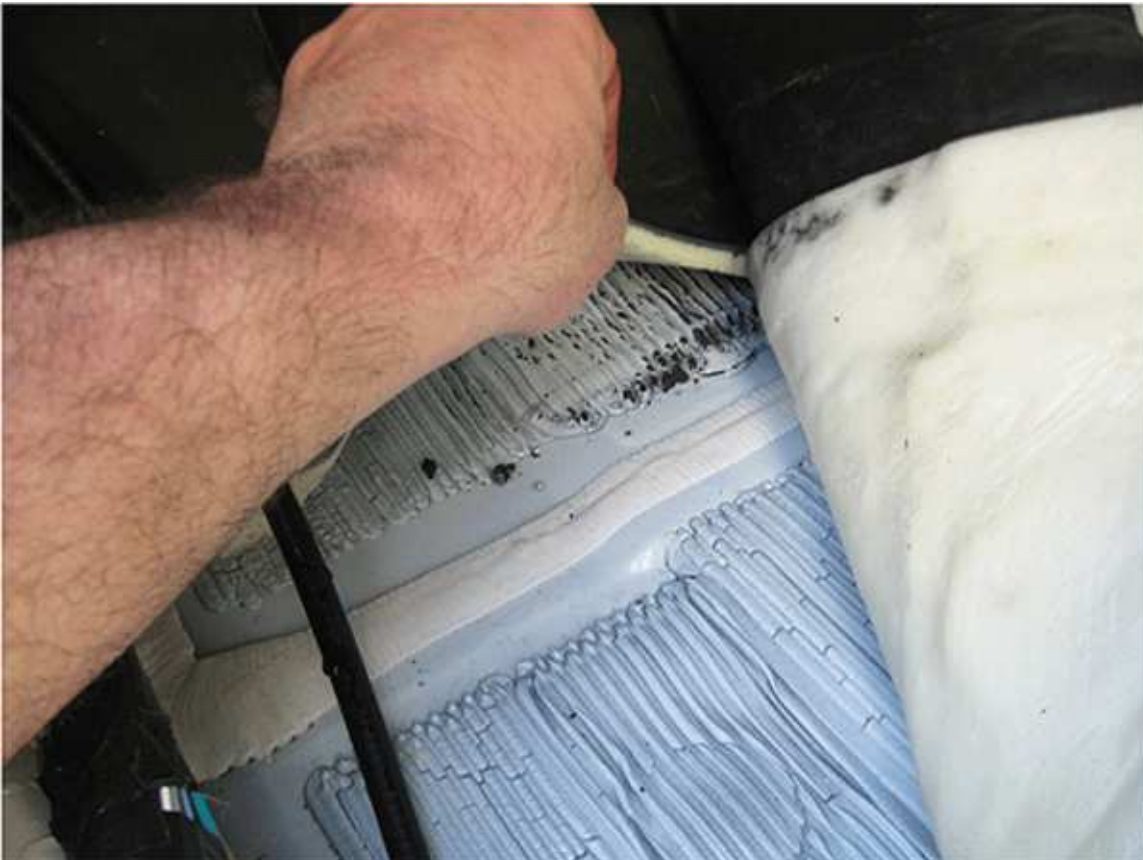
This condition may occur due to incomplete or insufficient sealing within the front roof to body side outer panel seams. The condition is most commonly found in the roof ditch within the first 30.5 cm (12 in) rearward from the windshield glass.

Inspect the vehicle for accumulated water or water spotting in the driver and passenger front footwell areas. Reposition the front carpet and inspect for

If evidence of water is found in these locations, inspect the affected side roof ditch for possible voids in the sealer. Inspect for, and correct this leak, following the repair steps below:

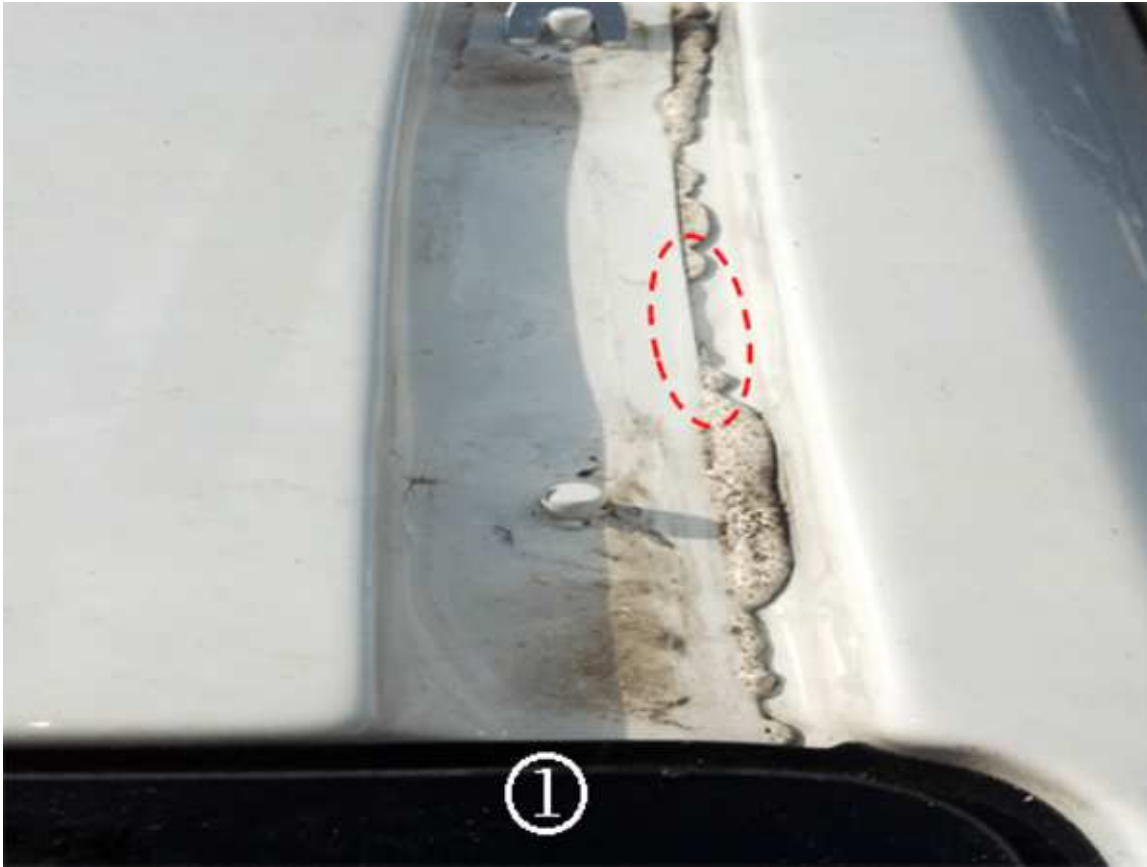
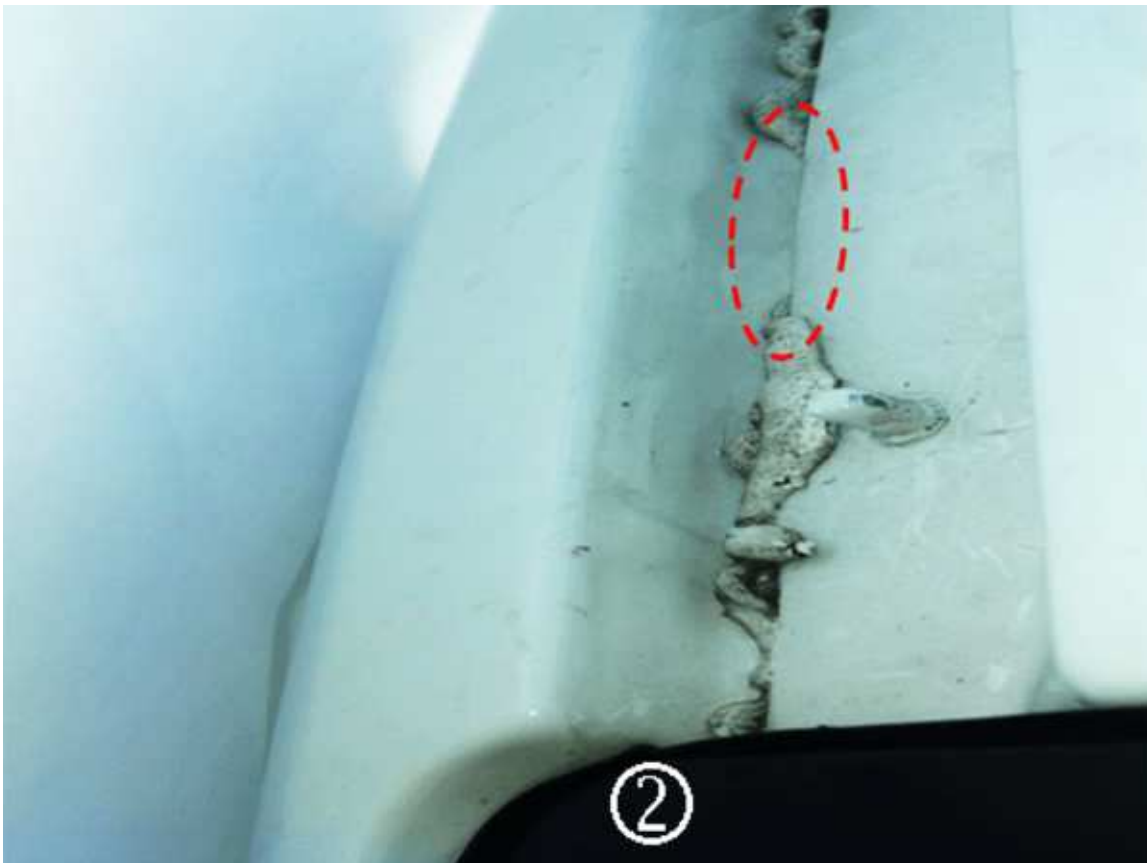
2. Inspect for voids/gaps in the seam sealer along the outboard edge of the roof ditch. Examples of this condition are shown in the driver side (1) and passenger side (2) graphics above.
3. Clean the affected area and seal all gaps with \*Kent Automotive High-Tech™ Clear Seam Sealer, P/N 10200 (5 oz tube), or equivalent. Avoid excess sealer build up within the ditch while assuring any voids in the factory seal are filled.
4. Allow the seam sealer to adequately set-up, then water test by placing a water hose mid-roof near the ditch, allowing water to run forward to the A-pillar. Visually inspect for any water leaks along the inner roof, A-pillar and floor areas.
5. Once the repair is verified, reinstall the roof ditch molding. Refer to Roof Panel Molding Replacement in SI.
6. Dry the interior of the vehicle as needed. Refer to Floor Carpet Drying in SI.
