Reference	SSM72516
Models	XF / X260
Title	X260 XF Boot spring bracket detaching
Category	Body
Last modified	18-Aug-2016 00:00:00
Symptom	111000 Body Panel(s)/Unibody
Attachments	1BIW Spring bracket SSM 2 (1).pdf (1BIW Spring bracket SSM 2 (1).pdf) Swan neck brackets - X260.pdf (Swan neck brackets - X260.pdf)

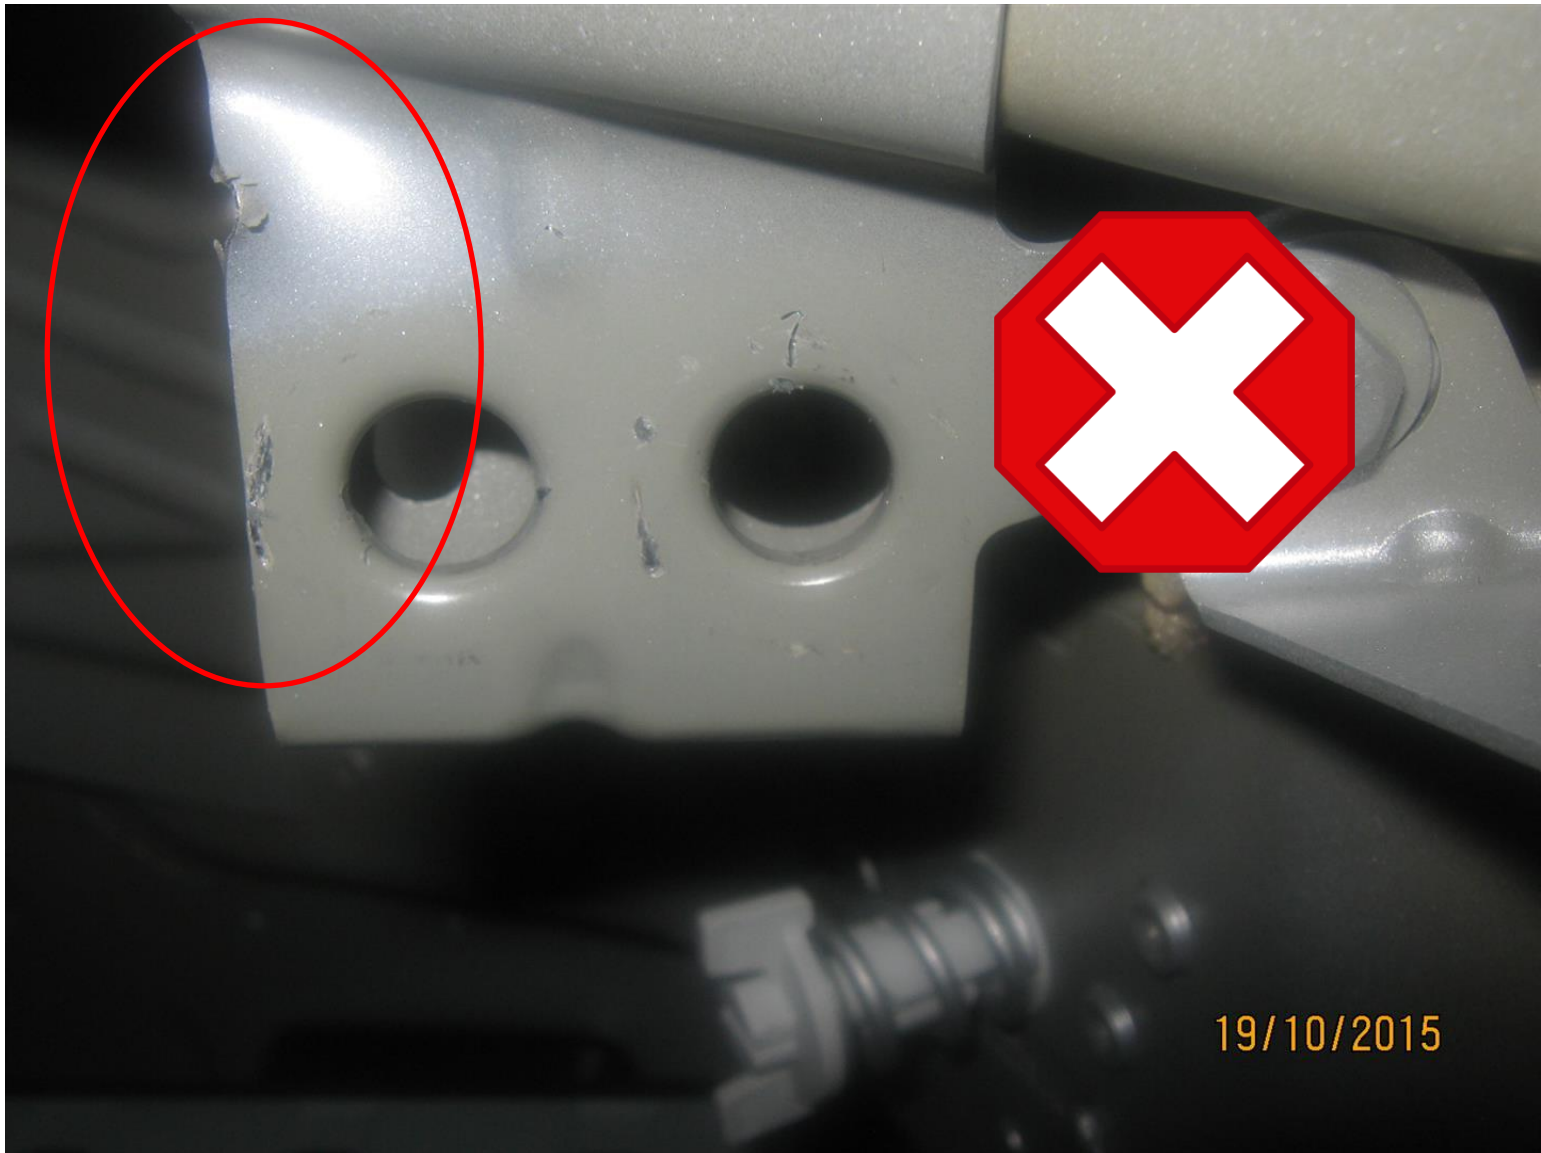
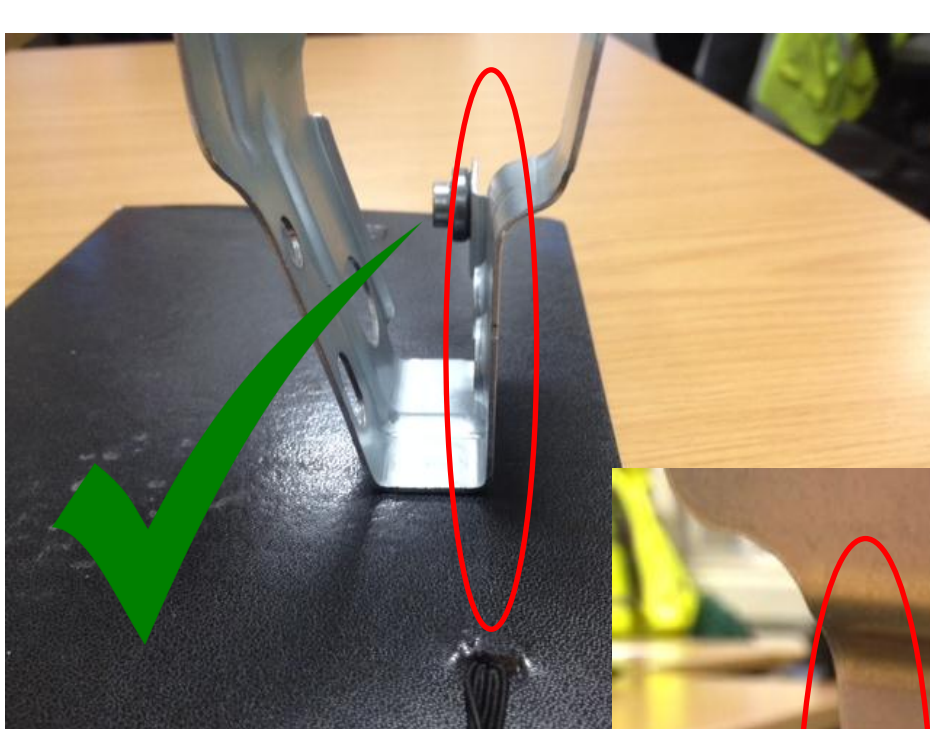
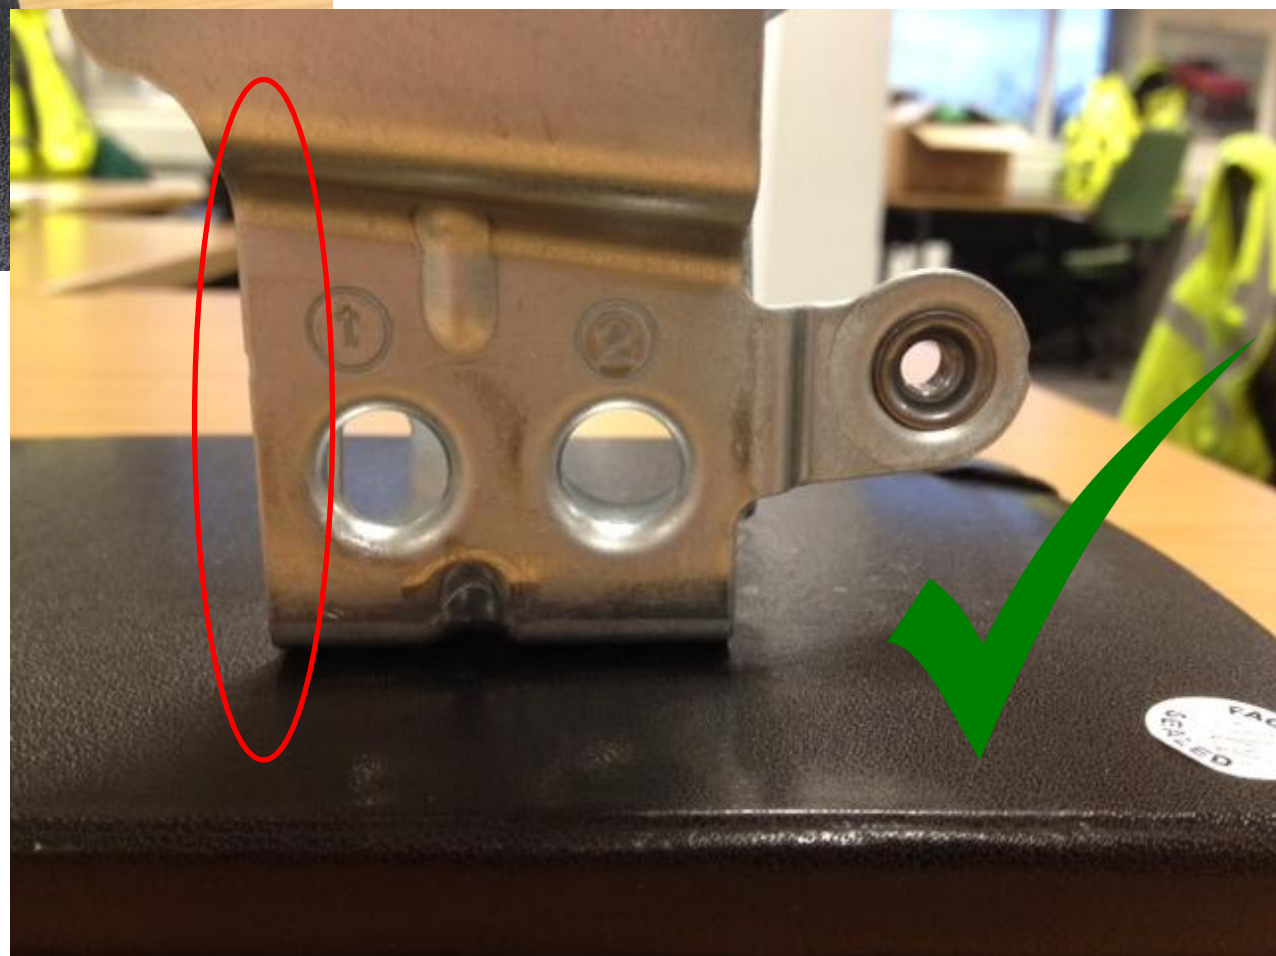
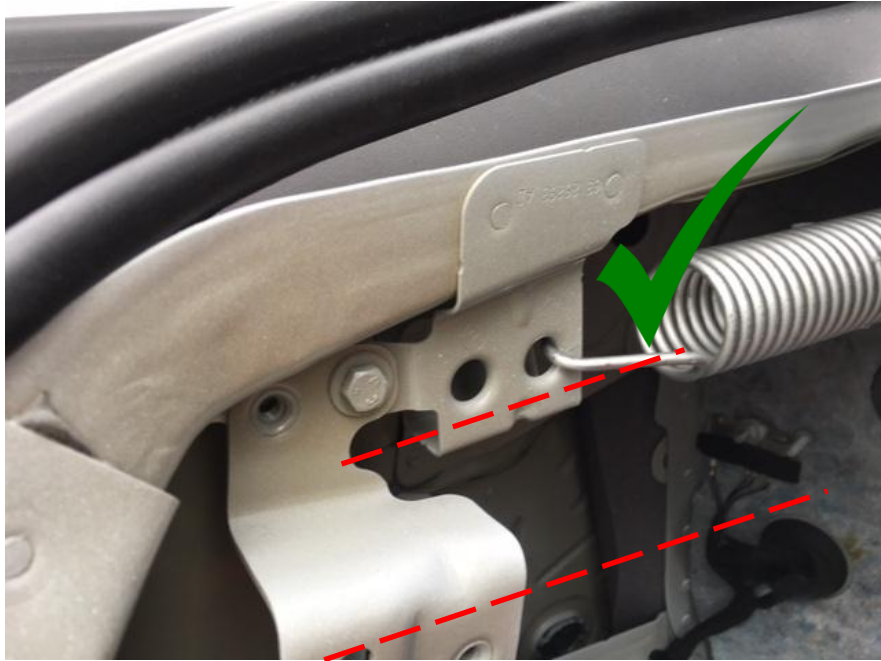
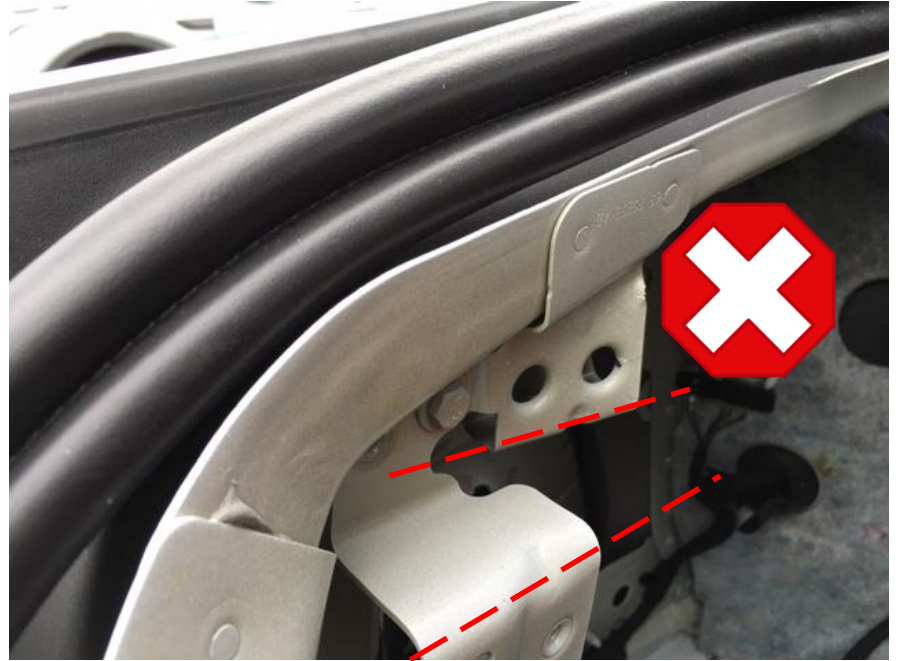
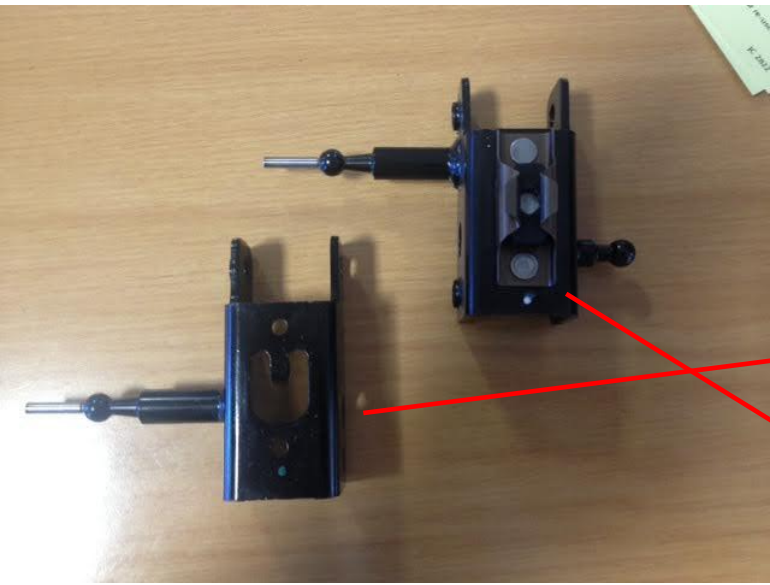
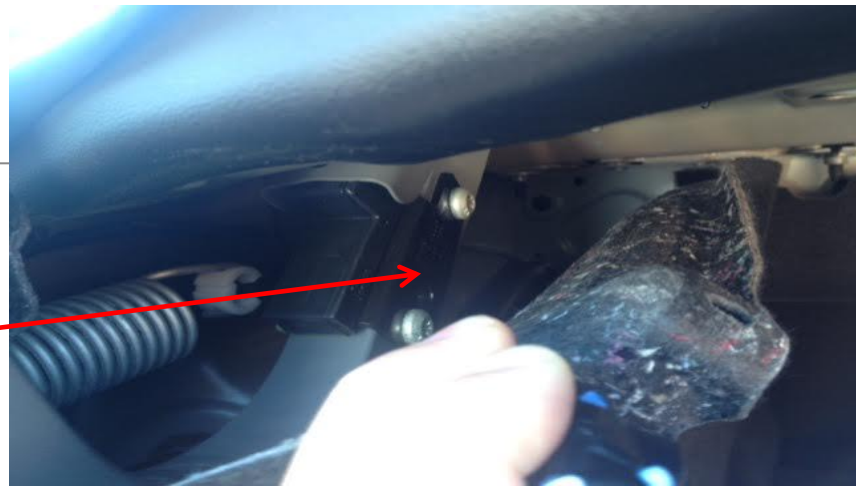
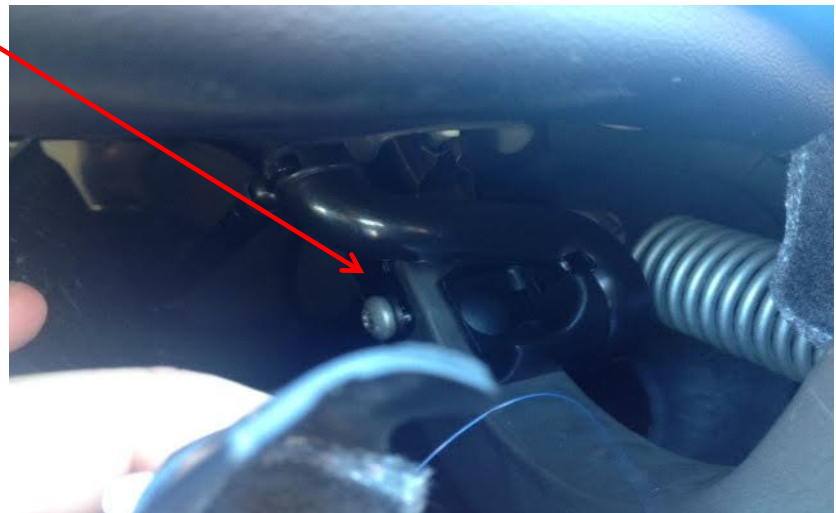
X260 Boot spring detaching from Body In White bracket and / or spigot bracket

Tolerance between fulcrum points on components

If you have a X260 where the boot spring has detached, please order replacement assistance springs and spigot / ball fixing brackets located on the swan neck assemblies and replace both sides regardless of which has failed. For clarity regarding what the spigot / ball fixing brackets are, please see the PDF attachment named 'swan neck brackets', which shows images of them and where they are located. They are listed in the catalogue as follows - 'Mounting bracket - Conventional tailgate - Trunk lid hinge - LH T2H19924 & RH T2H19923'. Both must be changed, regardless which side spring has failed.

In addition, please check the integrity and condition of the Body In White bracket on both sides for any damage and re-work / rectify to bring them to the acceptable condition, particularly the profiling and alignment, as shown on the attachment - before installing new components.
