Service Bulletin

Subject: Intermittent Service Power Steering Message Displayed on DIC, DTC C056D, C0475 or U0131 May Be Set

Models: 2013-2016 Buick LaCrosse 2014-2016 Buick Regal 2014-2016 Cadillac XTS 2014-2016 Chevrolet Impala (VIN 1) Equipped with Belt Drive Electronic Power Steering (RPO NJ2)

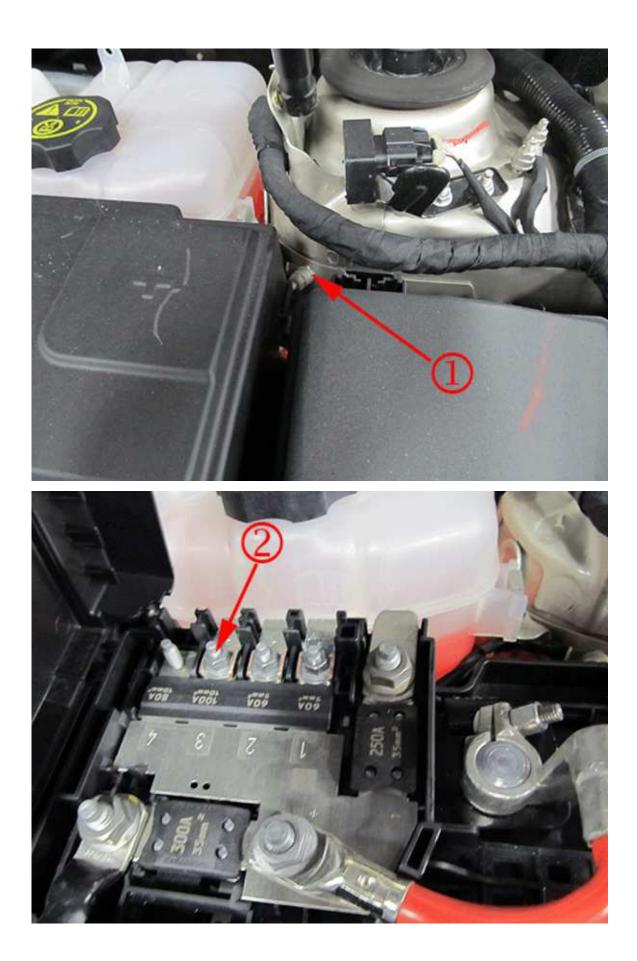
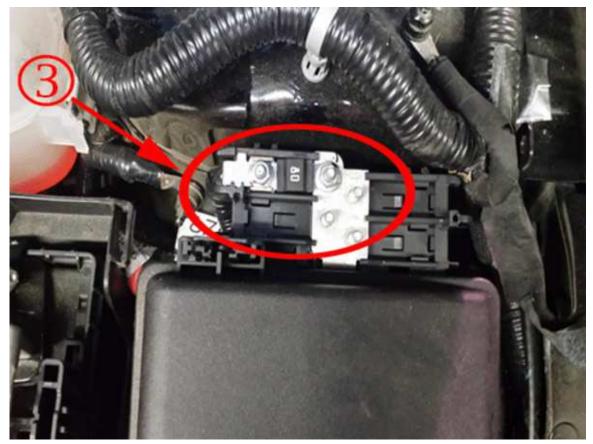
Some customers may comment on a Service Power Steering message being displayed on the DIC after a cold start. This condition may be intermittent. When checking the vehicle for DTCs, the power steering control module may report C056D 3C, C0475 00 or the BCM may report a U0131 set as current or in history.

1. Inspect the G111 ground (1) and the 100A F3UB fuse (2) (LaCrosse, Regal, Impala) or 80A F72UA fuse (3) (XTS) for proper connection. Ensure the ground is free of paint and both connections are tight.

- Tighten the G111 ground to 9 N•m (80 lb in).
- Tighten the F3UB fuse to 4.7 N•m (42 lb in).
- Tighten the F72UA fuse to 4.7 N•m (42 lb in).
- 2. Fully charge the battery using the GR-8 Tool (EL-50313).
- 3. Reprogram the power steering control module using the Service Programming System (SPS) with the latest calibrations available on TIS2WEB. Refer to the *Power Steering Control Module Programming and Setup (NJ2)* procedure in SI.
