Service Bulletin

Subject: Information on Vibration Analysis and Diagnostic

Models: 2014 Chevrolet Silverado 1500
 2015-2016 Chevrolet Silverado
 2014 GMC Sierra 1500
 2015-2016 GMC Sierra

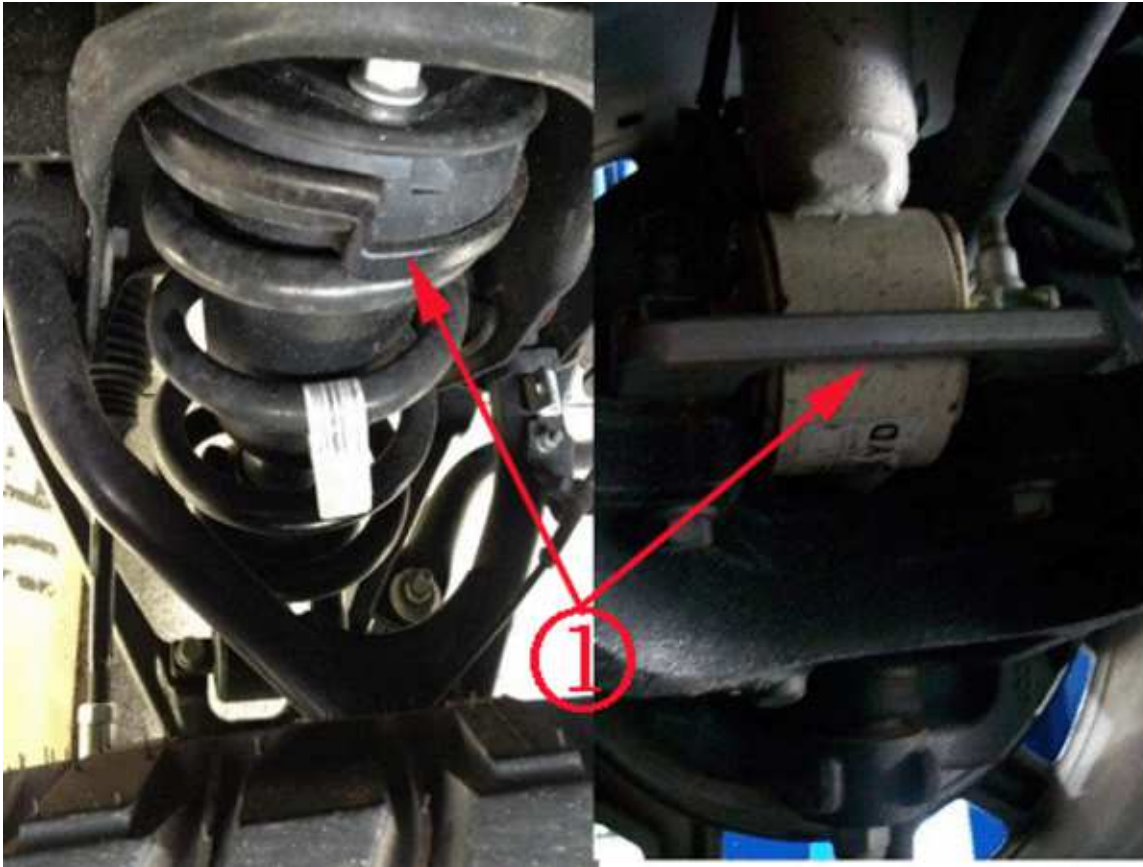
1. Inspect the truck for any aftermarket equipment installations. For example: non factory tires, wheels and/or lift kits or leveling kits – shims (1) installed as shown above. Aftermarket equipment does include running boards, bug deflectors, and window shades, etc. Remove any aftermarket that might cause vibration transmission paths.
2. Mark each tire valve stems location on the tire. This will be utilized to check for tire slippage on the rim.

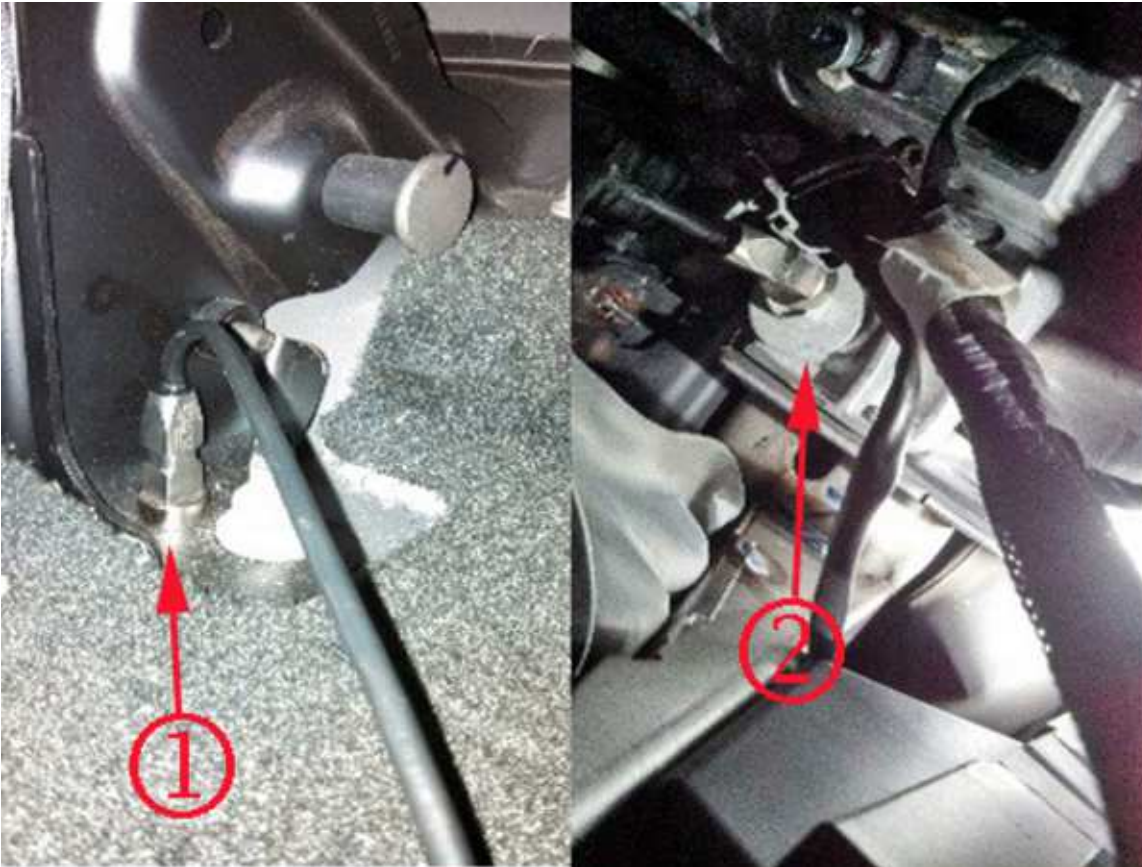
3. Using a Pico Oscilloscope Diagnostic Kit, mount the PicoScope vibration sensor on one of the two locations shown above.

- Seat Vibration – mount the sensor to the front right corner of the driver's seat bracket (1).
- Steering Wheel Vibration – mount the sensor to the steering wheel bracket (2) under dash.

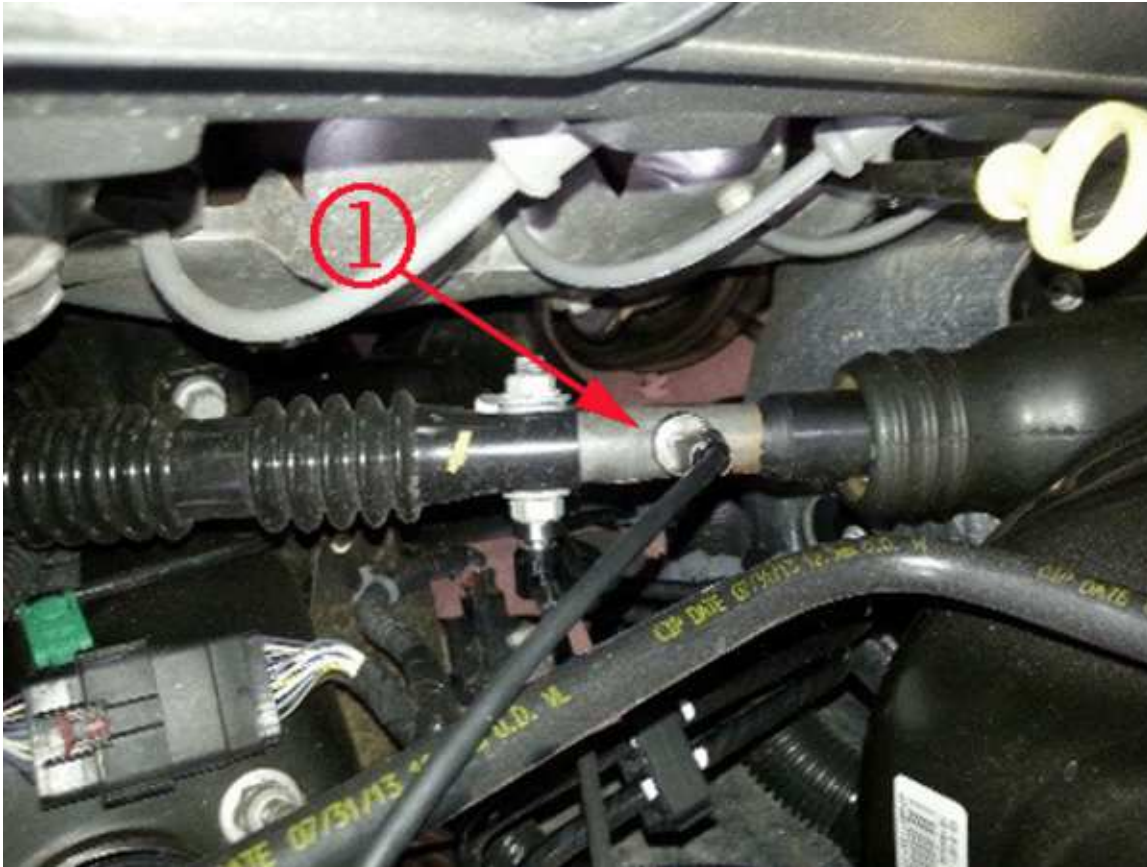
4. This step should be only be used if the vibration can be felt while running the vehicle on the rack. Mount the sensor on the steering shaft(1), under the hood as illustrated above.

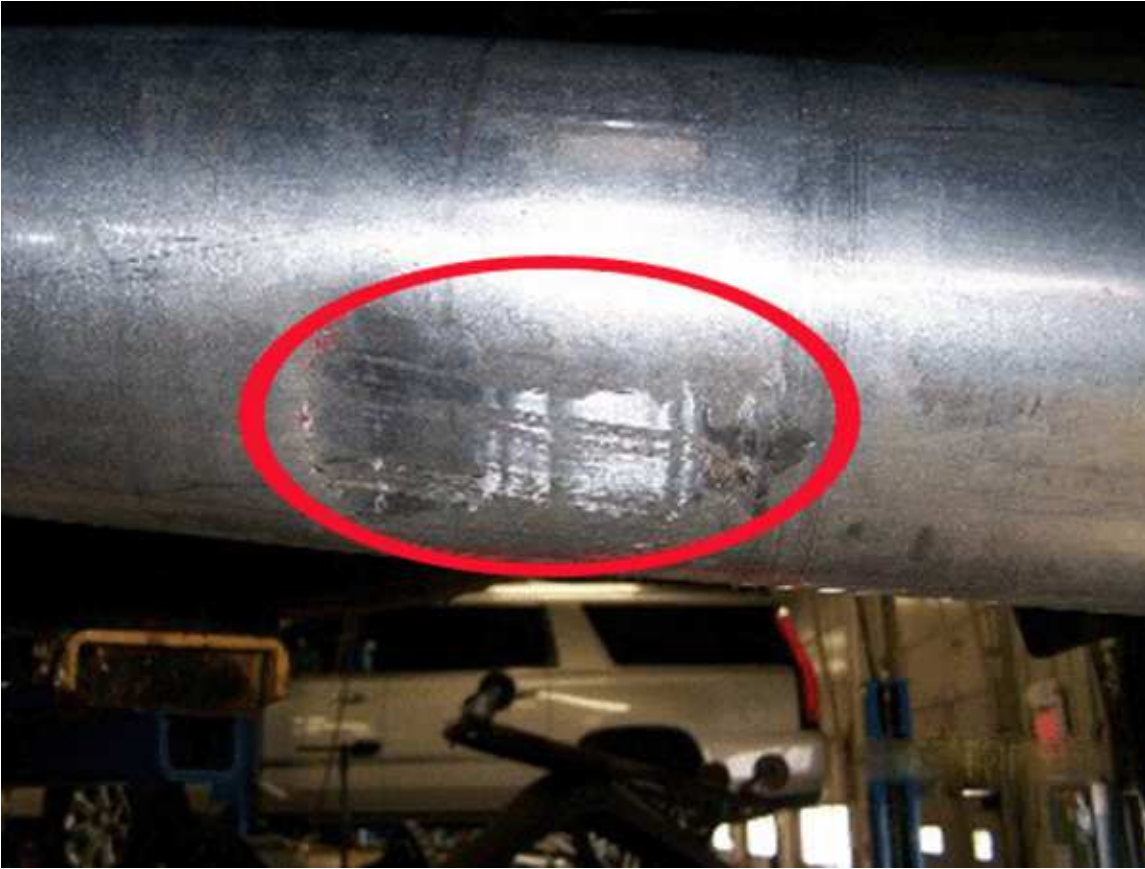
- Inspect the propeller shaft for dents or damage. There have been many cases of dented propeller shafts.
- For 4WD Trucks, remove the rear propeller shaft, seal output shaft and drive the vehicle in 4WD. If the vibration is gone, the rear prop shaft could be the problem.
- For vehicles with a 3:08 with a one-piece steel shaft, this can be replaced with a one-piece aluminum one that is utilized on all 3:42 and 3:73 ratios (K15543 and K15753 Models only).
- PIP5140: Low Speed Vibration 30-35 mph (48-56 km/h).
- Inspect the transmission output shaft bushing for irregular wear.

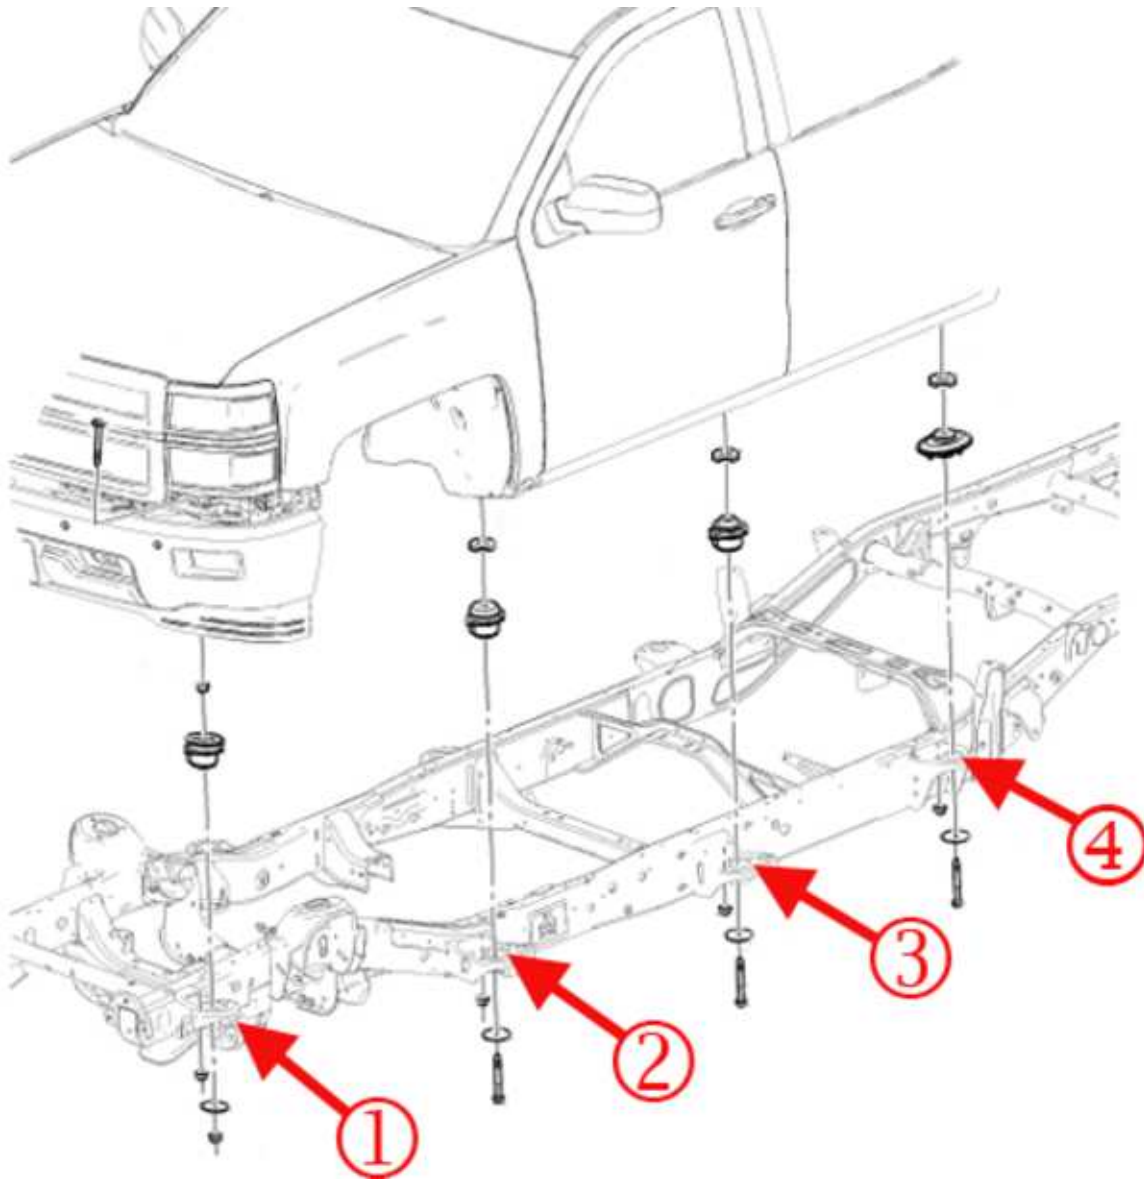
The numbers in the picture below indicate the specific mount position. The mounts on the passenger side of the vehicle are identified the same way. This will assist the technician to identify the correct location of each mount so they can be torque to the proper specification.

- 1 = body mount cushion front
- 2 = body mount cushion position number 1
- 3 = body mount cushion position number 2
- 4 = body mount cushion position number 3

Visually verify that the cab to box alignment is correct before re-torquing all mounts to specification found in Service Information, body repair, frame and under body section.
