Service Bulletin

Subject: Loss of Power Steering Assist, Hard to Steer, and/or Service Power Steering Message on DIC

Models: 2012-2015 Buick Verano
2013-2016 Buick LaCrosse Equipped with NJ1
2013-2017 Buick Regal Equipped with NJ1
2014-2016 Cadillac ELR
2010-2017 Chevrolet Equinox
2011-2015 Chevrolet Cruze, Volt
2016 Chevrolet Cruze Limited
2013-2015 Chevrolet Malibu
2016 Chevrolet Malibu Limited
2014-2016 Chevrolet Impala (VIN 1) Equipped with NJ1
2016 Chevrolet Cruze Limited, Malibu Limited
2010-2017 GMC Terrain

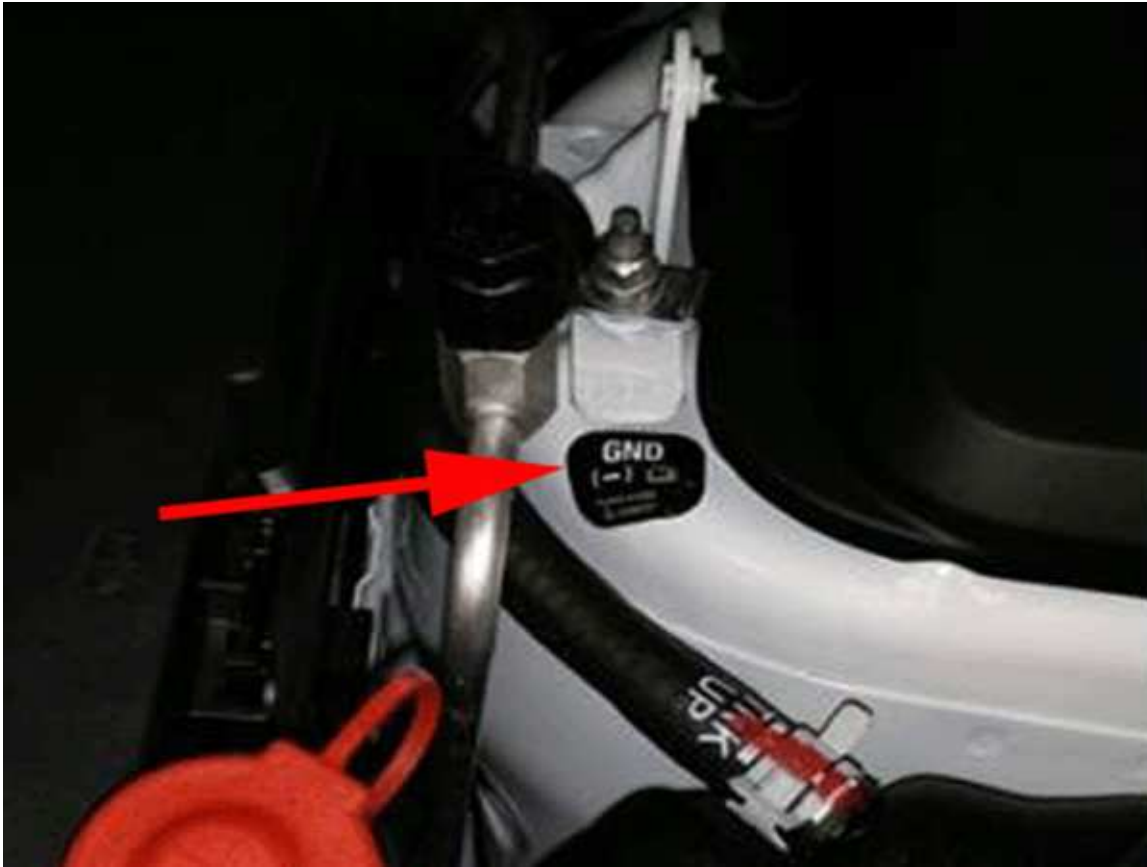
Some customers may comment on loss of power steering assist, hard to steer, and/or Service Power Steering message on DIC.

This may be caused by a blown/failed power steering fuse, which could be a result from improper jump starting.

1. Locate the power steering fuse.
2. Check to determine if the fuse is open. To do so, check for continuity using a Digital Multimeter (EL-39200) or a continuity tester.
3. If the fuse element is broken, replace the fuse.

Important: When installing the new fuse, tighten the fasteners to 5 N•m (44 lb in).

4. After fuse is replaced, install an electrical ground point label, GM P/N 10384767, in the approximate location as illustrated above.
