INSTRUCTION TO SERVICE

ITS: 6085	
SECTION:	Chassis
WRITTEN BY:	Kevin Robinson
SUBJECT:	MiDI - Remove and replace the harness bracket on the steering column.

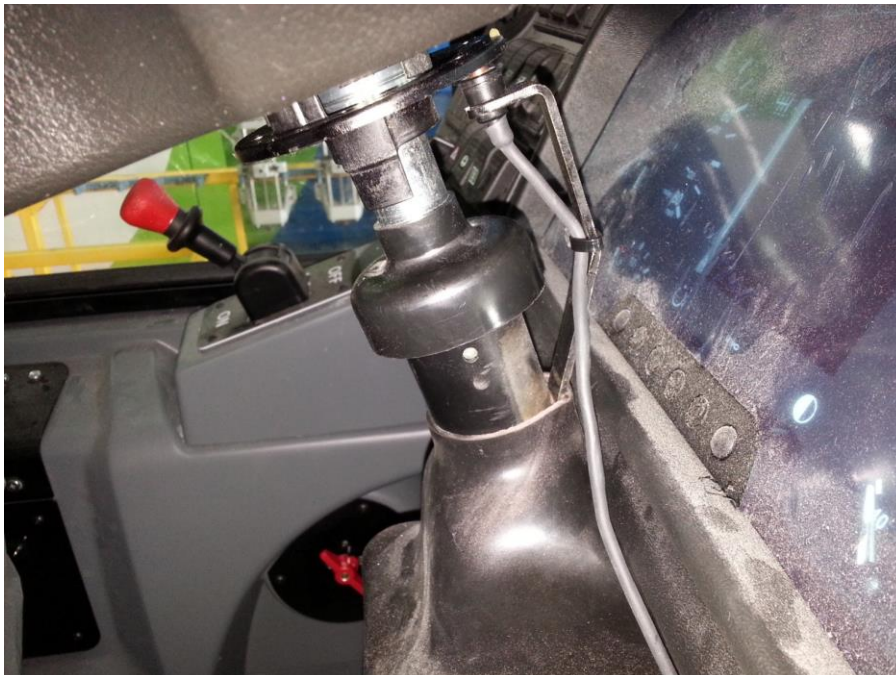
Figure 1: New bracket installed – welding complete, finish painting yet to be done.

10. Clean the new bracket of any oils and rust and tack it into place.
11. Test fit the harness and ensure everything will operate properly.
12. Finish-weld the new bracket in place and grind excess weld and any splatter off of the column so it is smooth.
13. Paint the steering column flat black
 - a. Mask off column, boot, and area to prevent overspray
 - b. Prime and paint the column flat black.
