Service Bulletin

PRELIMINARY INFORMATION

Subject: Stalling Shudder And/or Hard shifting Into 1st Gear Or Reverse Vibration On launch (With Excessive Crankshaft End Play)

Models: 2014-2016 Chevrolet Corvette, Silverado,
2016 Chevrolet Camaro
2014-2016 GMC Sierra
2015-2016 Chevrolet Tahoe, Suburban, GMC Yukon / XL
2015-2016 Cadillac Escalade
2016 Cadillac CTS-V
With engines 4.3L, 5.3L, 6.2L L83, L86, LT1, LT4, LV3
2014-2016 Chevrolet Corvette
Built with an 6.2L, LT1, LT4 engine and auto or manual transmission with crank shaft end play concern

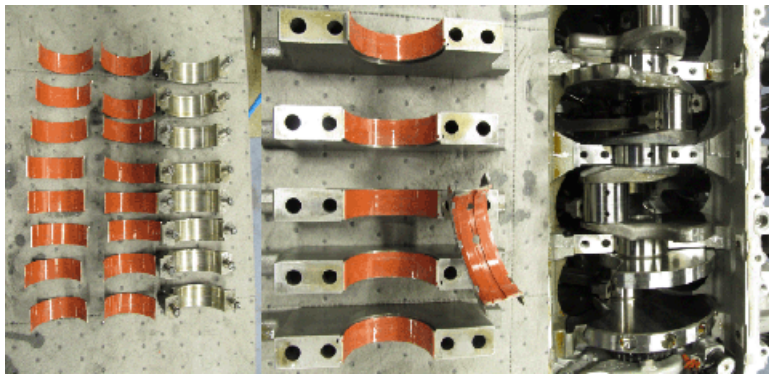
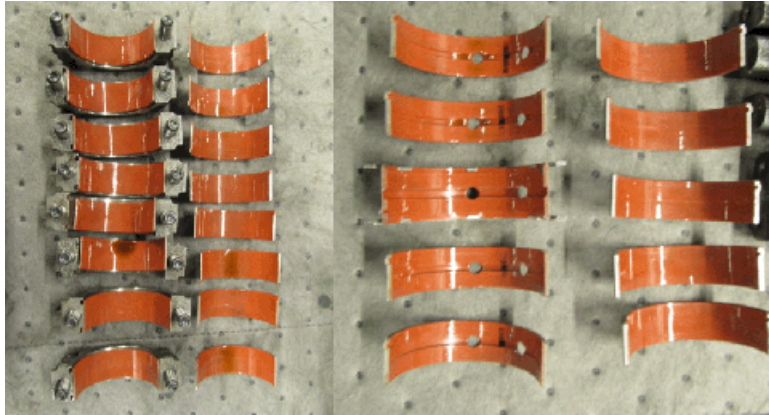
Note: If bearings and crankshaft look like components in attached picture, damage has not occurred.

Inspect thrust bearing for wear on one side and crankshaft on that “mating” surface.

If wear is evident (3 vertical channels worn off) replace connecting rod bearings, main bearings, thrust bearing and crankshaft.
