Tech Tips

TT 40-16-02

2017 Golf, Golf Sportwagen, GTI – Sub frame Center Bushing Area Visual Concern

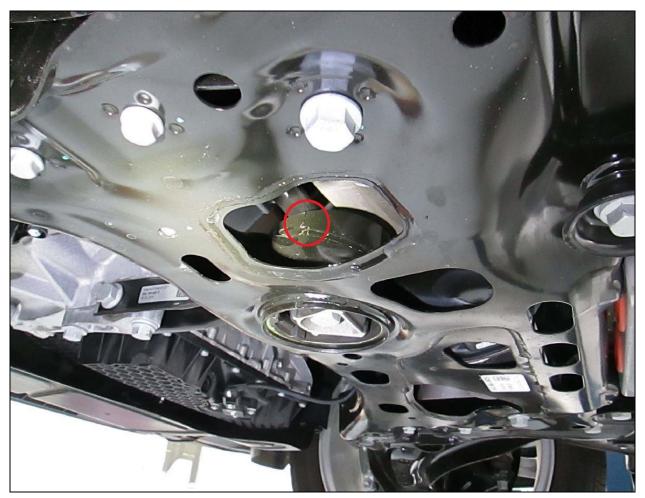
Figure 1

If there are any visual concerns for the sub-frame at the center bushing (see photos), no action is needed as this is a normal condition. The sub-frame should not be replaced for this condition.
