Water Leak From Moonroof Drain Hose - Kinked Hose - Panoramic Roof Only

14-15MY Highlander/HV

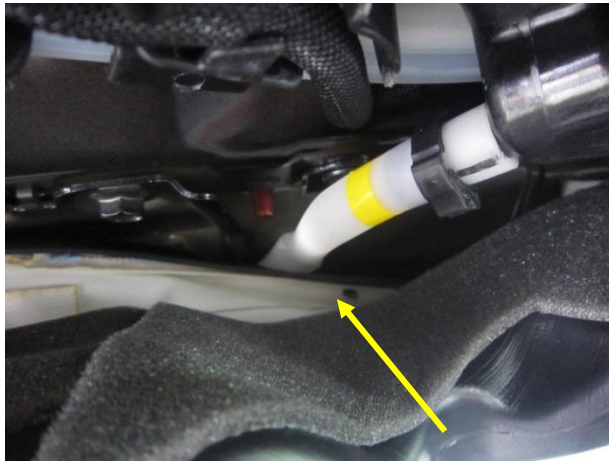
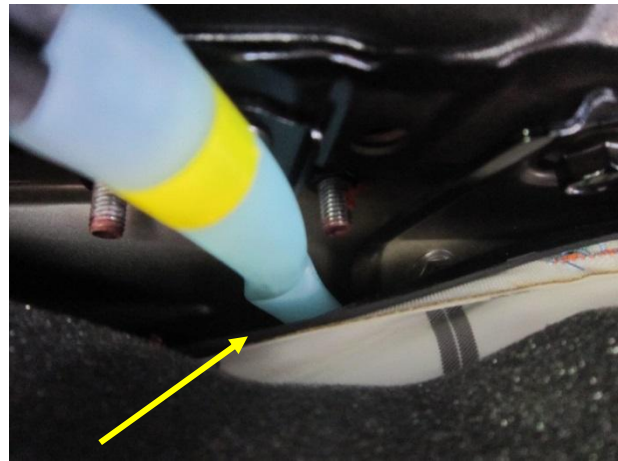
Some vehicles may experience a condition in which the drain hoses for the sunroof/moonroof assembly become kinked, or pinched. This may cause water leaks into the cabin from the housing assembly drip trays, or the customer may note water stains on the headliner assembly.

The material used on these hoses will retain a shape memory once pinched, kinked, or damaged. Therefore it is important that vehicles experiencing this condition, receive replacement service part drain hoses that have not been kinked/pinched/damaged during storage or shipping and are completely clear of any shape abnormalities.
