# Service Bulletin

## PRELIMINARY INFORMATION

**Subject:** Diagnostic Tip - Battery Discharged Overnight

**Models:** 2015-2016 Chevrolet Colorado  
2015-2016 GMC Canyon

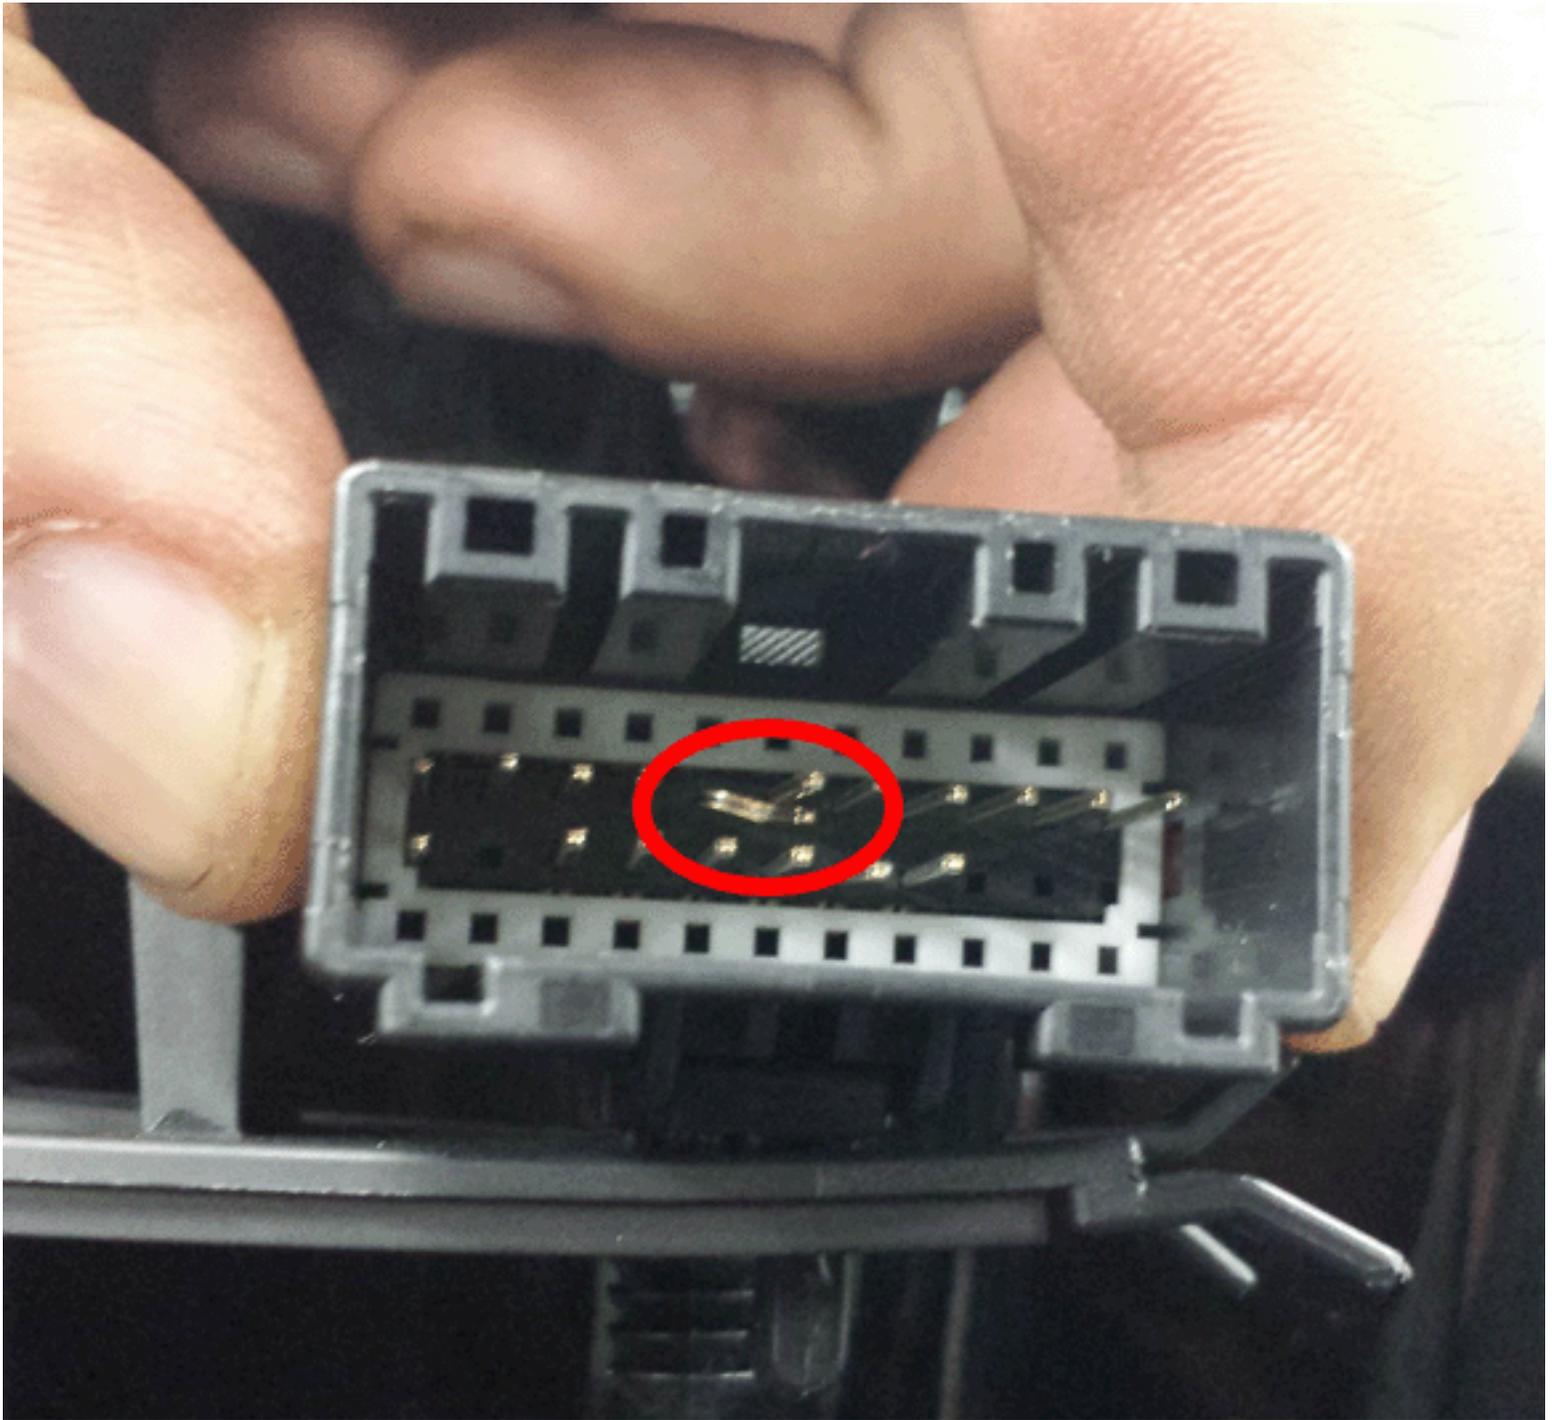
The customer may state that the battery is discharged overnight. The technician may duplicate a 150mA to 450mA draw.

Inspect X301 (Headliner to Body Harness near the CHMSL) for bent pins as shown below. Repair or replace terminals as needed.
