Technical Service Webinar
July 12, 2016

Technical Service Webinar

Agenda:

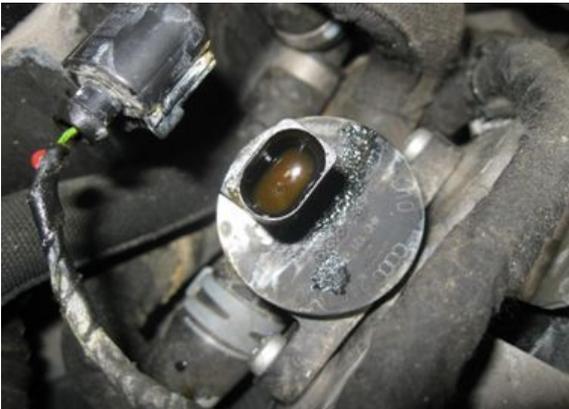
- Coolant loss is found from one or more control valves: N82, N509, or N488. Coolant may have migrated into the wiring harness through the connector and into various control units.
- Inspection of the coolant control valves N82, N509, or N488 reveals the presence of coolant inside the electrical connector.
- Improved coolant control valves are available to rectify the problem.
- Further diagnosis is required after valve replacement to identify the full extent of the damage. Check the ECM, TCM, and HVAC modules for the presence of coolant at the connector.

Example of coolant leaking through the valve.

The coolant is pushed through the harness by the pressure in the cooling system. The wiring will need to be cut back until dry non-corroded wire is found then new wire and terminal ends can be installed.

If the coolant has traveled all the way to the module then it is recommended to overlay the wiring for that coolant valve circuit from the valve to the module using new terminal ends. The plastic harness connectors can almost always be cleaned and re-used, unless they fail to hold the terminal end in place.

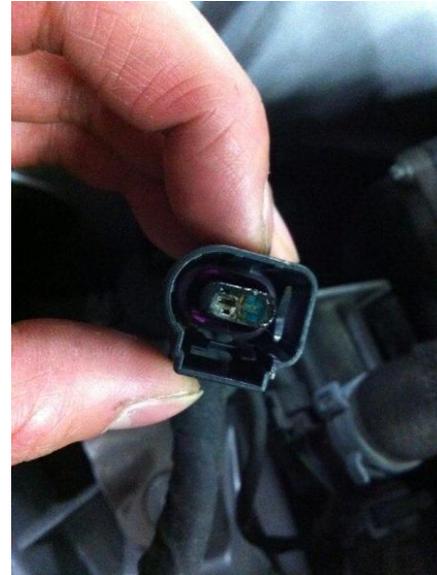
Example of coolant leaking through the harness connector.

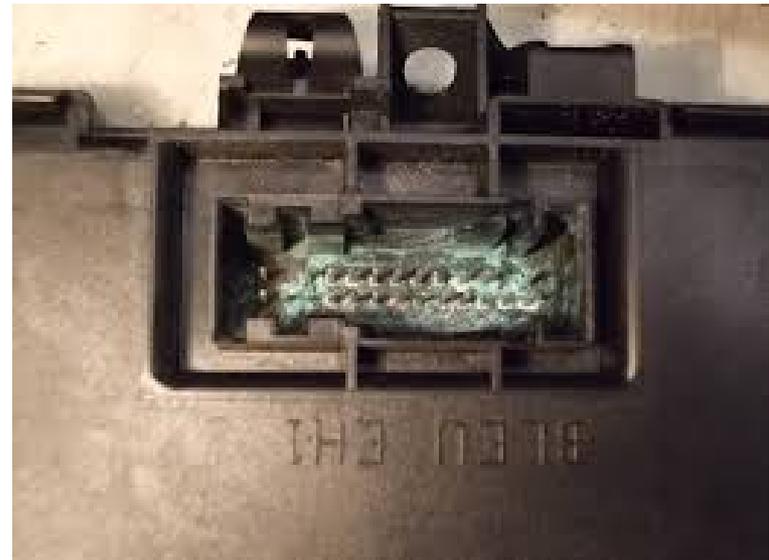
Control module inspection

Check the ECM, TCM, and HVAC modules for corroded pins or the presence of coolant. If a corroded pin is found then that module will need to be replaced. If the pins are wet but no corrosion is found then clean the module and continue with repairs.
