# Service Bulletin

**Subject:** Antenna Missing During PDI

Brand:	Model:	Model Year:		VIN:		Engine:	Transmission:
		from	to	from	to		
Chevrolet	Trax	2016	2017	All	All	All	All

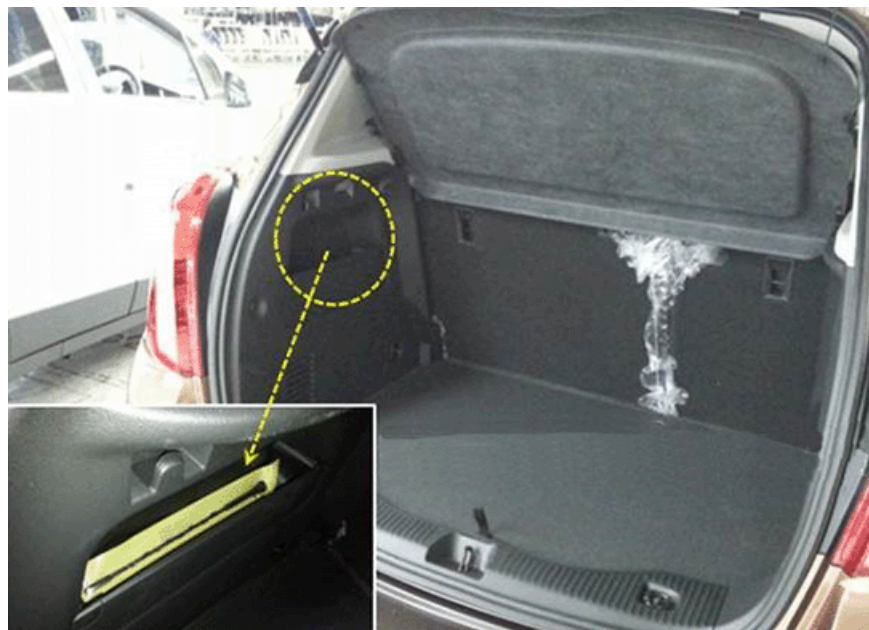
Involved Region or Country	North America
Additional RPO/s:	N/A
Condition	Dealers are unable to locate antenna during PDI
Cause	PDI does not show location of the antenna

Antenna is located in the LH trim pocket in the trunk.
