Service Bulletin

PRELIMINARY INFORMATION

Subject: Rough Idle In Drive

Models: 2015-2017 Cadillac Escalade Models
2014 Chevrolet Silverado 1500
2015-2017 Chevrolet Silverado 1500, Suburban, Tahoe
2014 GMC Sierra 1500
2015-2017 GMC Sierra 1500, Yukon Models
With engines 4.3L, 5.3L, 6.2L RPO L83, L86, LV1, LV3

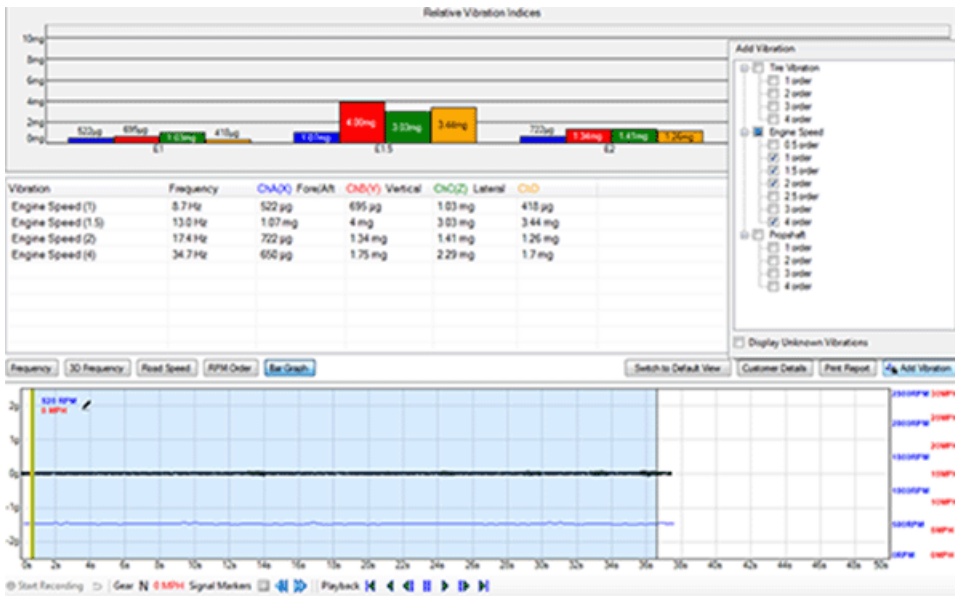
Add E1.5 to the displayed data and turn off T and P related data (under Add Vibration in Pico) since issue occurs with vehicle stationary.

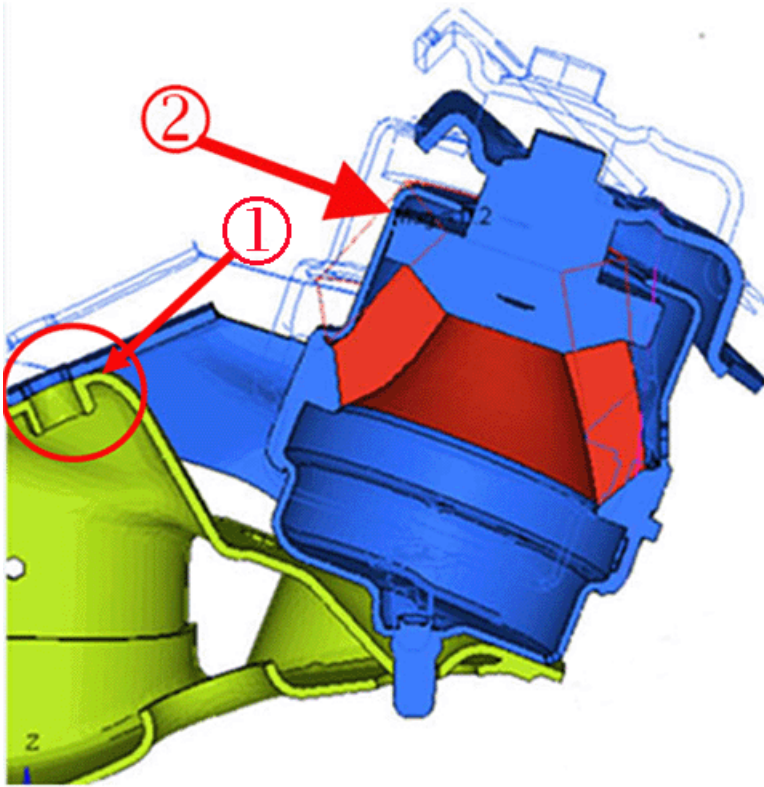
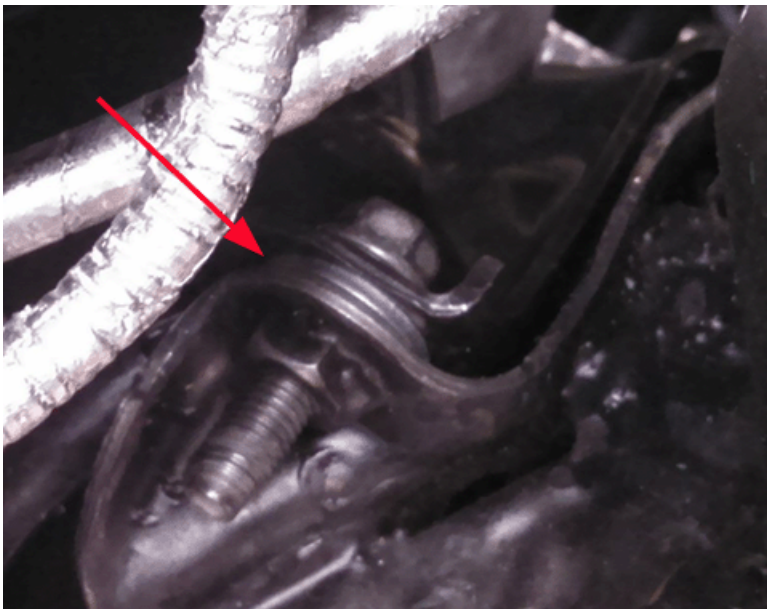
Spacer Washer at Frame Bolt Location Example

Note: Often the idle vibration caused by ground-out within an engine mount (2) may be able to be turned off/on with a single bolt location – shimming that bolt location may greatly reduce the vibration. In some cases, a combination of bolt location shimming may be needed.

- 1.5. If idle vibration could Not be turned off/on – repeat process with middle bolt.
 - 1.6. If the idle vibration Could be turned off/on with one bolt, add a spacer washer, approximately 2.5 mm thick (1) when the engine mount and frame attachment at that bolt location.
