Service Bulletin

PRELIMINARY INFORMATION

Subject: Vibration During Active Fuel Management V4 Mode Operation 1200 – 1400 Engine RPM

Models: 2014-2015 Chevrolet Silverado
2014-2015 GMC Sierra
Equipped with 4.3L RPO LV3

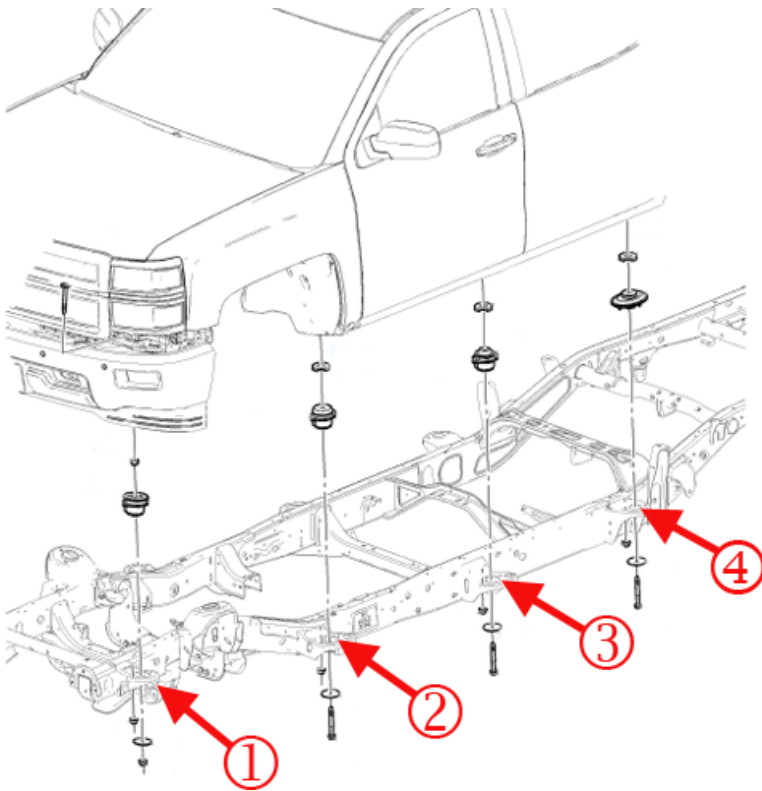
The cab / body mount position locations

The numbers in the picture below indicate the specific mount position. The mounts on the passenger side of the vehicle are identified the same way. This will assist the technician to identify the correct location of each mount so they can be torque to the proper specification.

1 = body mount cushion front

2 = body mount cushion position number 1

3 = body mount cushion position number 2

4 = body mount cushion position number 3

The technician should first loosen the fastener located at the center of each body mount (6 for a regular cab, 8 for crew and double cab).

Using a large angled pry bar, lift up the cab body slightly to settle / relax it. Perform this at each mount location one at a time.

Repeat this cab mount settling process twice, to confirm the mounts are settled / relaxed.

Visually verify that the cab to box alignment is correct before re-torquing all mounts to specification found in Service Information, body repair, frame and under body section.
