Bulletin No.: PIP5419

Subject: Crack Around Left Hand Catalytic Converter Mounting Flange

Brand:	Model:	Model Year:		VIN:		Engine:	Transmission:
		from	to	from	to		
Chevrolet	Impala	2014	2016	All	All	3.6L RPO LFX	All
Cadillac	XTS	2013	2016	All	All	3.6L RPO LFX	All

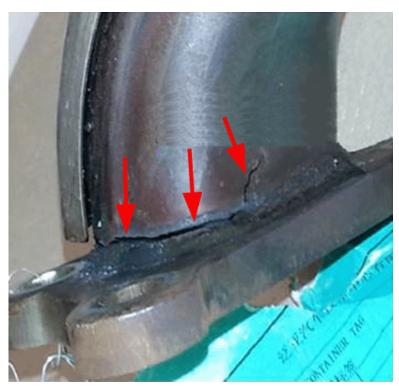
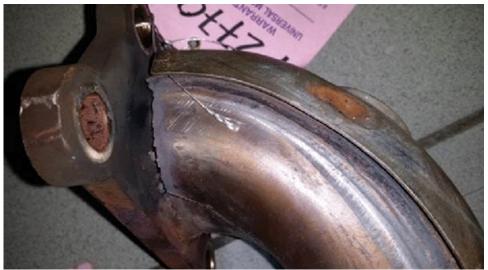
Involved Region or Country	North America, Middle East & South Korea
Additional RPO/s:	LFX
Condition	Customer may experience noise from the exhaust. Catalytic converter pipe cracking at the left hand (front bank) catalytic converter near cylinder head mounting flange weld. In rare instances the failure may reoccur after the catalytic converter has been replaced.
Cause	Under Engineering investigation.

Examples of a crack at the catalytic converter mounting flange:

If the above conditions are not applicable and the pipe is found to be cracked at the left hand (bank 2 / front) catalytic converter mounting flange, replace the catalytic converter with latest part number from GMSPO.
