Service Bulletin

PRELIMINARY INFORMATION

Subject: Malfunction Indicator Lamp Illuminated With DTC P0300

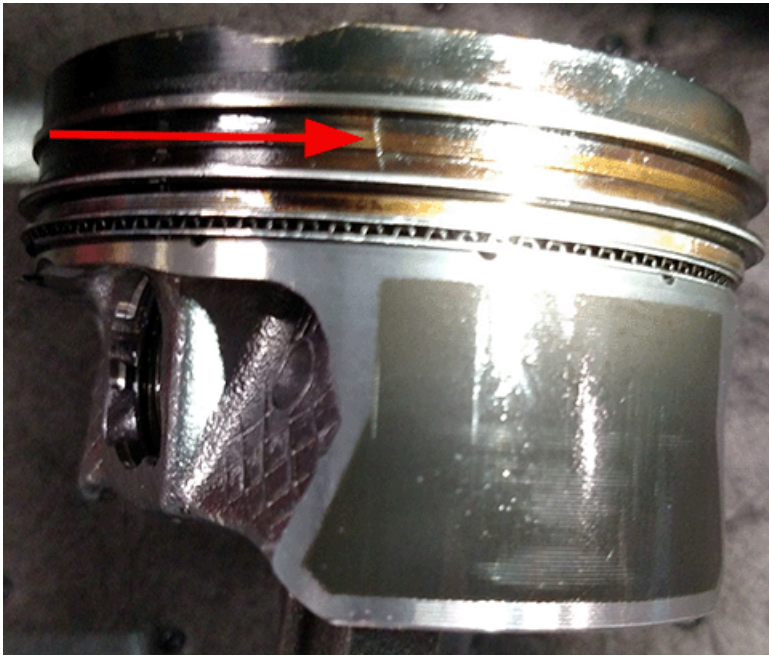
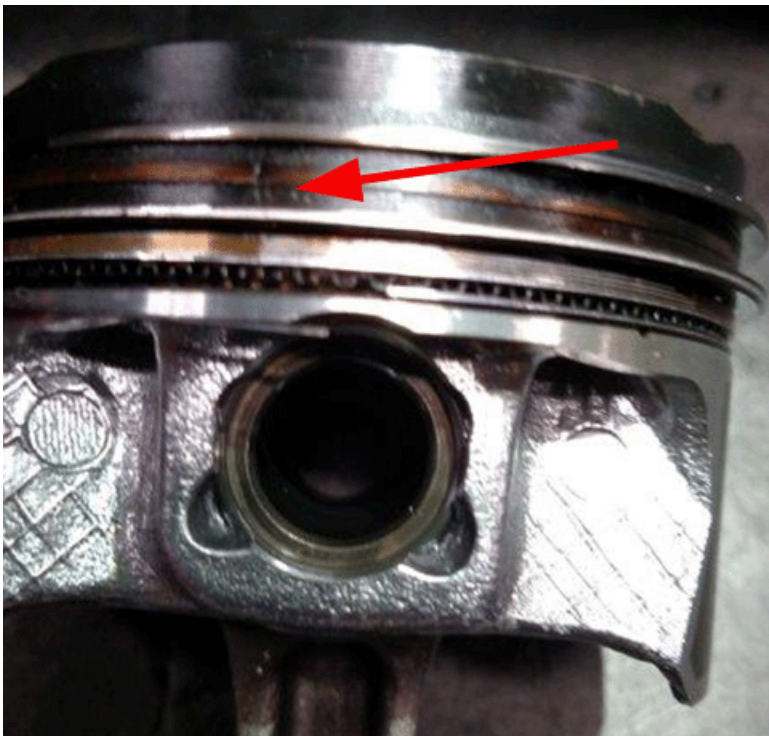
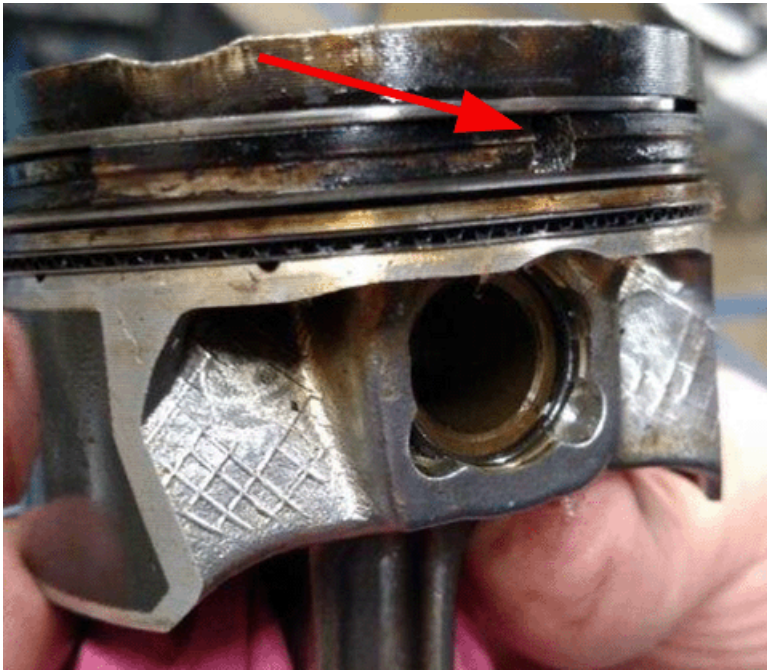
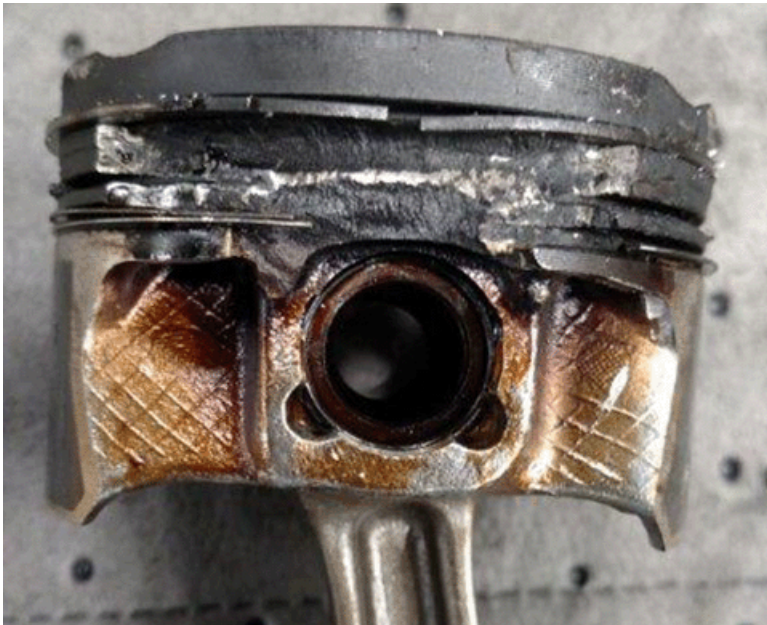
| Cause | This condition may be caused by a damaged piston. |

Shown below are examples of pistons with varying levels of damage.

If the cylinder wall surface has not been compromised, replace the damaged piston.

Note: Do not replace pistons that do not show damage.

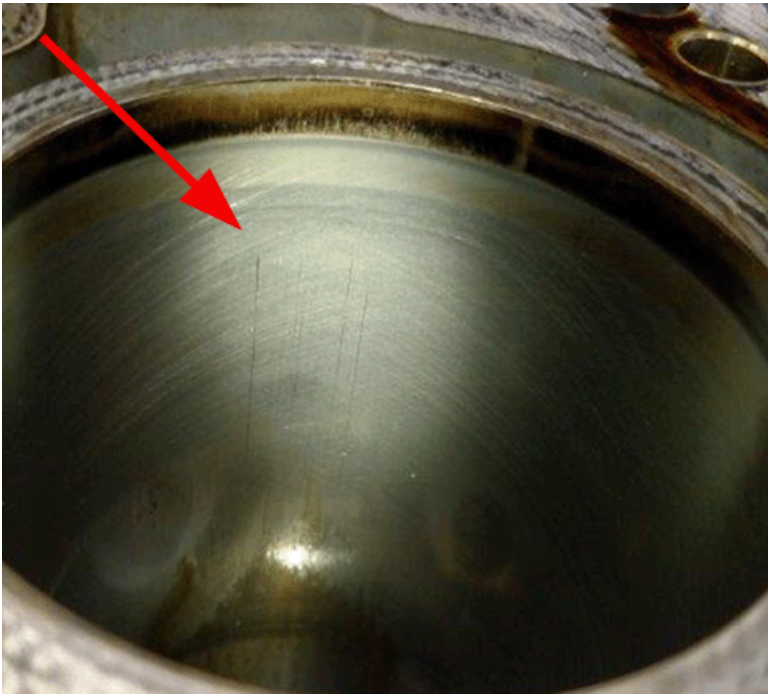
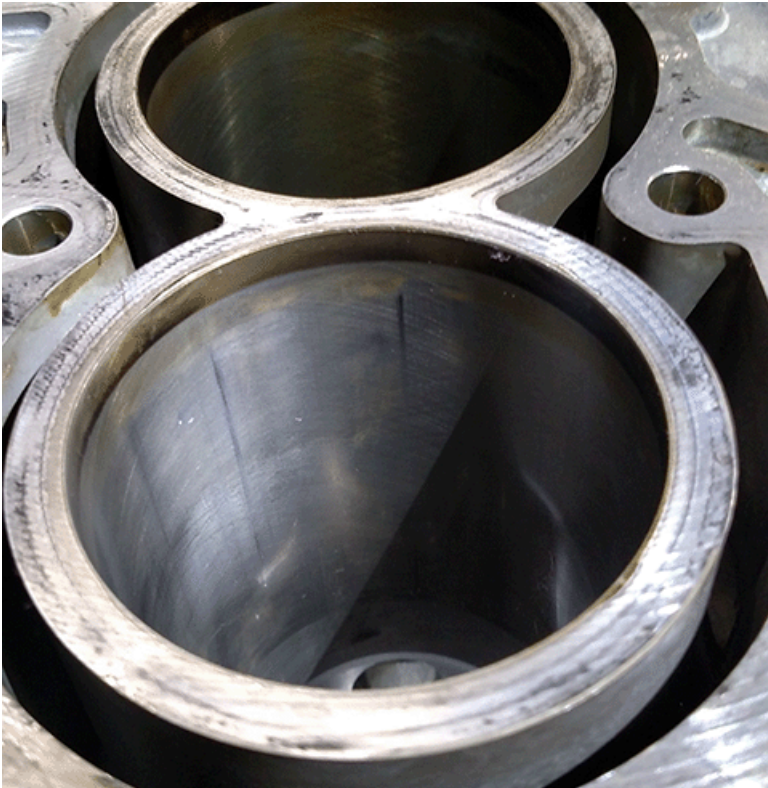
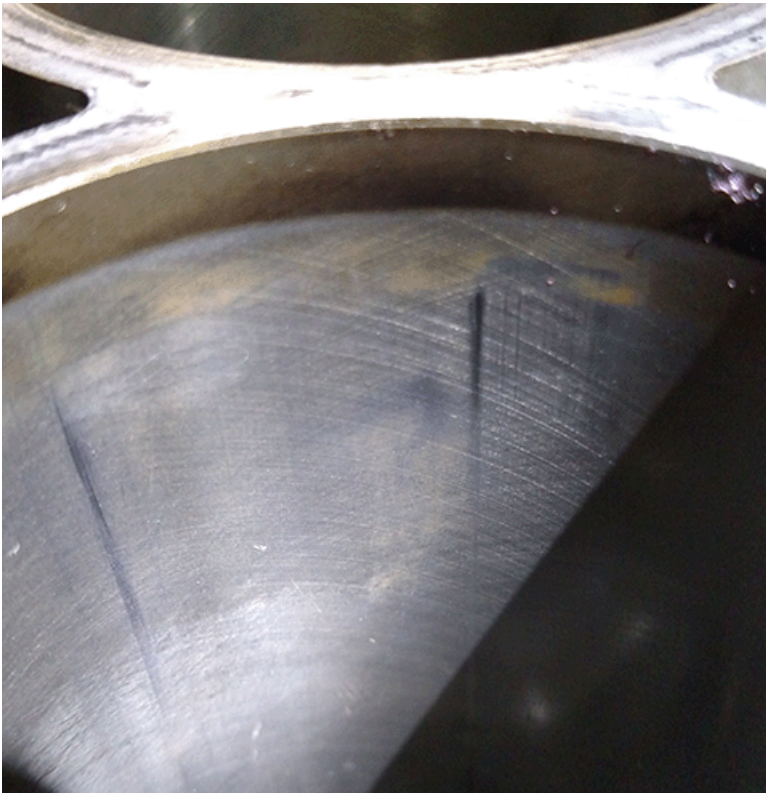
Shown below are several examples of light vertical marks visible on the cylinder wall.

In these examples, none of the marks in the cylinder walls could be felt with the finger tip or nail and engine replacement is not recommended.

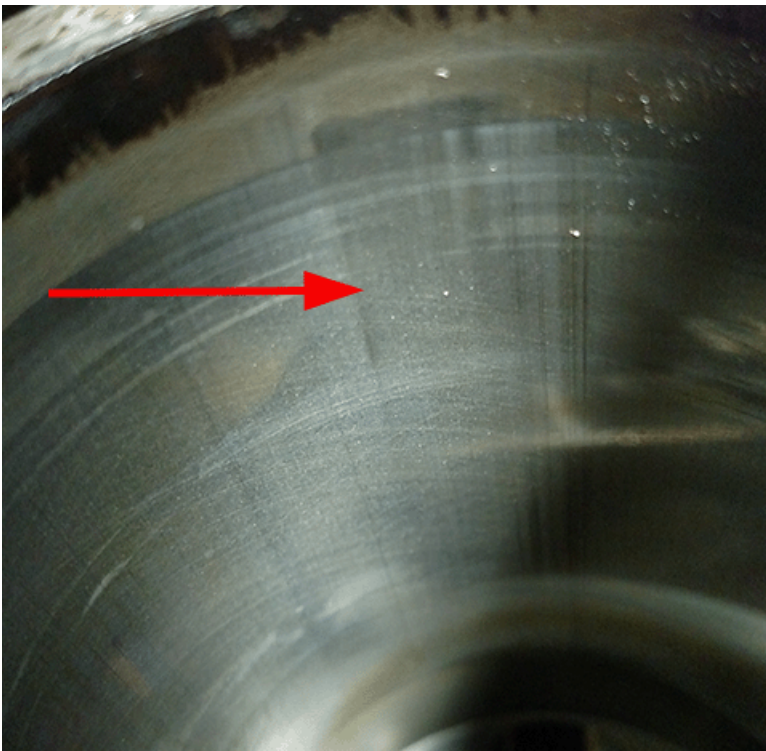
Shown below is an example of a damaged cylinder wall.

In this example the scuffing is wide and has removed the crosshatch from the cylinder wall in the area above the arrow.

This would result in oil consumption and requires engine replacement.
