Service Bulletin

Subject: Dent/Ripple Appearance Around Wheel Well Opening

Models: 2007-2017 Chevrolet Silverado
2007-2017 GMC Sierra

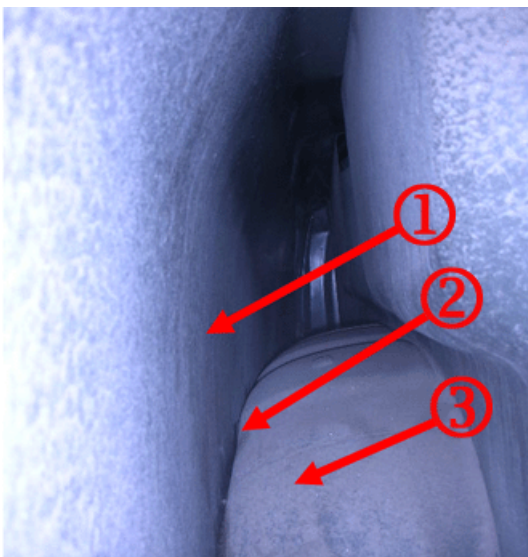
Raised dents or ripple appearance in the side outer panel of the cargo box around the perimeter of the wheel house opening due to the lodging of stone/aggregate/debris between the wheelhouse, and the side outer panel.

1. Side outer panel
2. Area where stone/aggregate/debris can get stuck

3. Wheelhouse

1. Remove the tail lamp to access the inner area of the side outer panel above the wheelhouse, see picture below.
2. Inspect for any stone/aggregate/debris. Remove as needed using a power washer and/or shop air blow gun.

4. Access the rear of the inner wheelhouse area through the tail lamp cavity; and the front of the wheelhouse from under the vehicle, and coat the inner hem of the wheel house to side outer panel, with 3M Rust Fighter I, or equivalent, see latest version of 01-08-51-003.

7. Apply enough undercoating to prevent stone/aggregate/debris from getting between the inner wheel house and side outer panel.
8. Reinstall tail lamp.
