Service Bulletin

PRELIMINARY INFORMATION

Subject: EZ Lower Tailgate Opens Too Quickly / Additional Effort To Close

Models: 2014 Chevrolet Silverado 1500
2015-2017 Chevrolet Silverado
2014 GMC Sierra 1500
2015-2017 GMC Sierra
With EZ Lift and Lower Tailgate (RPO PPA)

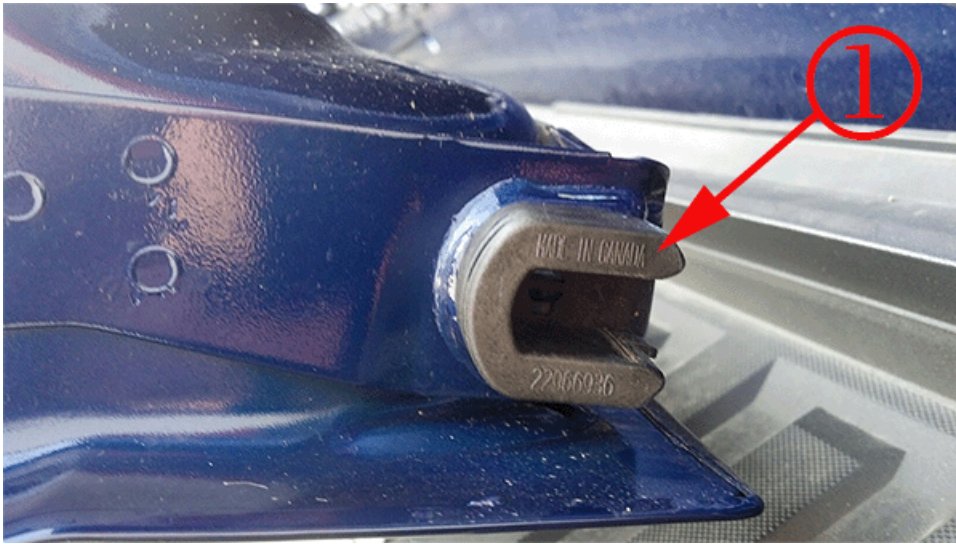
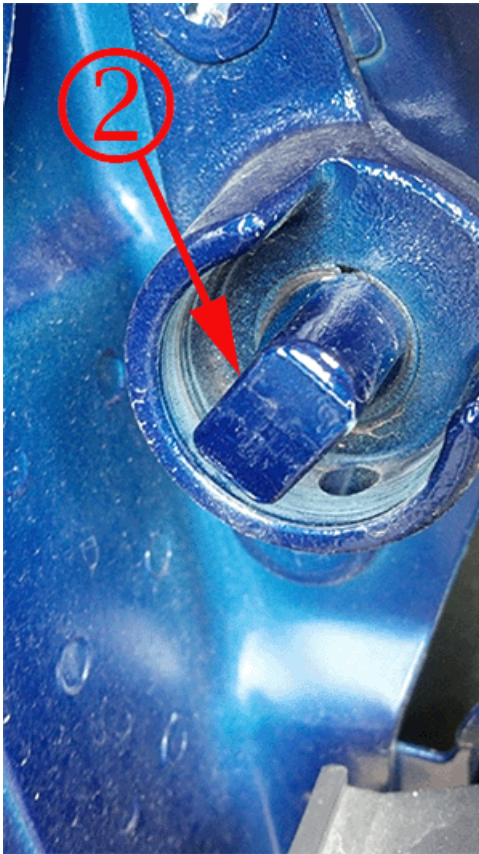
3. If the tailgate opens too quickly, inspect the right tailgate bushing. The right tailgate bushing (1) has a double flat design which keys/splines the tailgate to the dampener shaft (2). If the right tailgate bushing (1) becomes deformed/cracked/broken/etc., the dampener will no longer be keyed/spined to the tailgate. This can cause the tailgate to open too quickly. The tailgate bushing would need to be replaced to correct this concern.
