In This Issue...

Vehicle Technical Information

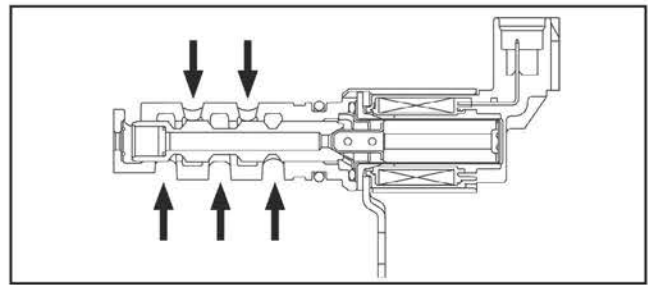
MIL ON, DTCs FOR VARIABLE VALVE TIMING CODES P0010, P0011, P0013, P0014, P0016, OR P0017 -- 2013-2015 Outlander Sport/RVR. Remove the intake and exhaust oil control valves and inspect for contamination in the mechanical portion of the valve. If debris is found, use a dental pick or similar tool to remove it from all 5 oil passages. See drawing at upper right.

Confirm the solenoids' electrical operation by performing Actuator Test (Item No. 17) as detailed in Group 13A before reinstalling the intake and exhaust oil control valves.

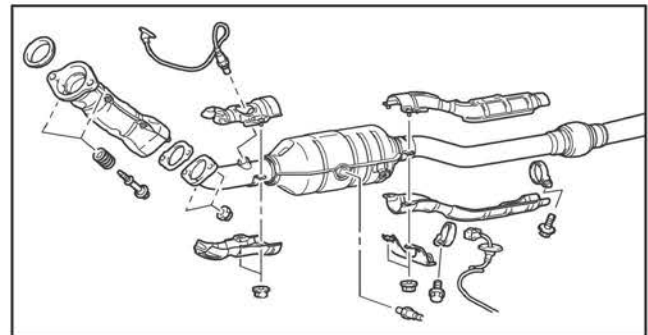
EXHAUST HEAT SHIELD SERVICE PARTS AVAILABILITY -- 2013 and newer Outlander Sport/RVR. Several of the exhaust pipe heat shield components are now available as service parts. When repairing a vehicle for a noise due to a loose heat shield, do not replace the center exhaust pipe with catalytic converter if the heat shield can be serviced separately. Consult CAPS for further details.

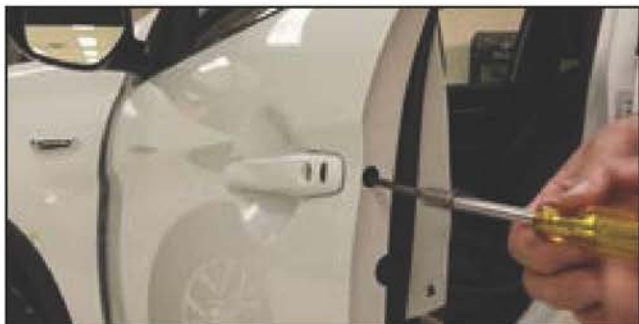
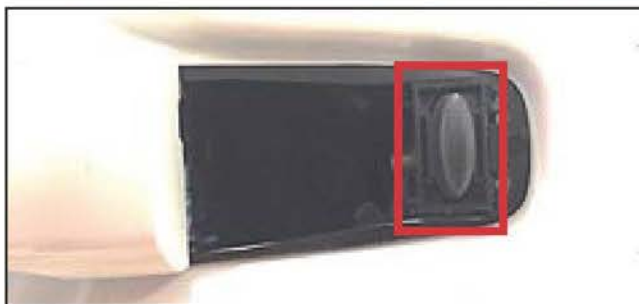
KOS OUTSIDE DOOR LOCK PUSH BUTTON SWITCH NOT FUNCTIONING – 2013-2015 Outlander Sport/RVR. The LH and RH outside door lock push button switch can become stuck against the side of the door handle cap. This causes the lock button to not extend above the door handle surface making the locking function inoperable. This may be an intermittent condition.

Repair: Remove the outside door handle cap from the door assembly per the following instructions. Open the door and remove the round black sticker adjacent to the outside door handle from the rear face of the door (save for reuse). Loosen the Torx 30 bolt through the uncovered access hole. The bolt will not come completely out as it is retained in the handle assembly by a clip. When the bolt is loosened, it must be pulled rearward (magnet) to clear the handle cap attaching hole. Open the outside door handle half way and pull the cap straight out. Examine the surface of the rubber boot to confirm there are no holes that would allow water into the switch. Replace the push button switch on any vehicles with damaged switch boots. Apply Krytox Weatherstrip Lubricant - MMNA P/N 04773427 to the side surfaces of the rubber boot cover. Allow a minimum of 15 minutes of drying time before reassembling. Only Krytox should be used due to its long term durability and lack of silicone. Silicone

based lubricants can adversely affect the electrical function of the door latch immediately below this KOS switch.

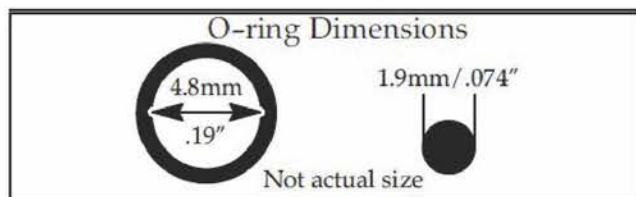
✓ **WASHER PUMP LEAKING AT FITTINGS**
2013-2015 Outlander Sport/RVR. If you find leakage at the washer pump forward of the right front tire, or the washer is inop, check if the washer pump fluid inlet/outlet assembly has become dislodged from the pump (refer to Group 51 - Exterior → Windshield Wiper and Washer for information). Confirm the o-rings on the pump outlets are in place. If o-rings are missing, it is NOT necessary to replace the entire washer pump. Though not available from your facing PDC, suitable replacements can be sourced locally using o-rings made of EPDM (Ethylene Propylene Diene Monomer) rubber, with an I.D. of 4.8mm and a material cross section of 1.9mm (NAPA p/n - 727-2602).

Install the new o-rings to the outlet fluid connections and reinstall the outlet to the pump. If the o-rings are simply dislodged, but not lost, and they are not cut or damaged, they can be reused. If it is necessary to replace the gasket between the fluid tank and pump, it is available separately (PNC 84233, p/n 8260A161).

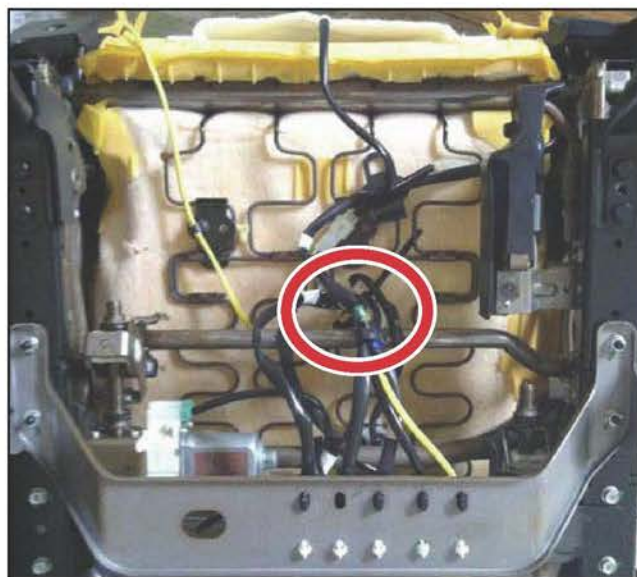
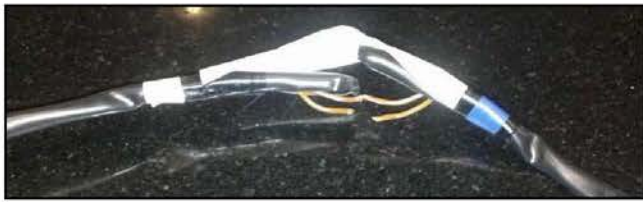
DRIVER'S SEAT SLIDE SENSOR WIRING HARNESS DAMAGE UNDER DRIVER'S SEAT with DTC B1556 -- 2013-2015

Outlander Sport/RVR. As published in TIN-15-52B-001, MMNA has identified warranty claims for SRS DTCs B1558 [Occupant Classification-ECU DTC Present] and B1556 [Driver's Seat Slide Sensor Malfunction (Occupant Classification-ECU)] with OCM DTC B1B8D [Driver's Seat Slide Sensor Open Circuit]. Additional OCM DTCs that may also be present are: B1B8C [Driver's Seat Slide Sensor Circuit Performance] and B1B8E [Driver's Seat Slide Sensor Short Circuit].

During diagnosis, technicians should check for damage to the driver's seat slide position sensor harness in the location shown below.

If a damaged harness is found, DO NOT replace the front seat adjuster or SRS ECU for this condition. The harness is now shown in CAPS and is available as P/N 6979A429.

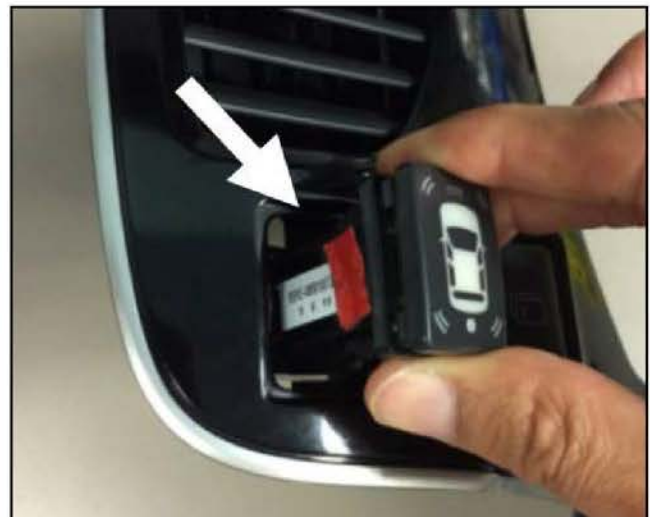
FRONT AND REAR ACCESSORY PARK ASSIST SWITCH INTERMITTENTLY STICKS -- 2016 Outlander. The Park Assist switch (located on the far left side of the vent panel) may intermittently stick when depressed. The left side switch slot wall support is thin/slanted allowing the switch to sit at an angle when fully inserted. **NOTE:** Replacing the vehicle vent panel with a new part will not resolve the concern.

Repair Procedure: Remove the Park Assist switch from the panel. Add a 3M tape or equivalent onto the panel. Dimensions: L 20mm x W 10mm and thickness of 1.5mm

Reinstall switch and verify proper operation.
Verify switch is secured by the 2 locking tabs.
