### SSM 72313 - L405 & L494 Fuel Filling Difficulties

# L405 & L494 Range Rover & Range Rover Sport Fuel Filling Concerns

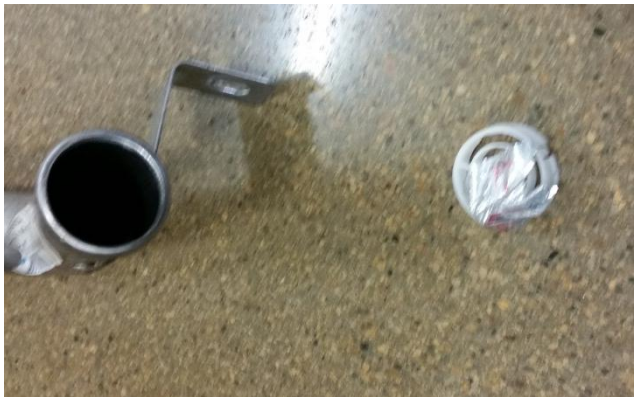
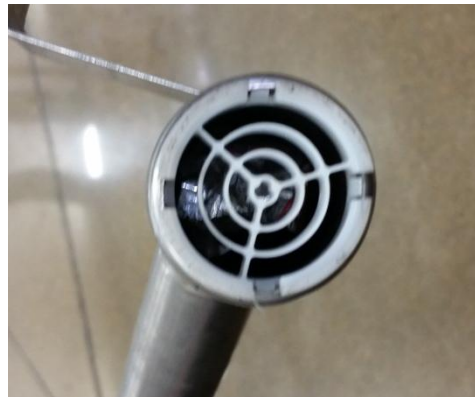
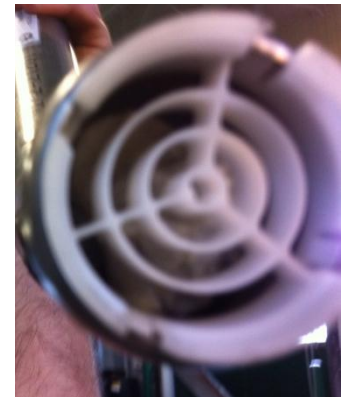
Reports have been submitted showing debris in the filler pipe was causing an obstruction and fuel filling problems.

Debris can be identified using a borescope (no need to remove the fuel filler pipe).

See the examples below:

- ONLY REPLACE THE FUEL FILLER IF A CLEAR FAULT IS OBSERVED. REPORT THE FAULT FOUND ON AN EPQR.
- If cause 1 is identified, correctly install the anti-siphon device.
- If cause 2 is identified, replace the fuel filler pipe (ensure the filler head is in the correct orientation on the new part).
- If cause 3 is identified, reroute the fuel pipe in the tank to prevent the check valve from being obstructed. Also take care to ensure the fuel sender is not obstructed.
- Fill with fuel and check to see if the issue is repaired. If so, report the fault found and fixed on EPQR. If not, raise a TA for further assistance to identify the fault.

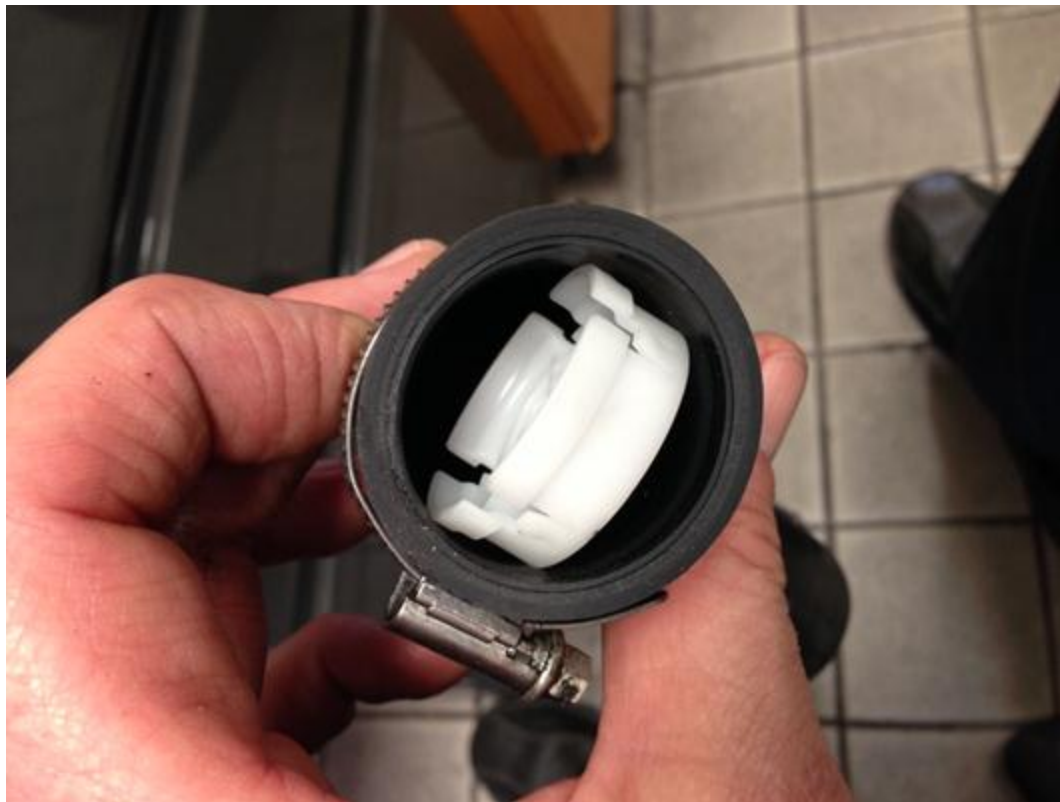
If the anti syphon device is dislodged it will cause the fuel flow to be disrupted and can cause shut off problems (as per the example below):

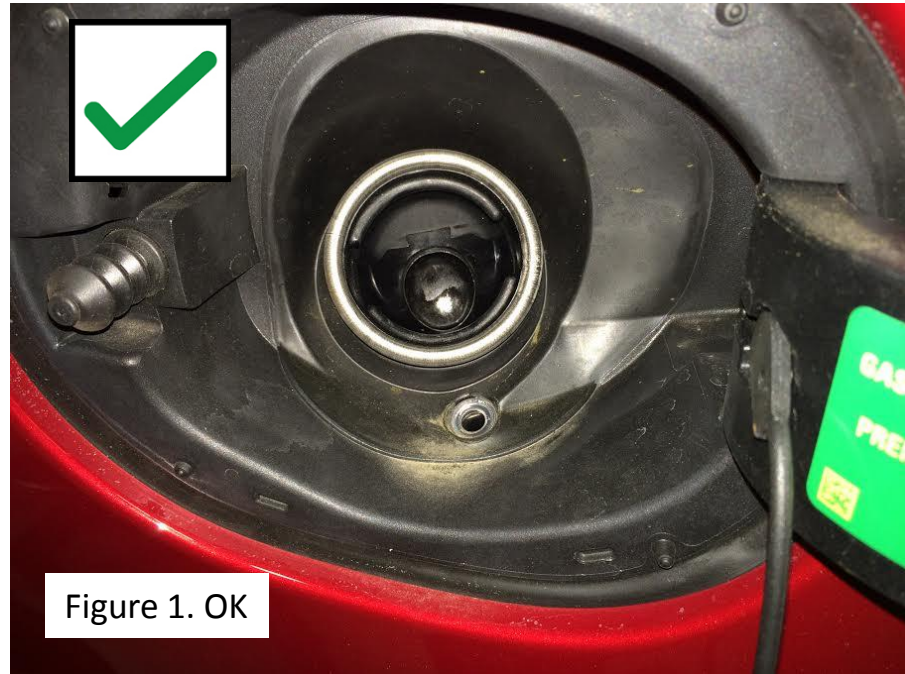
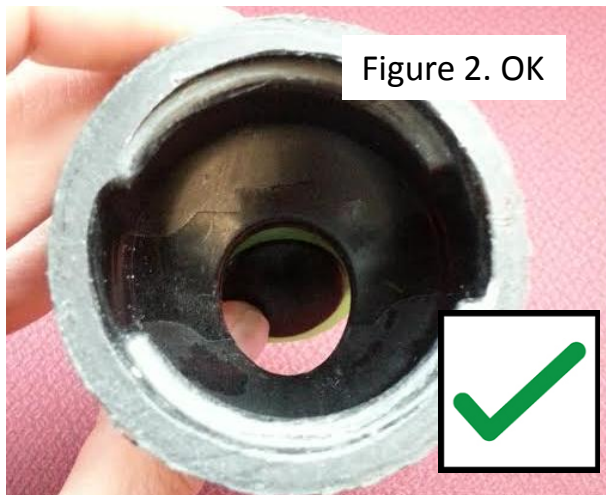
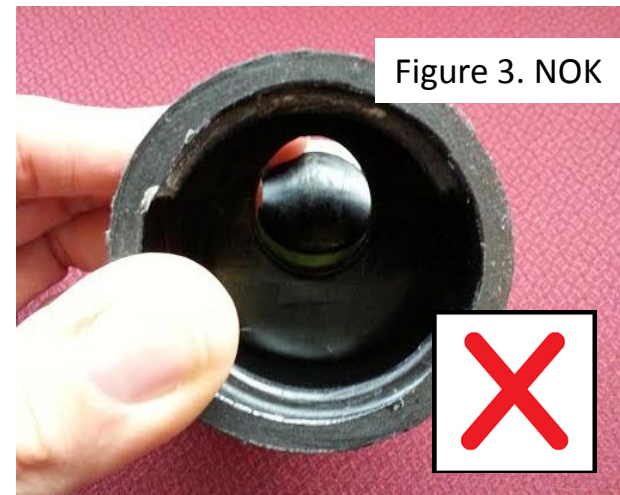
1. Flap should appear as per figure 1 and 2.
2. It must hinge from the top as per figure 2.
3. If it hinges from the bottom (as per figure 3.), the filler pipe must be replaced.
