L405 & L494 Range Rover & Range Rover Sport Fuel Filling Concerns

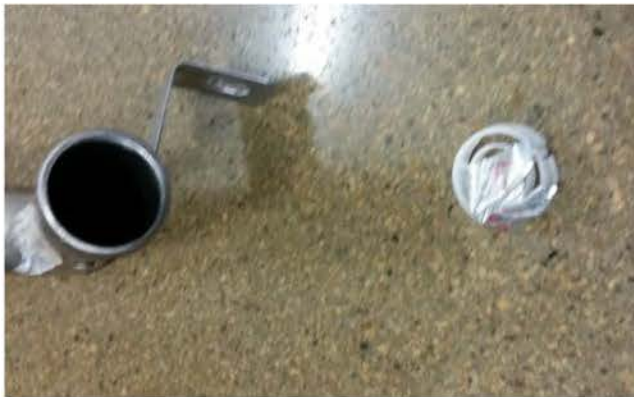
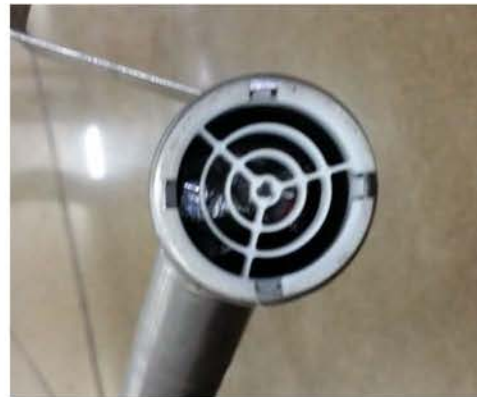
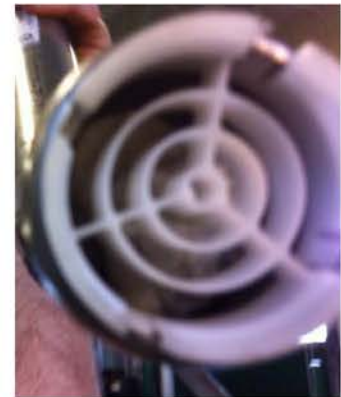
Reports have been submitted showing debris in the filler pipe was causing an obstruction and fuel filling problems.

Debris can be identified using a borescope (no need to remove the fuel filler pipe).

See the examples below:

- ONLY REPLACE THE FUEL FILLER IF A CLEAR FAULT IS OBSERVED. REPORT THE FAULT FOUND ON AN EPQR.
- If cause 1 is identified, correctly install the anti-siphon device.
- If cause 2 is identified, replace the fuel filler pipe (ensure the filler head is in the correct orientation on the new part).
- If cause 3 is identified, reroute the fuel pipe in the tank to prevent the check valve from being obstructed. Also take care to ensure the fuel sender is not obstructed.
- Fill with fuel and check to see if the issue is repaired. If so, report the fault found and fixed on EPQR. If not, raise a TA for further assistance to identify the fault.

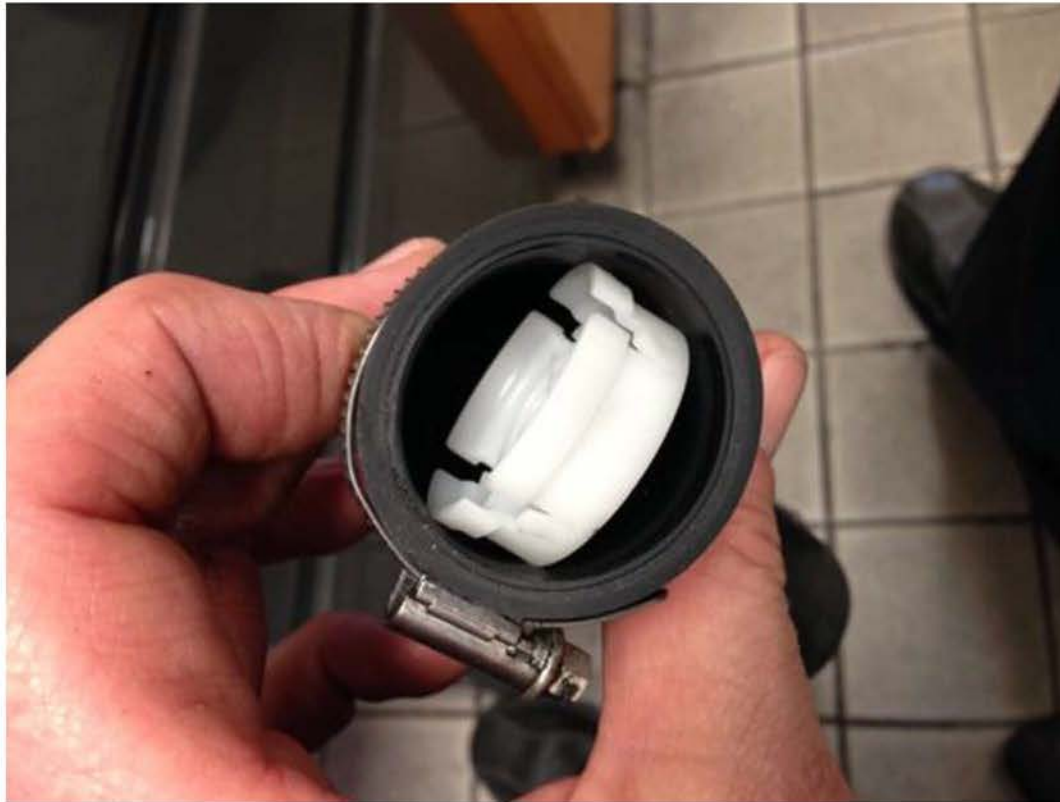
If the anti syphon device is dislodged it will cause the fuel flow to be disrupted and can cause shut off problems (as per the example below):

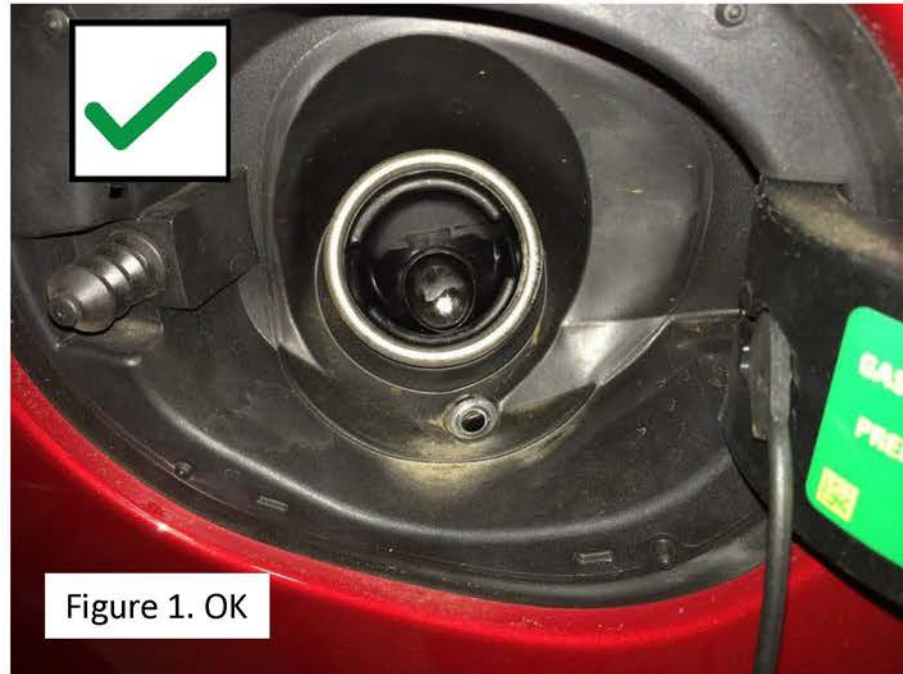
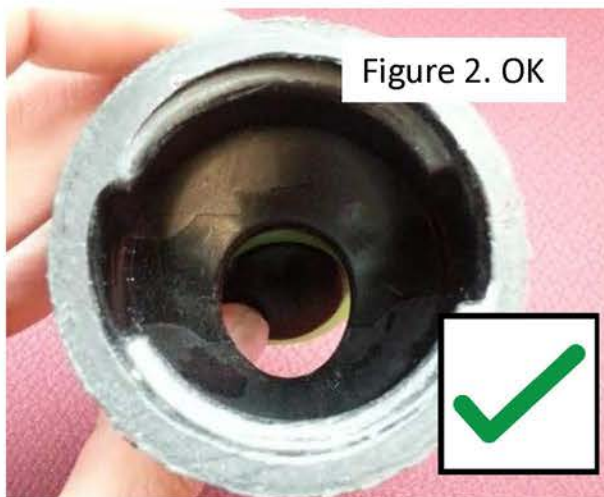
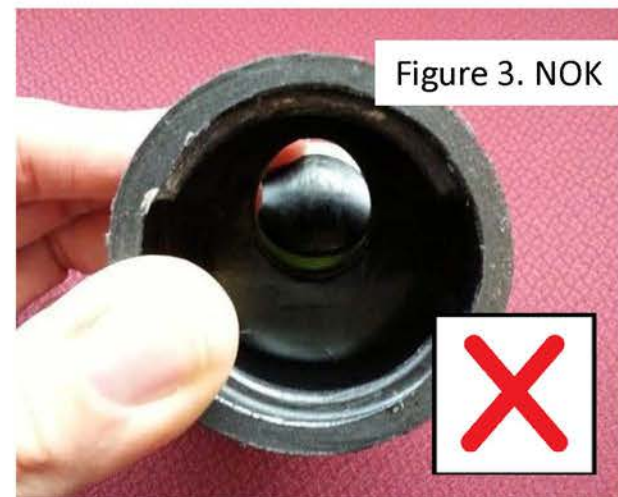
1. Flap should appear as per figure 1 and 2.
2. It must hinge from the top as per figure 2.
3. If it hinges from the bottom (as per figure 3.), the filler pipe must be replaced.

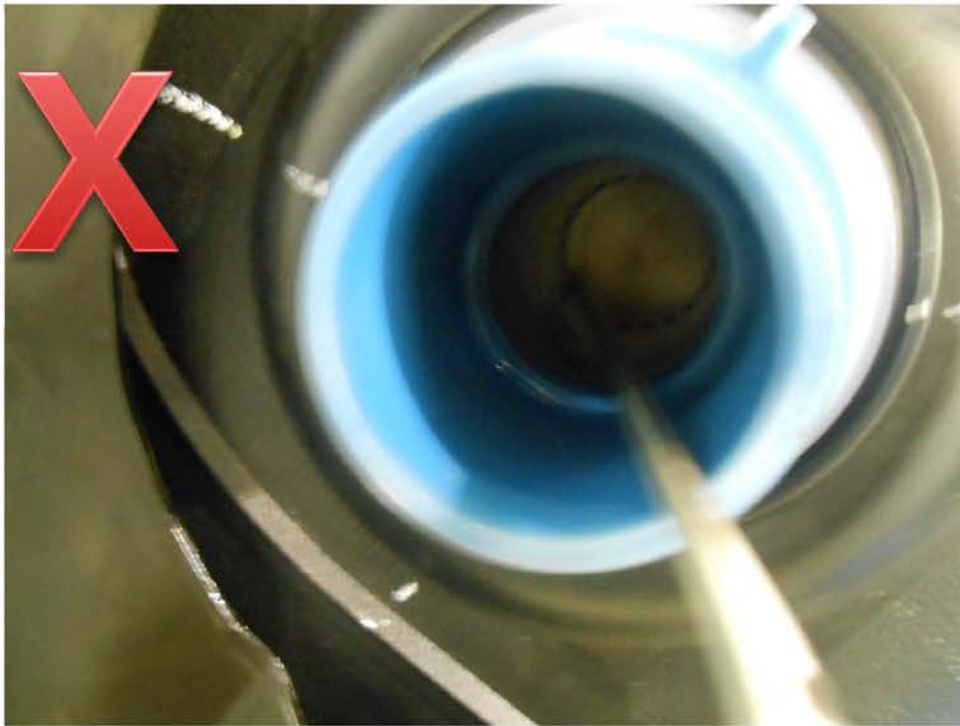
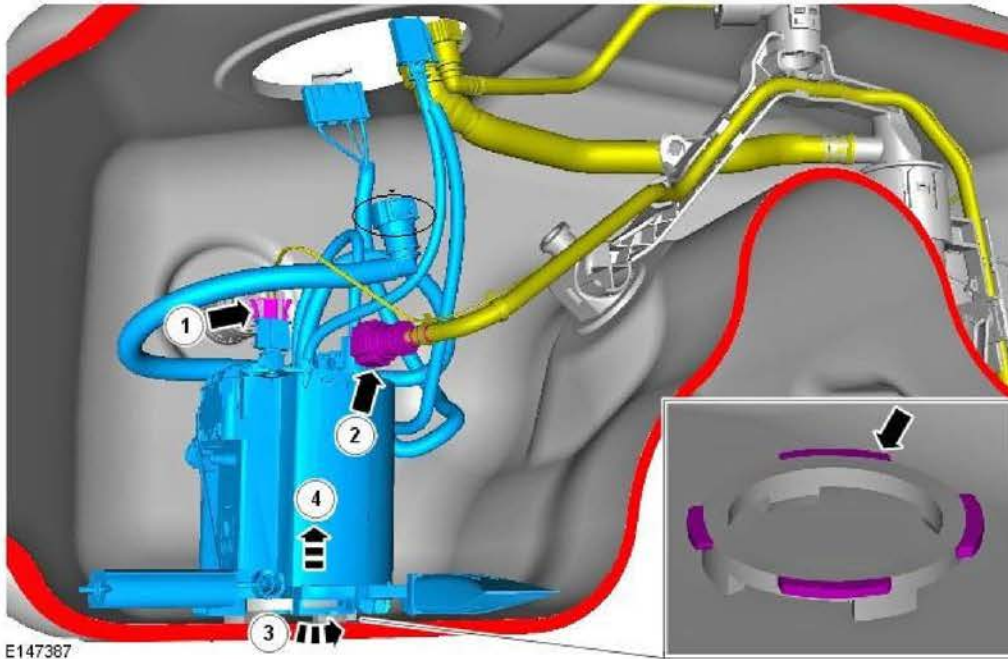
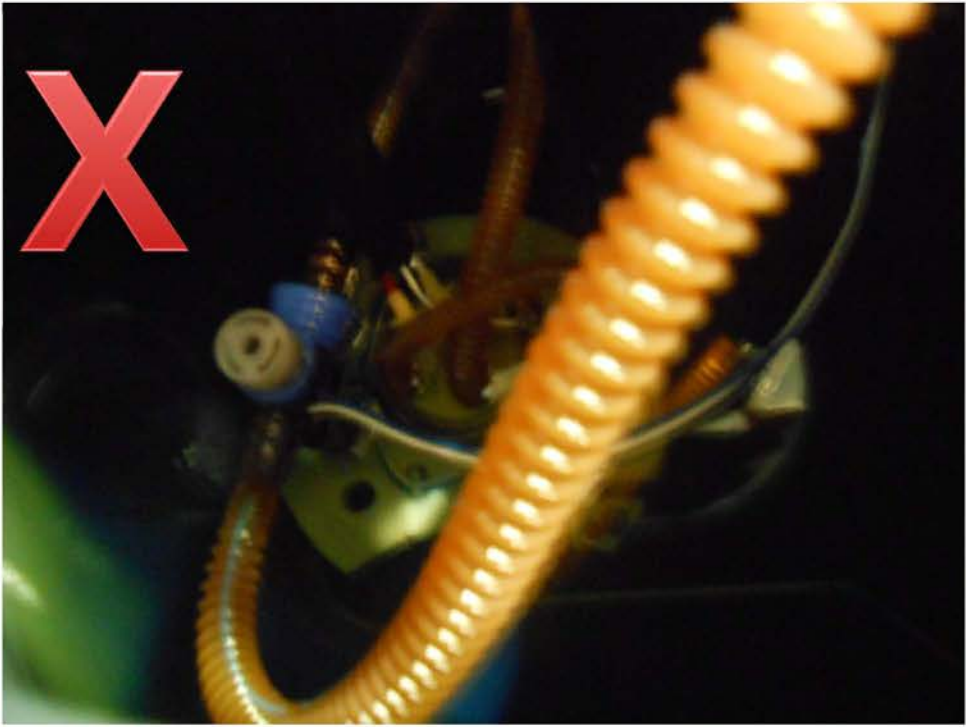
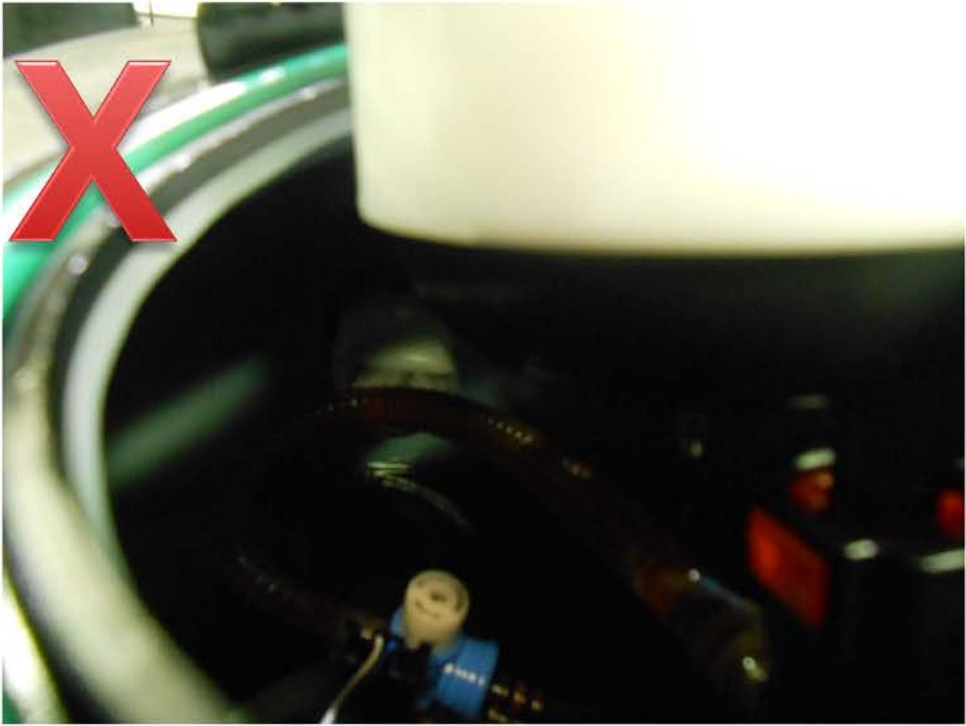
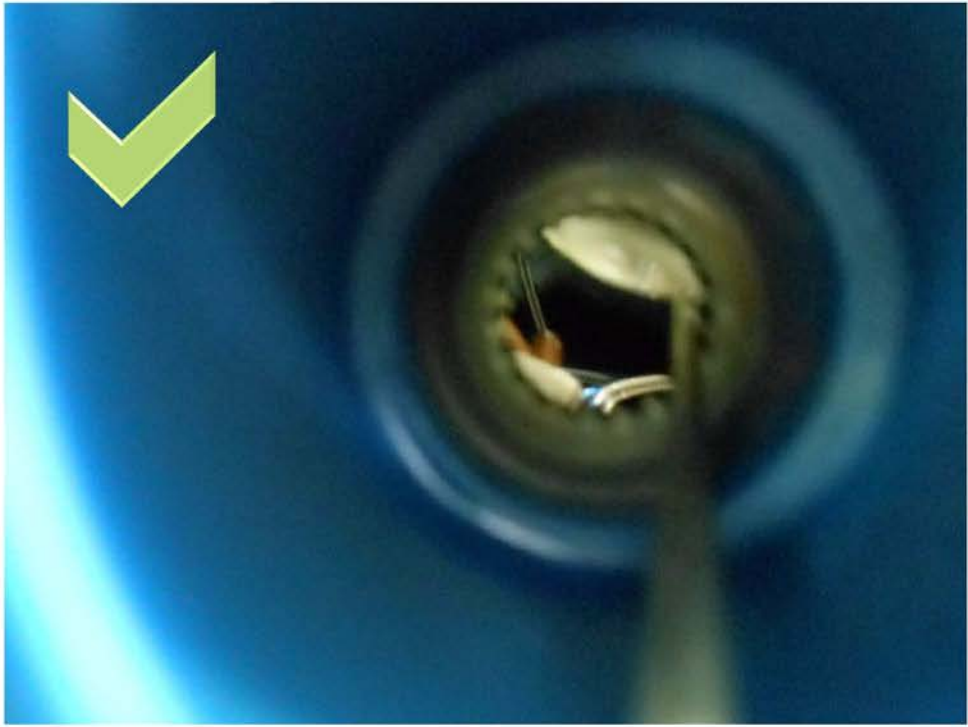
2. Press against the check valve. It should move easily through it's full range.
3. If it does not, refer to 'Removal and Installation' instructions for the fuel filter in workshop manual section 310-01: Fuel Tank and Lines
4. Do not remove the fuel filter, but carefully lift it an visually inspect for any obstruction of the check valve.
5. If obstruction is observed, reroute the fuel pipe in the tank to prevent the check valve from being obstructed. Also take care to ensure the fuel sender is not obstructed.
