# Tech Tips

TT 40-16-01

Date: June 2, 2016

**2014-2016 CC – Knocking Noise from Vehicle Front, Typically occurs only one time after each direction change (forward or backward, left or right)**

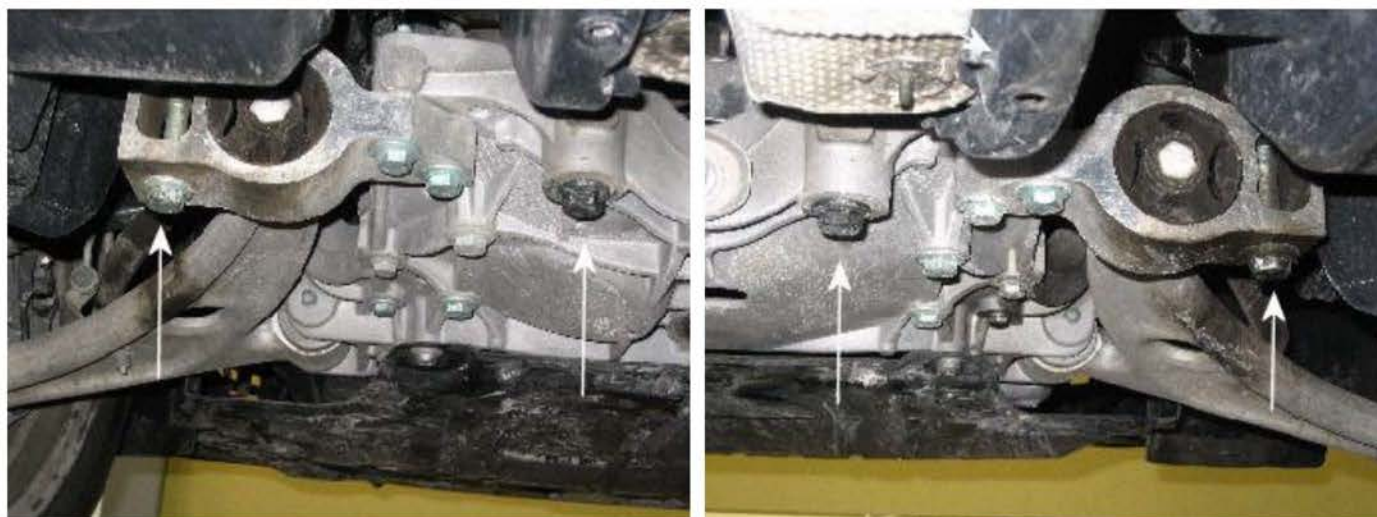
If this concern is identified, inspect to see if the two specialty plates (washers), Part No: 7M3499349A, are installed between the sub frame and body. If not, please perform the following:

- Loosen by two turns, the four bolts towards the rear of the sub frame.
- Remove one inboard bolt.
