Tech Tips

TT 40-16-01

2013-2016 CC - Knocking Noise from Vehicle Front, Typically occurs only one time after each direction change (forward or backward, left or right)

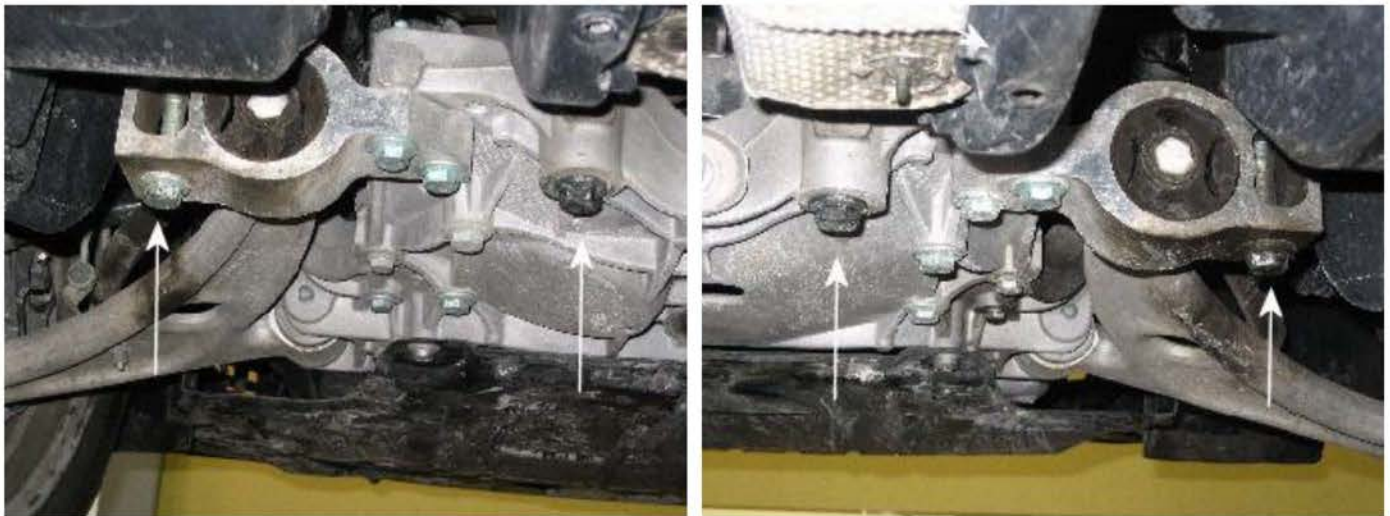
If this concern is identified, inspect to see if the two specialty plates (washers), Part No: 7M3499349A, is installed between the sub frame and body. If not, please perform the following:

- Loosen by two turns, the four bolts towards the rear of the sub frame.
- Remove one inboard bolt.
