Tech Tips

TT 96-15-02

2013-2017 Tiguan-Alarm Horn Tone Weak or Abnormal When Locking

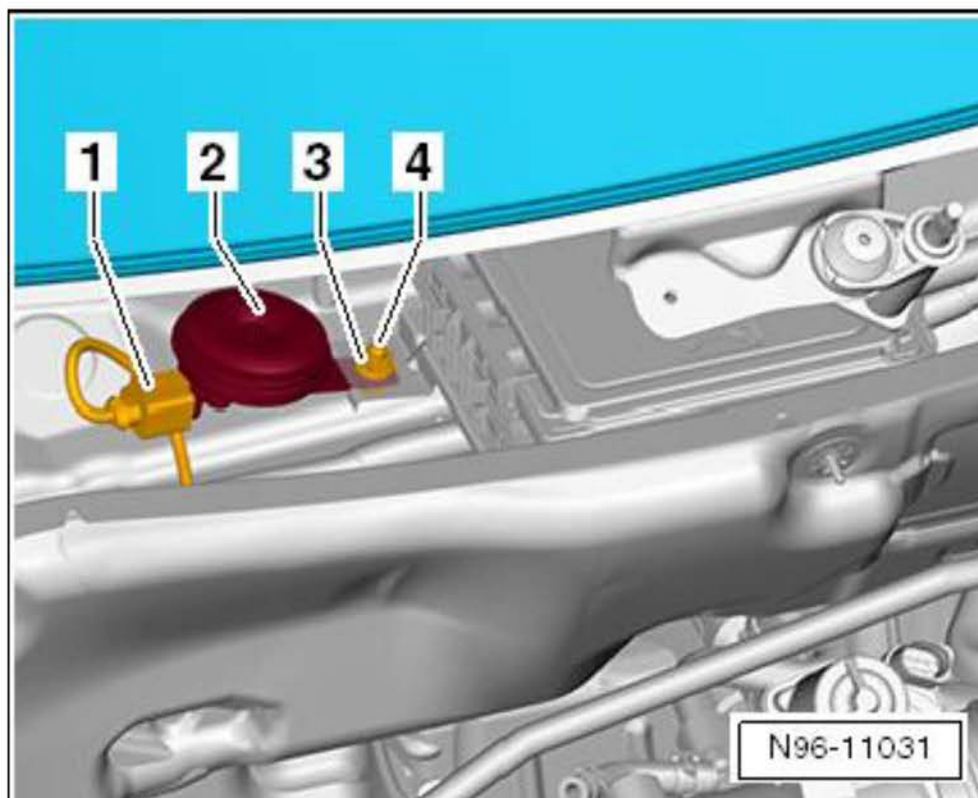
Before replacing the alarm horn (part number 5C0951115) for a weak, muffled, or abnormal tone condition, ensure that the alarm horn bracket mounting nut is securely fastened to the vehicle body (number 3 in the illustration below) with the proper torque specification. According to the Elsa Repair Manual, the specified torque for the securing nut is 20 Nm.
