Tech Tips

TT 61-08-05

2007- 2015 Eos – Convertible Top Repair Tip

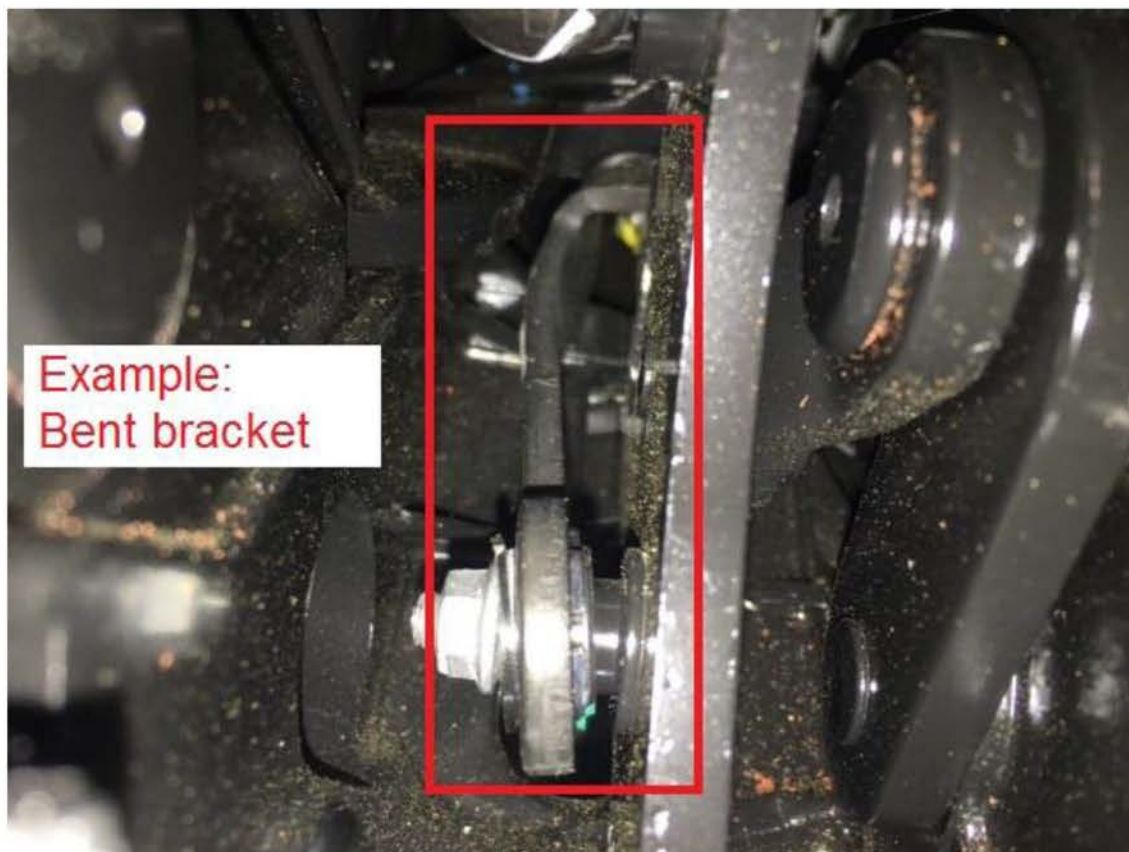
Figure 3b

If, during diagnosis of the convertible top, the adjuster arm for the front lock is found damaged / bent (figure 3b), order part number 1Q0898499 or latest supersession. This one part number will include both sides in the package. Adjuster arm location is shown below with painted roof pillar panel removed. Adjuster arm can be found bent on either or both sides of the vehicle. If adjuster arm is found to be bent, review Tech Tip 2032328 (TT 61-07-105) as a failed side rail latch could be the cause.
