Tech Tips

TT 61-12-01

2012-2016 EOS – Convertible Top Operation Stops, Trunk Does Not Lock Properly and/or Right Flap does not close

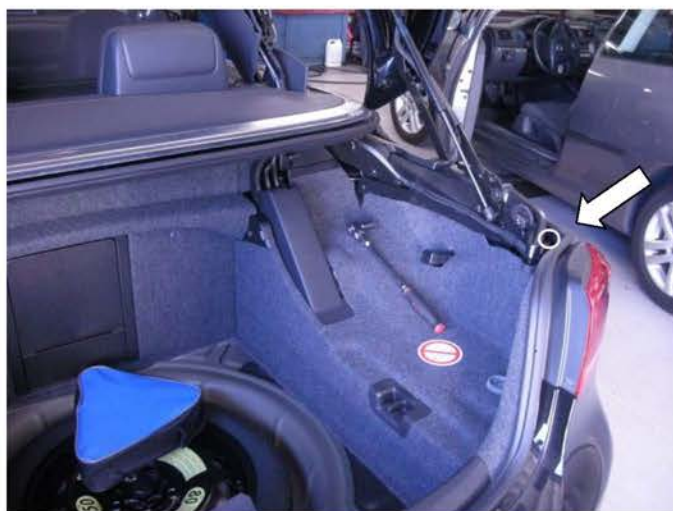
Figure 1: Overview of location on vehicle

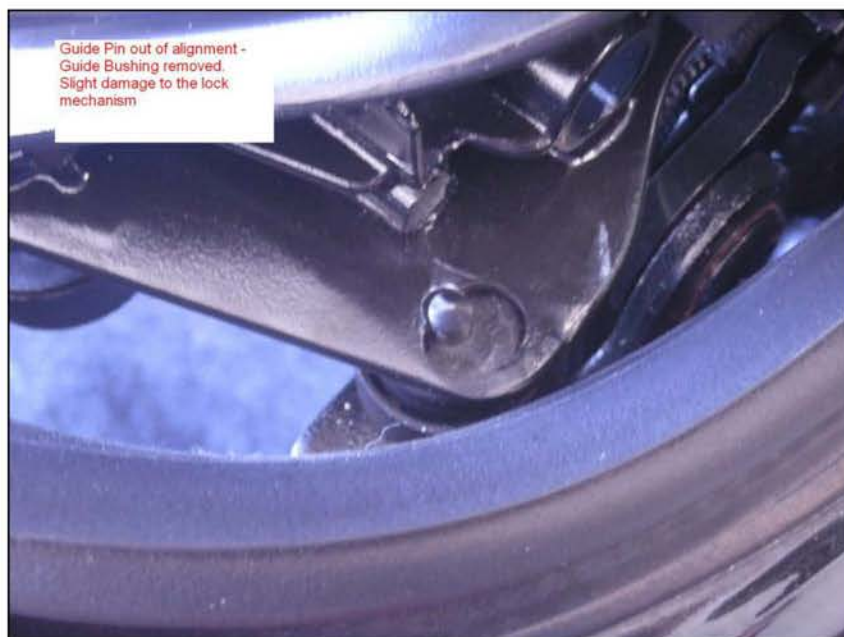
Some 2012-2013 EOS convertible tops may not function properly during opening or closing. The trunk lock operation may not complete, which can cause trunk to be inoperative and/or parcel shelf flaps to remain open when top opening cycle has completed. This may affect the G562, G563, or G564 sensors when running the test plan or looking at MVB 2. The guide bushing at the back of the lock mechanism (location circled in figure 1 below) may not align with the guide pin mounted on the body. It is necessary to remove trim on lock mechanism to inspect guide bushing. Misalignment of lock mechanism can cause damage to the guide bushing. The lock mechanism will need to be adjusted and the guide bushing replaced in most instances.

Figure 2: Guide pin out of alignment (shown with bushing removed)

To repair, open the trunk to access the underside of the parcel shelf. Remove the guide bushing if it is damaged. Loosen the 2 lock mechanism mounting nuts shown in figure 3 below on the underside of the parcel shelf (be sure to only loosen these 2 nuts due to pretension on the lock assembly). Adjust the locking mechanism so that the rear alignment guide pin is centered in the guide bushing hole. Tighten the 2 mounting nuts to 22NM. Close the trunk and cycle the top to check functionality. If the guide bushing was found to be damaged, replace with part number 1Q0898162A (see ETKA for latest supersession).

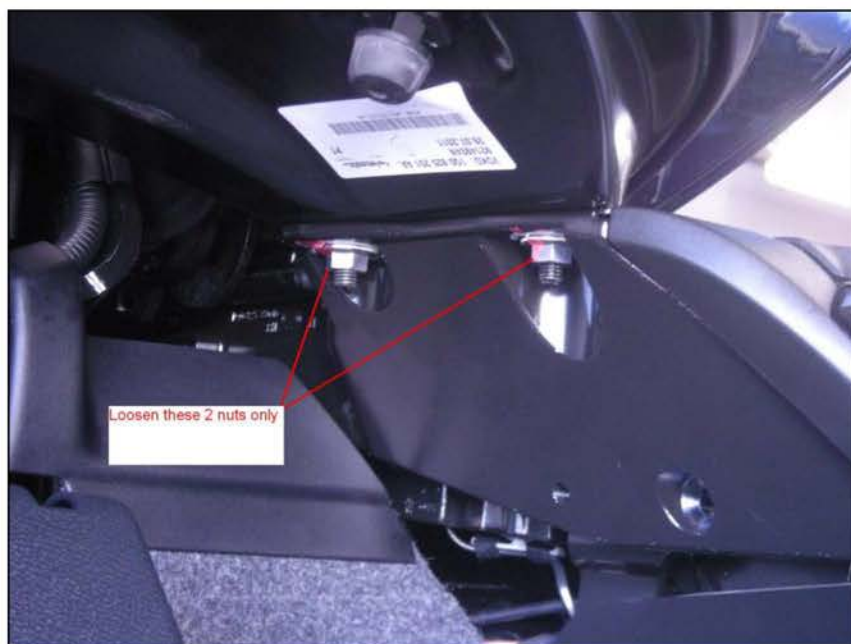
Figure 3: Lock mechanism mounting nuts

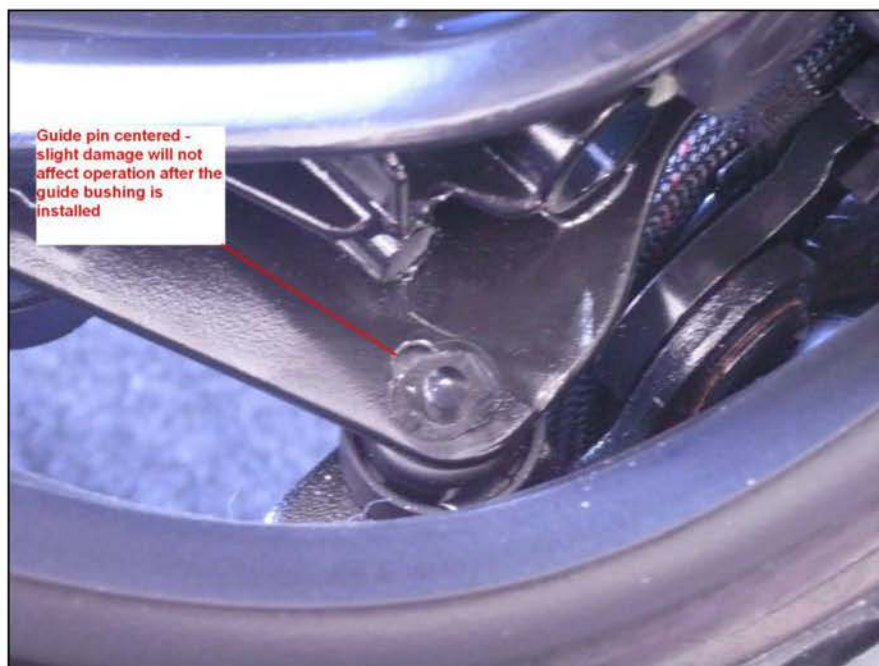
Figure 4: Guide pin centered after adjustment and before installation of new guide bushing.
