01 16 12 July 19, 2016 **2018652** Supersedes T. B. V011214 dated April 27, 2012 to update the warranty table service number.

MIL ON, DTCs P1545, P0121, P0123, P0221 or P0222 Stored in ECM Fault Memory

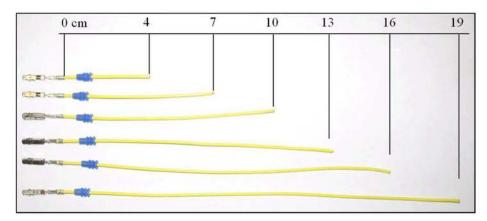
Figure 1. Correctly preassembled wires and seals.

· Lengthen wires and preassemble seals according to Figure 1.

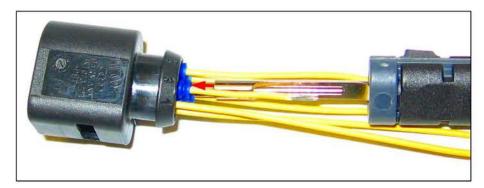
Figure 3. The single wire seal, slid as far as the stop

• Using an appropriate assembly tool, slide the single wire seal up repair wire until it contacts housing. Continue to slide seal into housing as far as the stop (Figure 3).
