Technical Bulletin

63 16 01 July 11, 2016 2044735

Extensive Stone Chipping on Front Bumper Cover

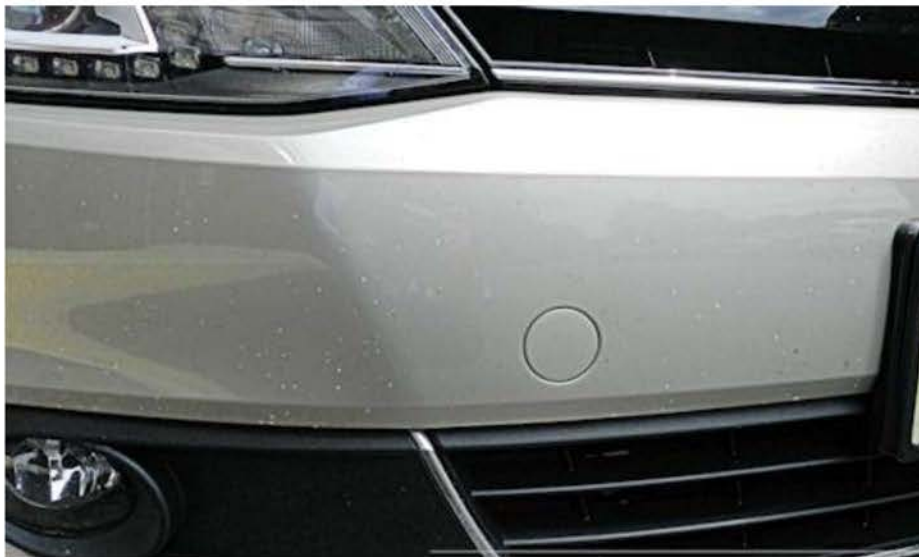
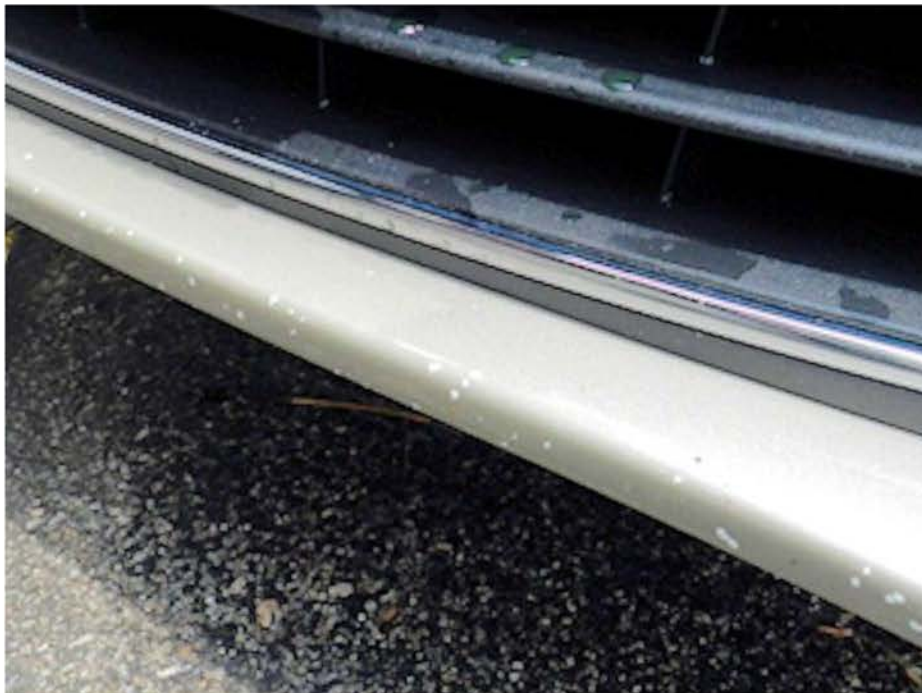
Extensive stone chipping may be found across the entire front bumper cover. Damage may be centralized to the bumper cover with no paint chipping anywhere else on the vehicle.

Incorrect repaint procedure in painting process in some cases caused the paint thickness to be too high on the front bumper covers.

Replace front bumper cover

- Paint new bumper cover according to Volkswagen guidelines.
- Remove the old front bumper cover according to the repair manual. See Repair Manual Group 63 in Elsa.
- Install new front bumper cover according to the repair manual. See Repair Manual Group 63 in Elsa.
